NOTICE OF UPDATED SEPA RECORD AND EXTENSION OF PUBLIC COMMENT PERIOD FOR THE ZENITH PROPERTIES BUILDING DEMOLITION APPLICATION DRAFT ENVIRONMENTAL IMPACT STATEMENT (DEIS)

CITY OF DES MOINES
ZENITH PROPERTIES BUILDING DEMOLITION
PERMIT APPLICATION

DRAFT ENVIRONMENTAL IMPACT STATEMENT
APPENDICES (PART 2: APPENDICES E-K)

Zenith Properties LLC Des Moines Masonic Lodge Economic Feasibility Analysis

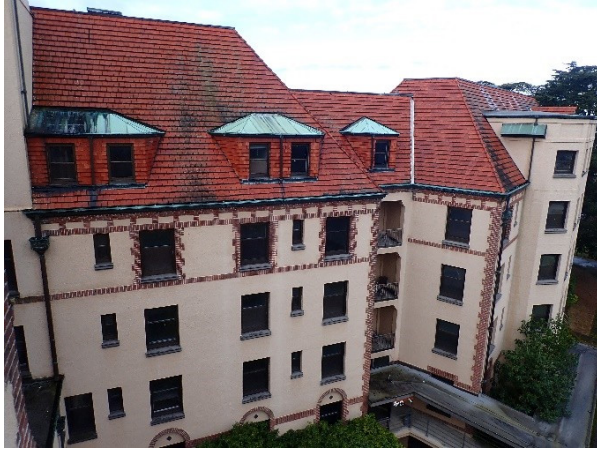
Photo BE1 Typical Roof

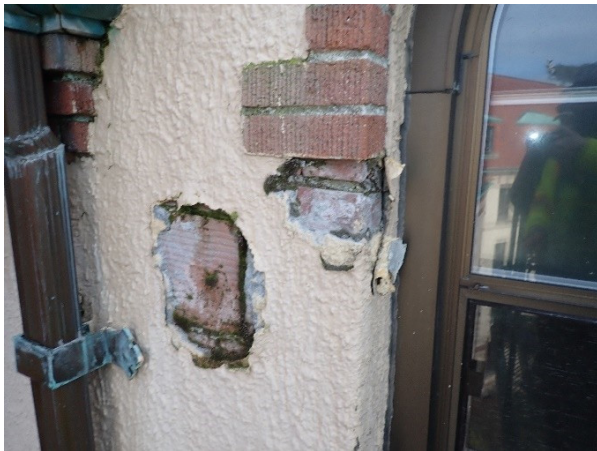
Photo BE3 Typical Wall Plaster Damage

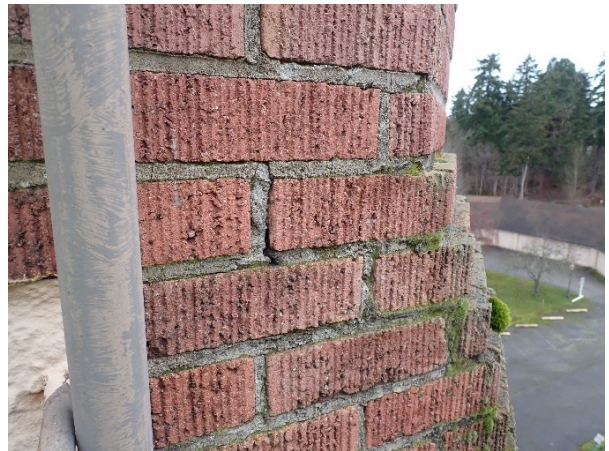
Photo BE4 Typical Wall Brick

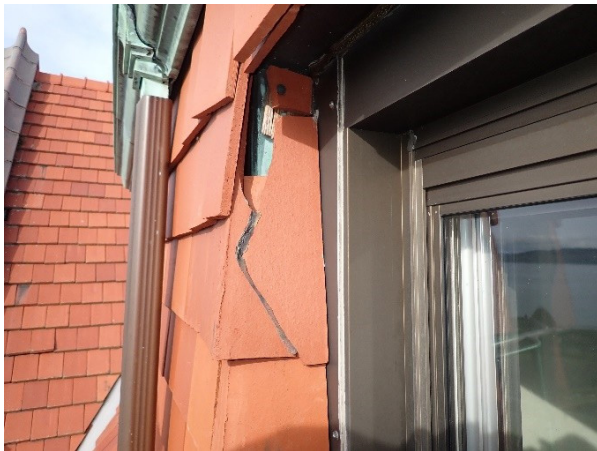
Photo BE9 Typical Terra Cotta Façade Damage

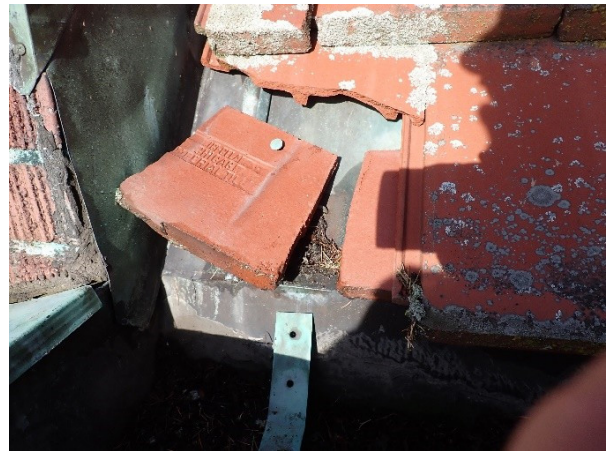
Photo BE10 Typical Terra Cotta Roof Damage

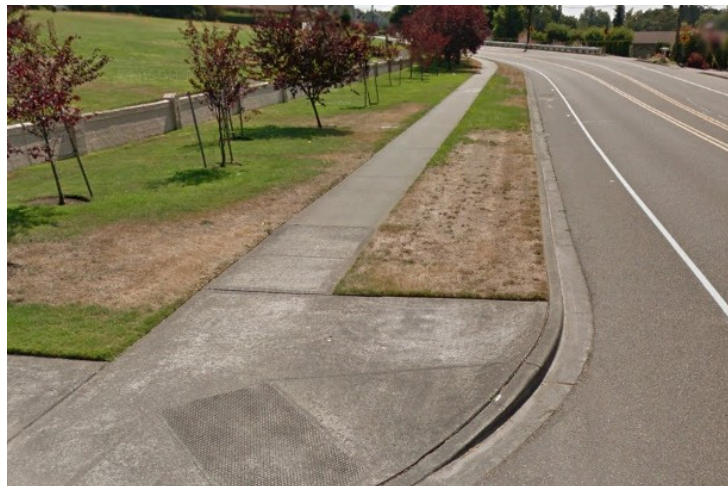
Photo C1 Marine View Drive Typical Frontage Section

The existing 6-inch curb, landscape strip, sidewalk, and driveways appear to be in good condition, see Photo C1. The existing driveways are too narrow to meet current codes and the main entrance may be too steep. The city may require one or both driveways to be replaced and upgraded to their most recent standards.

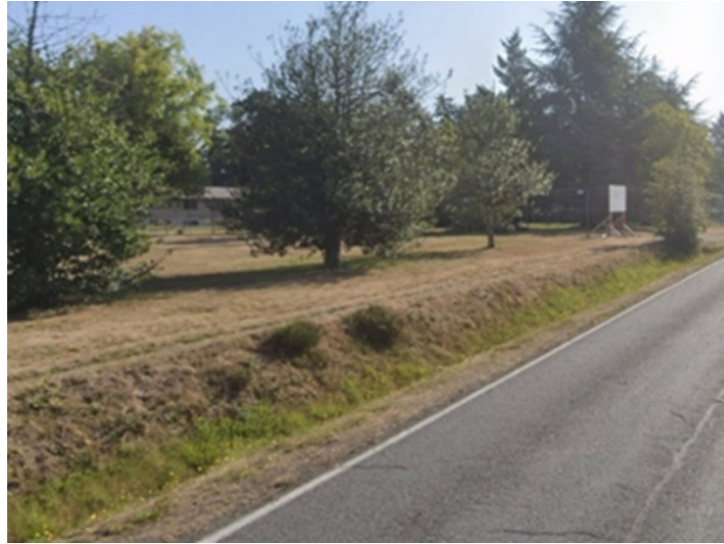
Photo C2 S 240th Street Typical Frontage Section

There is no curb, sidewalk, or planter strip along the north side of S 240th Street, see Photo C2. There is an existing roadside swale/ditch along this frontage that conveys stormwater west and an existing worn gravel path just north of the swale for pedestrian travel.

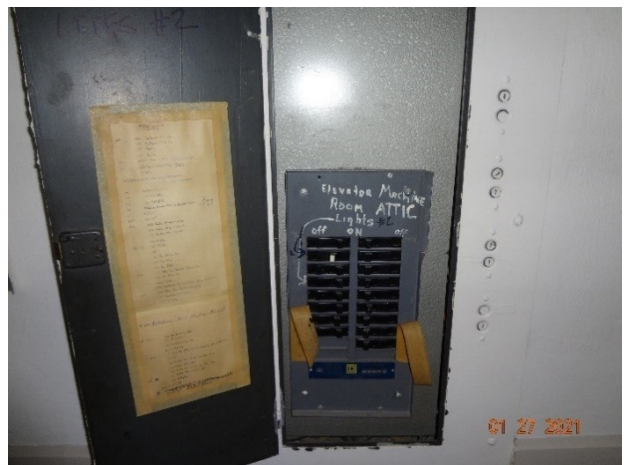
Photo E12 Panelboard in working but poor condition

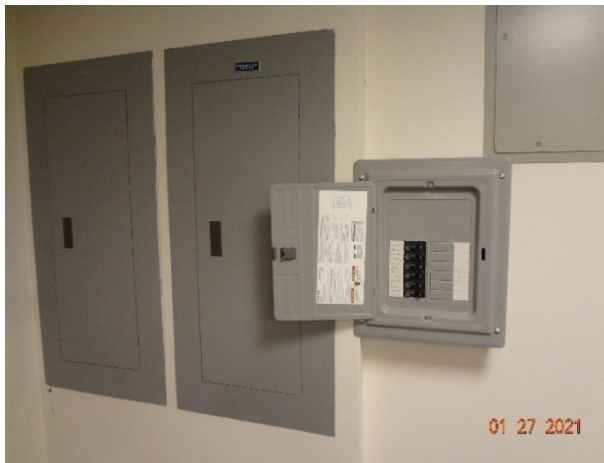
Photo E13 Panelboards in infirmary building in good condition

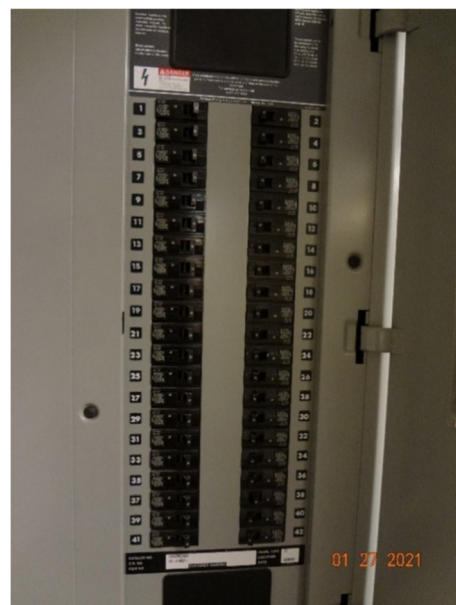
Photo E14 Panelboards in infirmary building in good condition

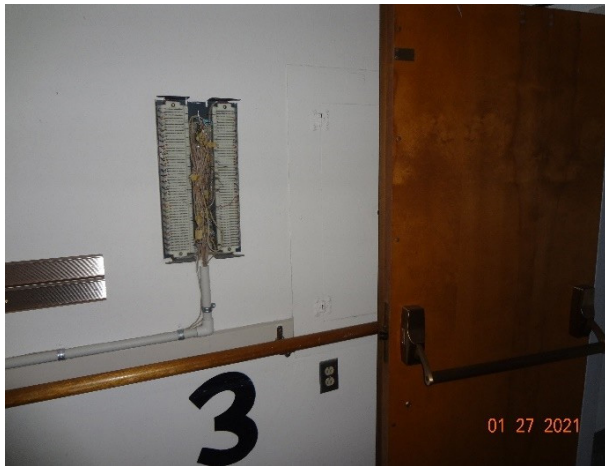
Photo E17 Corridor receptacles in fair condition

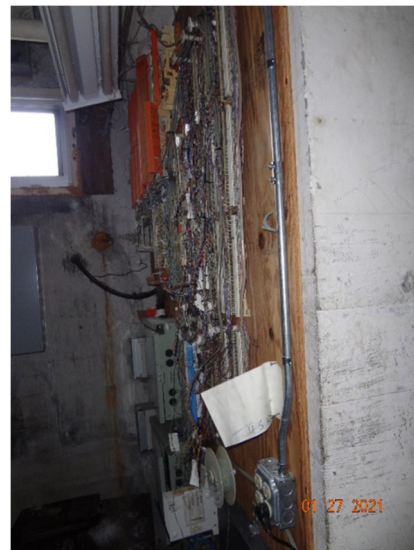
Photo E18 Telecom backboard in main electrical room

- Telecom and cable service distribution are in fair condition (Photos E18, E19).
- Fire alarm system panels are in fair condition, but the FA devices are outdated and may be discontinued on the market (Photos E20, E21).

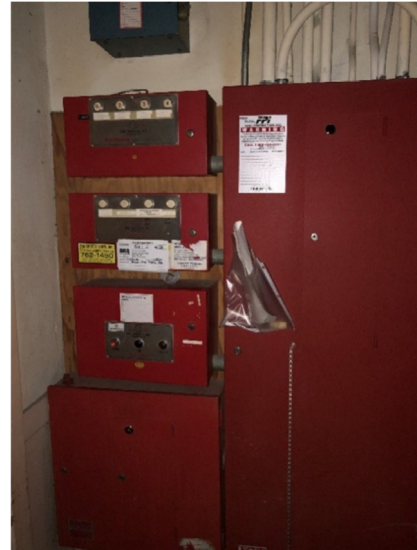
Photo E20 Fire alarm equipment in fair condition

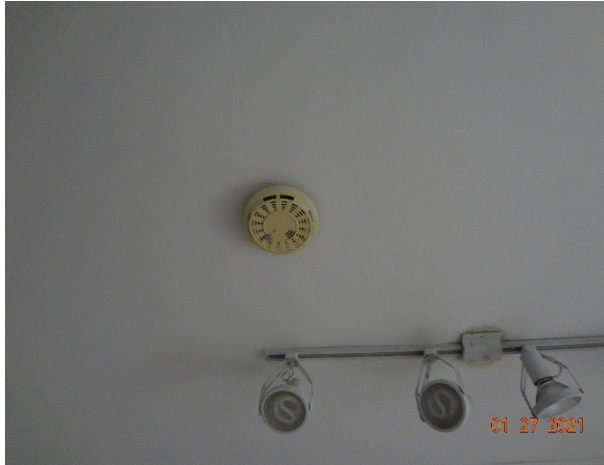
Photo E21 FA devices are outdated

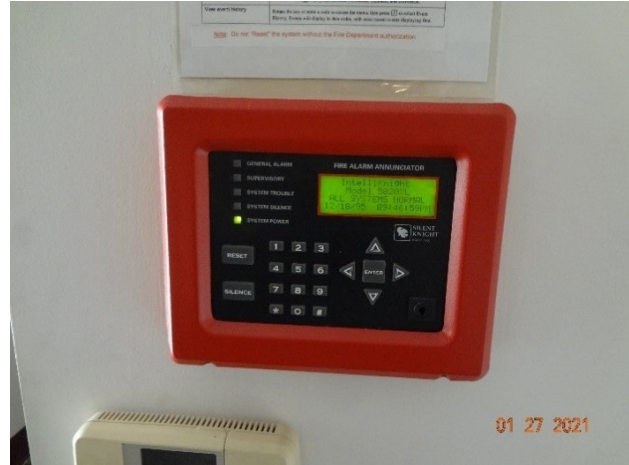
- Fire alarm devices and annunciator panel in 2-story infirmary building addition are in good condition and was recently upgraded (Photos E22, E23).

Photo E22 FA annunciator in infirmary building is in good condition

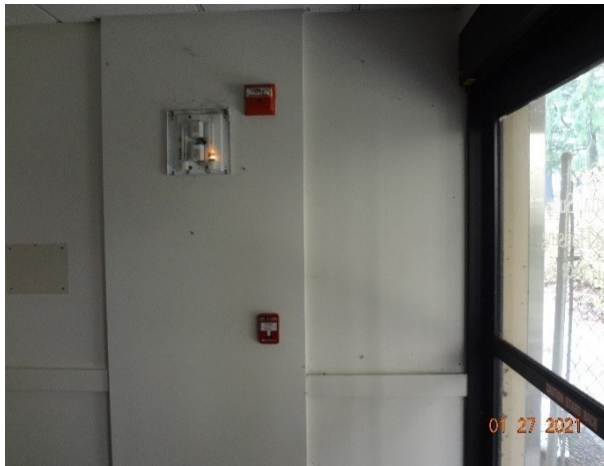
Photo E23 FA devices in infirmary building are in good condition.
