NOTICE OF UPDATED SEPA RECORD AND EXTENSION OF PUBLIC COMMENT PERIOD FOR THE ZENITH PROPERTIES BUILDING DEMOLITION APPLICATION DRAFT ENVIRONMENTAL IMPACT STATEMENT (DEIS)

CITY OF DES MOINES
ZENITH PROPERTIES BUILDING DEMOLITION
PERMIT APPLICATION

DRAFT ENVIRONMENTAL IMPACT STATEMENT
APPENDICES (PART 2: APPENDICES E-K)

Zenith Properties LLC Des Moines Masonic Lodge Economic Feasibility Analysis

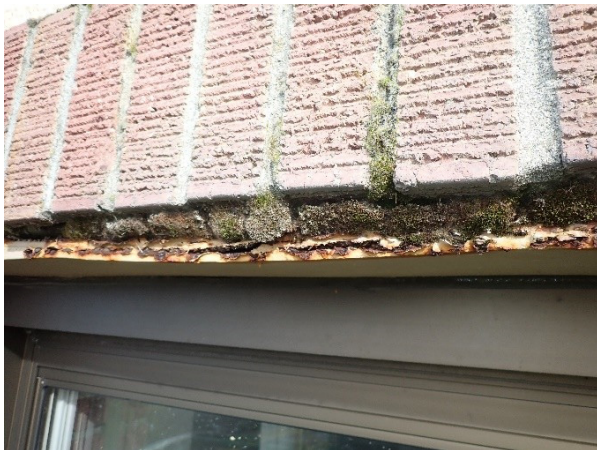
Photo BE5 Typical Lintel Supporting Brick

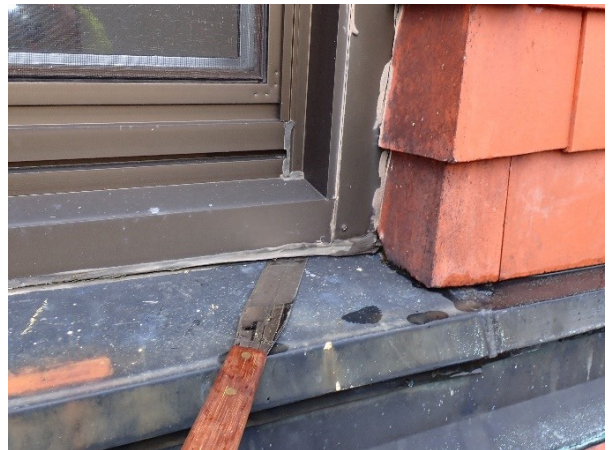
Photo BE6 Typical Window Seal

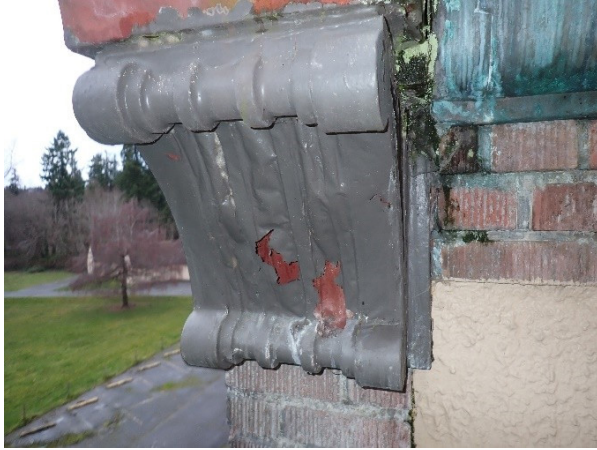
Photo BE7 Typical Ornamental Terra Cotta

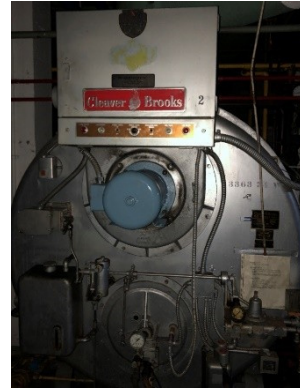
Photo M2 Abandoned Boiler #2 (3 is Similar)

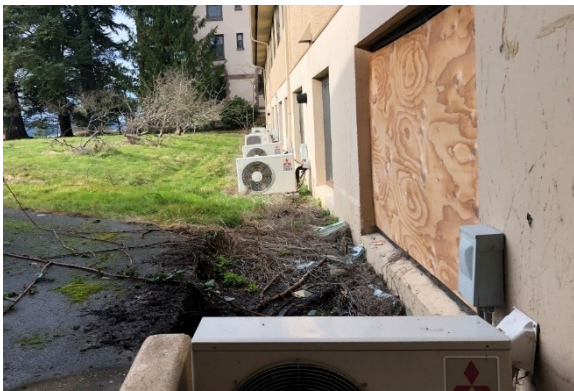
Photo M5 Split System Heat Pumps

- The infirmary building was served with split system heat pumps (Photo M5). Operability is unknown.
- The congregation hall was served with wall radiators and under seat ventilation via an air handling unit (Photo M10). Operability is unknown.

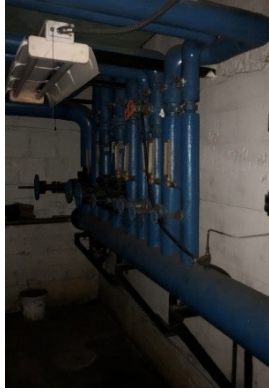
Photo M9 Heating Water Distribution Manifold

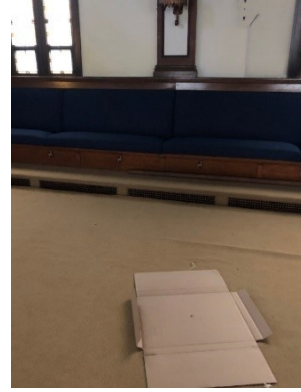
Photo M10 Under seat Ventilation within Hall

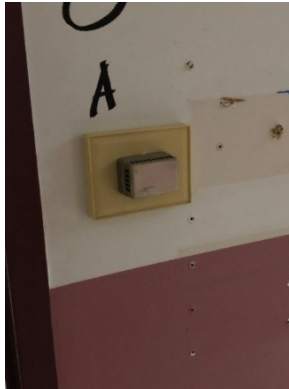
Photo M11 Pneumatic Thermostat

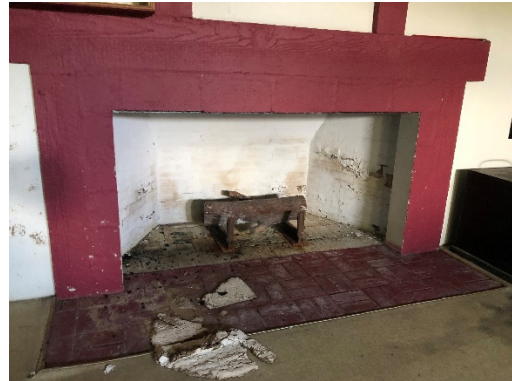
Photo M12 Woodburning Fireplace

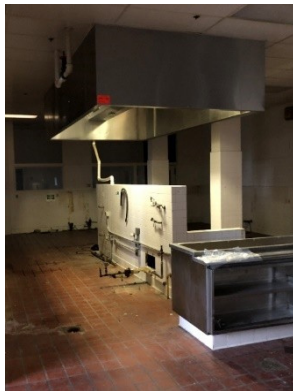
Photo M13 Decommissioned Commercial Kitchen

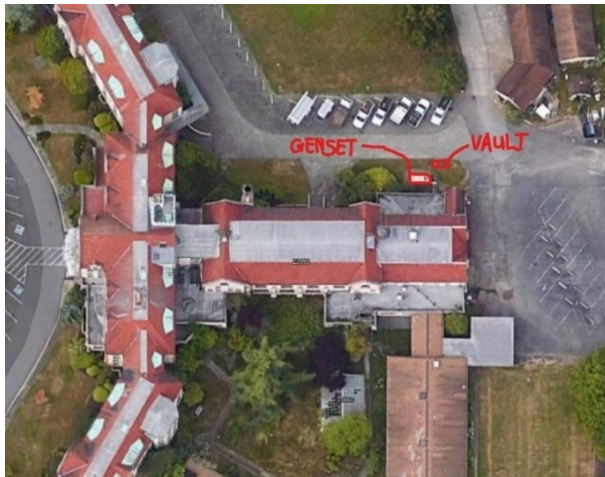
- An existing electrical utility (PSE) in-ground vault was noted at north side of building next to an existing Generator enclosure (Photo E1). PSE vault was not accessible (Photo E2) during field visit to confirm existing transformer capacity.
- PSE service meter for whole building is located with exterior wall mount (Photo E3) and wired back to main switchboard pull section. The main building service switchboard also feeds a separate 2-story infirmary building addition on site (Photo E4).
- Main switchboard has two sections rated at 1600A, 240/120V 3-phase Delta high-leg system, located inside electrical room under the meter at basement level (Photos E5, E6).

Photo E1 Aerial view utility/generator location

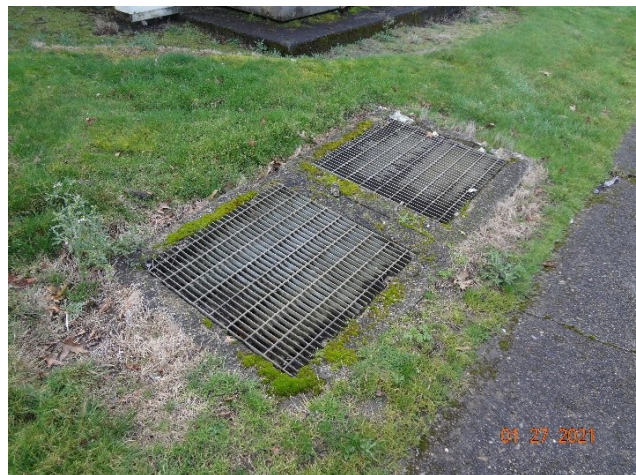
Photo E2 In-ground PSE vault

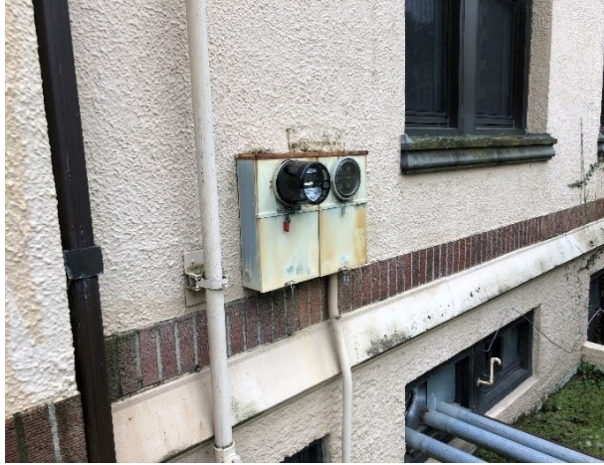
Photo E3 PSE meter exterior wall mounted

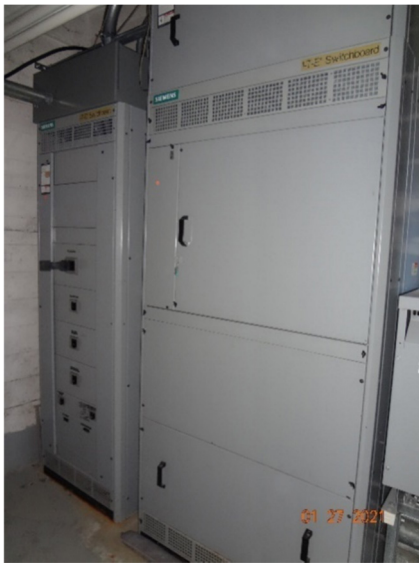
Photo E5 (2) Sections main switchboard

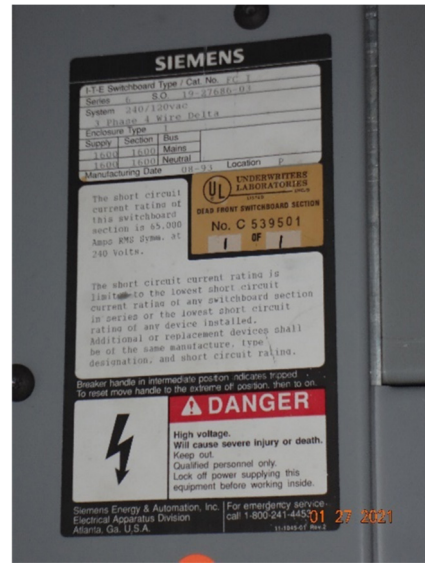
Photo E6 Main switchboard rating tag

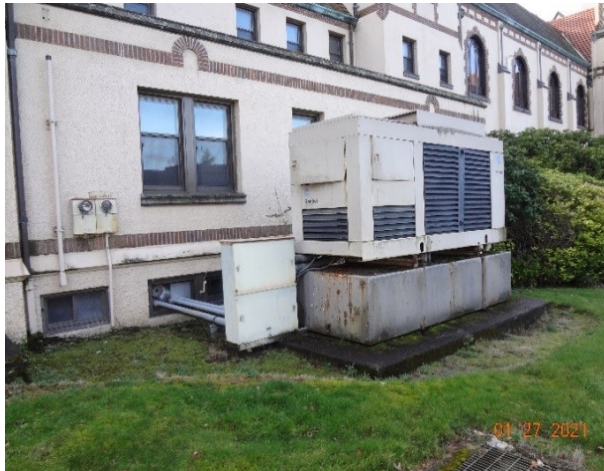
Photo E9 Generator sit outside building

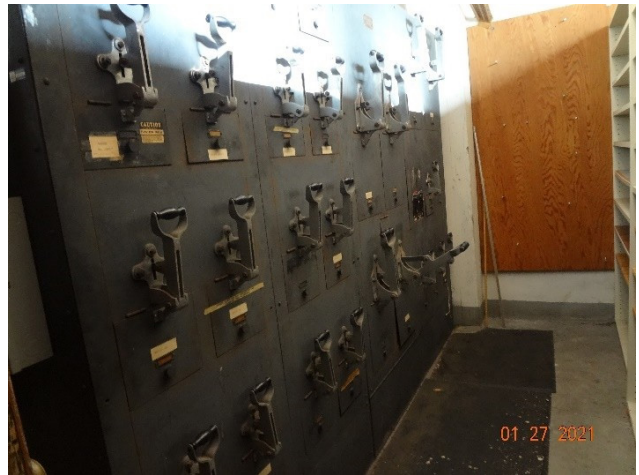
- Various aged panelboards are observed throughout building (Photos E10, E11, E12), in working but poor condition.
- 2-story infirmary building addition is fed from main switchboard, panelboards in this building is in good condition (Photos E13, E14).

Photo E10 A panelboard may be built in late 1920's

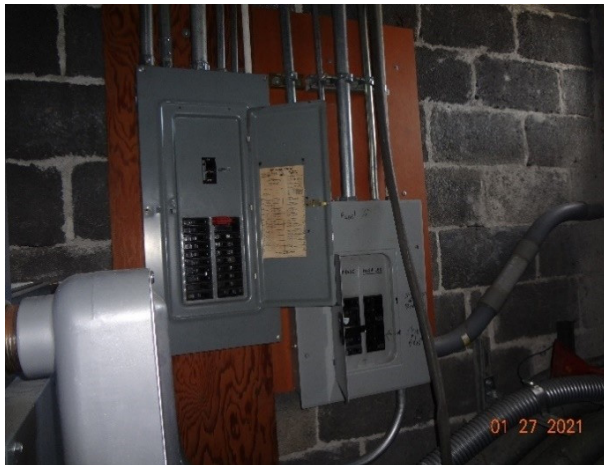
Photo E11 Panelboards may be upgraded with main switchboard in mid-1990's

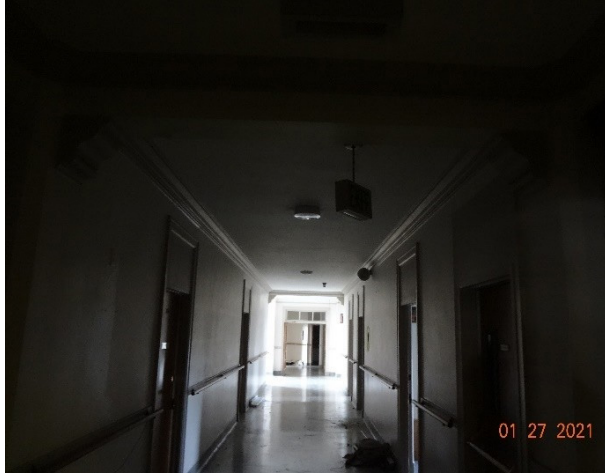
- Lighting fixtures are most compact fluorescent, or incandescent type (Photos E15, E16), will not comply to current energy code.
- Dwelling units and corridor receptacles are in fair or poor condition and mix with surface and recess mounted type (Photo E17)

Photo E15 Surface mounted lighting fixture in corridor

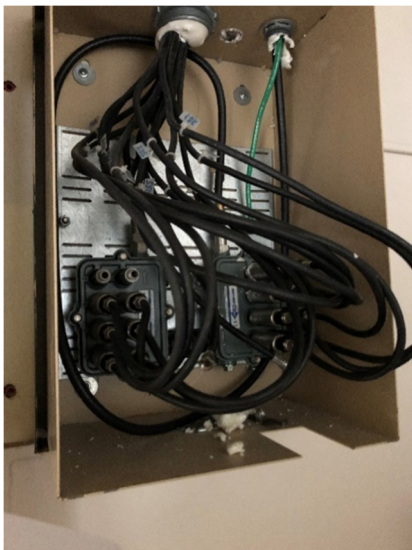
- Telecom and cable service distribution are in fair condition (Photos E18, E19).
- Fire alarm system panels are in fair condition, but the FA devices are outdated and may be discontinued on the market (Photos E20, E21).

Photo E19 Cable terminal box in each floor janitor

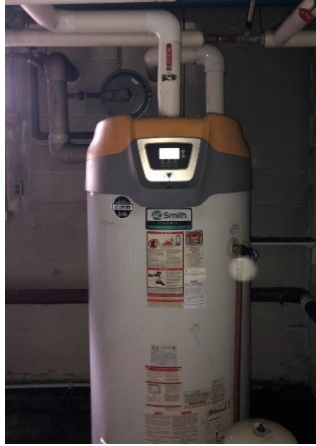
- The water heater serving the public restrooms and back-of house spaces is fairly new and could be re-used (Photo P1).
- The original sump pump was full of water during the site visit and appeared to be non-operational (Photo P2).
- The domestic backflow preventer is located in a hot box near the walking trail heading to the water tower (Photo P3).
- Many dwelling units include a lavatory (Photo P4). The public men's and women's restroom and shower facilities are located within each corridor near the main core.

Photo P1 Existing Water Heater

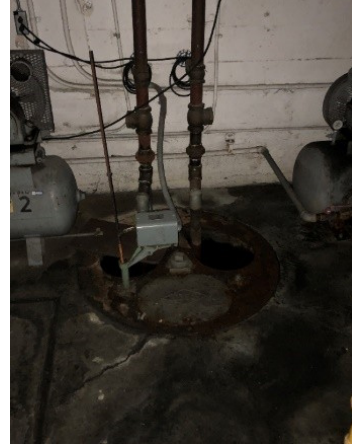
Photo P2 Existing Sump Pump

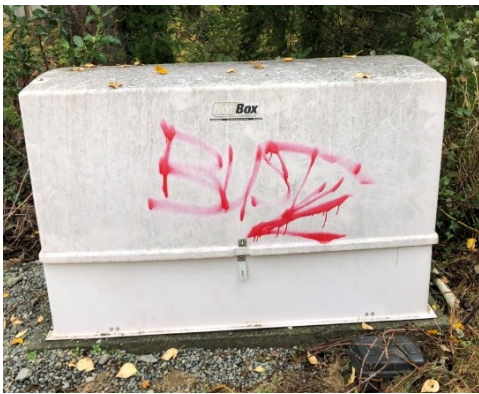
Photo P3 Hot Box for Domestic Backflow Preventer

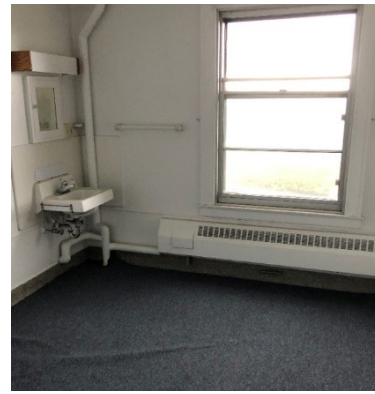
Photo P4 Dwelling Unit Plumbing

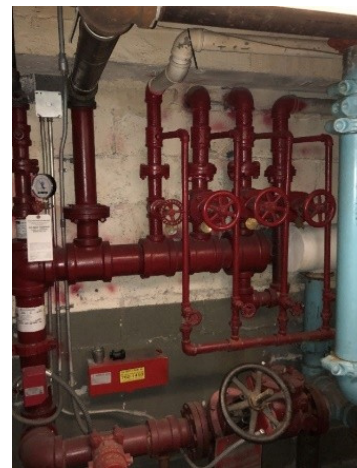
- The main building is served by multiple fire hose connections (Photo FP1) on various floors.
- The existing fire water controls valve are located in the basement (Photo FP2).

Photo FP2 Existing Fire Water Control Valves

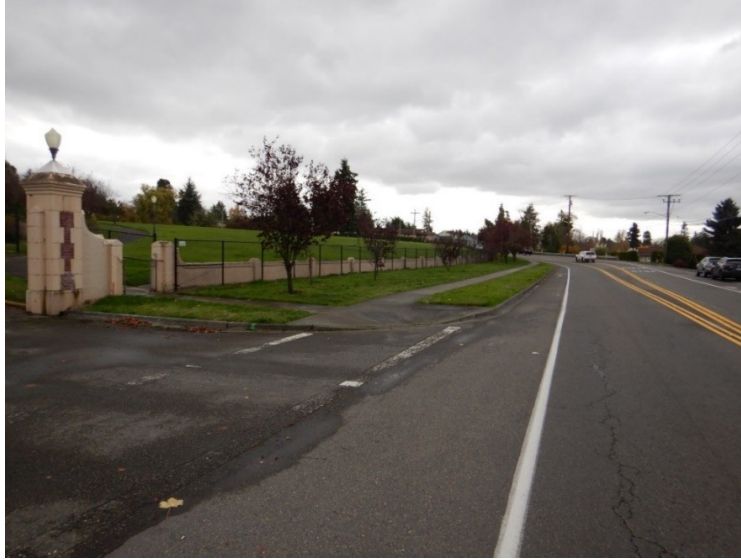
- Minimum required curb ramp width is 36 inches. Currently, the curb ramps at the North and South side of the entry drive have ramps 36 inches wide.

Photo ADA1 Existing Sidewalk Curb Ramp

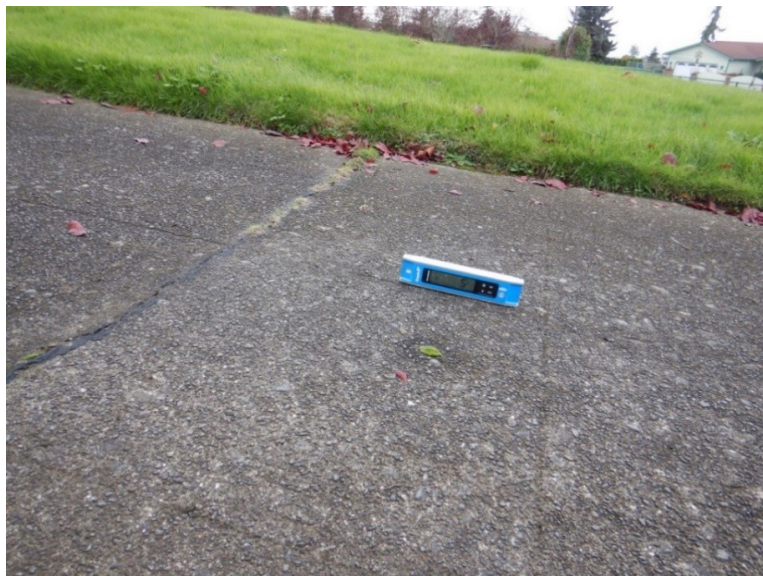
- Walking surface must have a running slope of no steeper than 1:20 and cross slope shall be no steeper than 1:48. Currently, the slope of the accessible path (where measured) is 1:20 with cross slope of less than 1:48.
- Walking surface clear width shall be 36 inches minimum. Currently, the clear width is greater than 36 inches.
- Walking surface, unless 60 inches shall have passing spaces. Currently, the width of the walking surface is greater than 60 inches.

Photo ADA2 Slope of Walking Surface (Street to Parking)

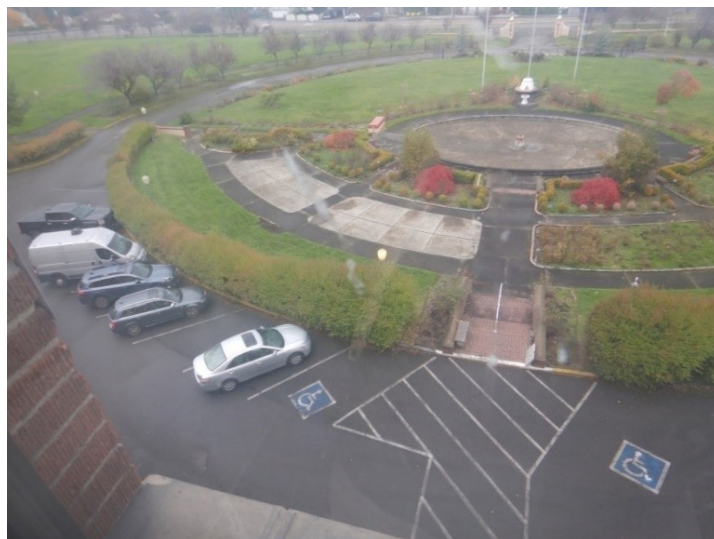
- Currently, this facility has only one standard and one van accessible spaces located at the main building entry (See Photo ADA3).
- Minimum width for a standard parking stall is 96 inches. Currently, both accessible stalls are at least 96 inches wide.
- Minimum width for a van parking stall is 132 inches unless access isles measure 96 inches, in which case the stall width can be 96 inches. Currently, one of the two accessible stalls are 132 inches wide or greater.
- Minimum width for a parking stall access isle is 60 inches. Currently, the access isle is greater than 60 inches.

Photo ADA3 Existing Accessible Parking Spaces

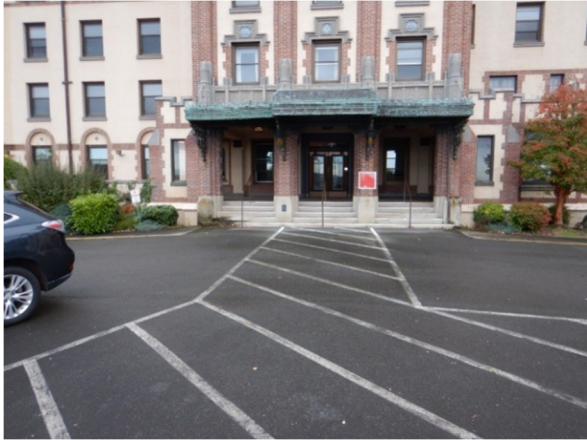
Photo ADA4 Accessibility Route as Viewed from Accessible Parking

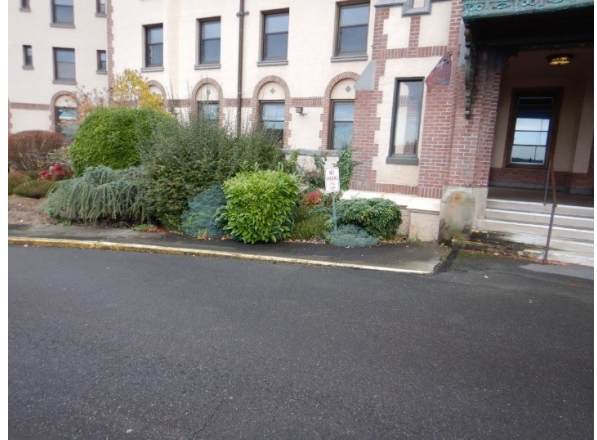
Photo ADA5 Overgrown Shrubbery in Access Walkway

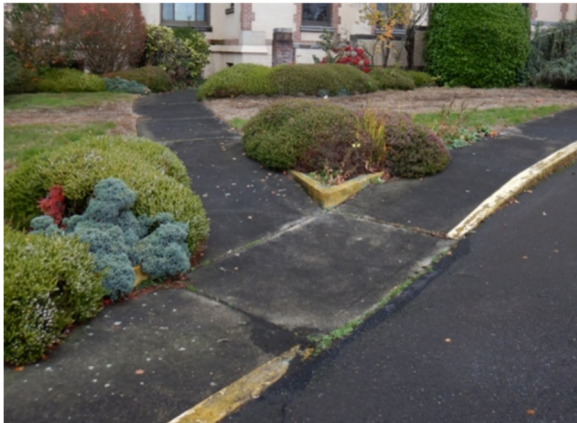
Photo ADA6 Access Route Walkway Surface with Slope Greater than 1:20

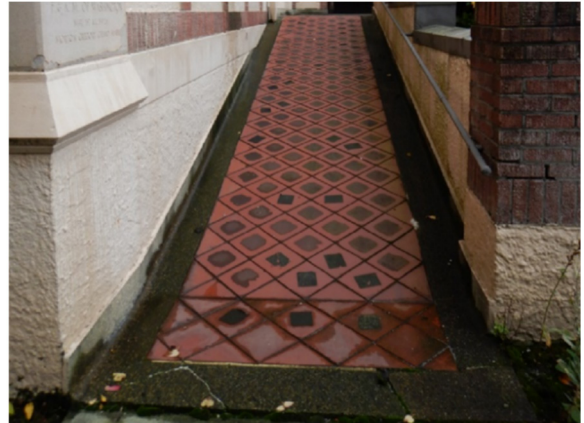
- Level landings are required at the top and bottom of all run/ramps. Currently, the landing at the bottom of this run/ramp is less than 60 inches x 60 inches.

Photo ADA7 Access Route with No Landing at Bottom of Ramp

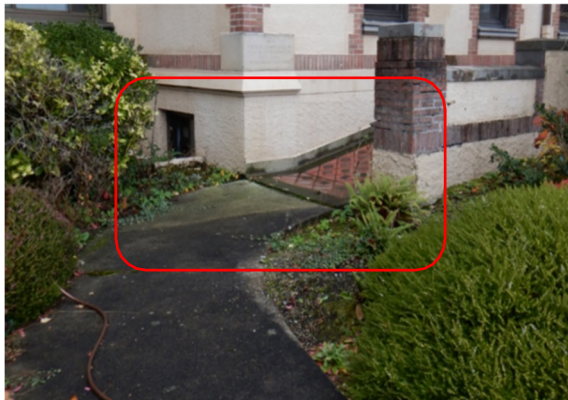
- Ramps with a rise of more than 6 inches shall have a handrail. Currently, this ramp does have a handrail.
- Ramp slope shall be no steeper than 1:12 with a cross slope no steeper than 1:48. Currently, the slope of this ramp is greater than 1:12.

Photo ADA8 Access Ramp with Slope Greater than 1:12 and Rise Greater than 30 inches

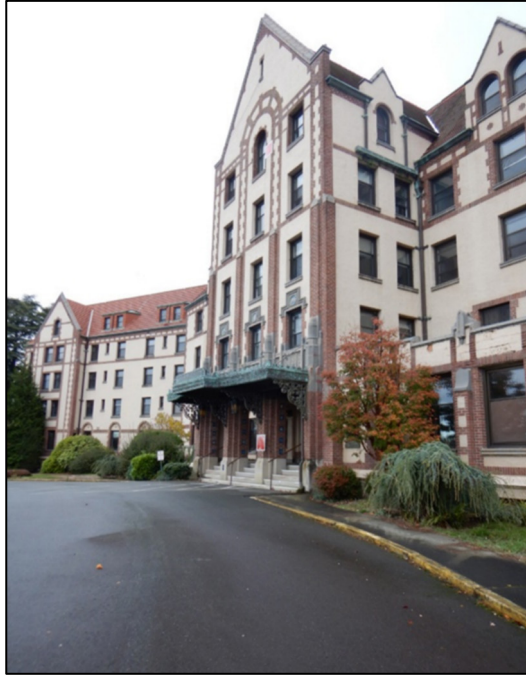
- Passenger loading area shall be a minimum 20 feet long and 96 inches wide with a vertical clearance of 114 inches. Currently, the passenger loading zone at the main entrance meets these requirements.

Photo ADA9 Passenger Loading Zone at the Main Entrance

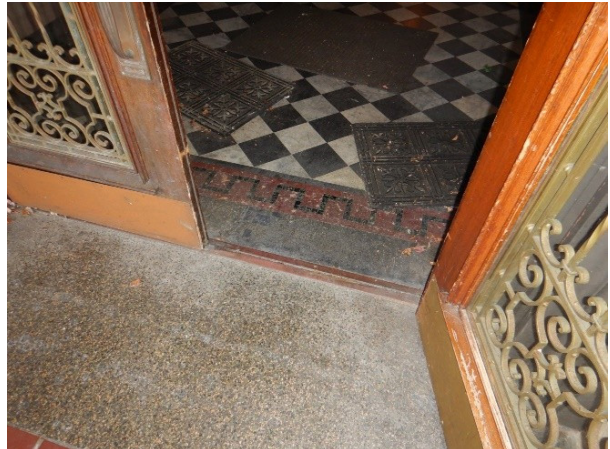
Photo ADA13 Main Entry Threshold

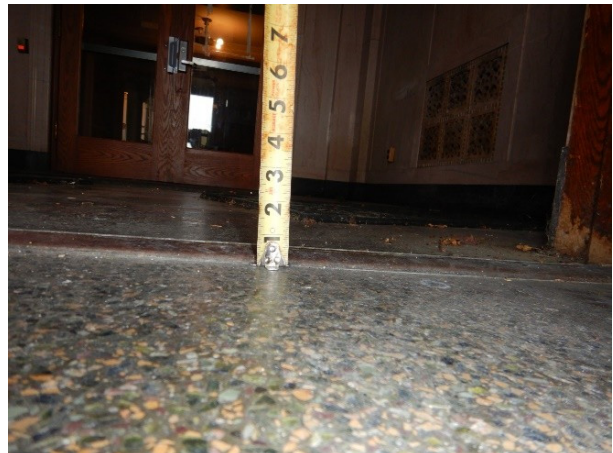
- Minimum clear width through any single door openings is 32 inches with no projections into the opening less than 34 inches above the floor. Currently, this door clear width is greater than 32 inches.
- Door closers should be adjusted so that closing time from 90 degrees to 12 degrees is 12 seconds minimum. Currently, the door closer speed is properly adjusted.
- Minimum maneuvering clearance in vestibule, between two doors is 48 inches plus the width of any door(s) swinging into that space. In addition to the 48 inches clearance there must also be a minimum maneuvering space of 60-inch diameter. Currently, this facility's main entrance vestibule maneuvering clearance meets the ADA requirements.
- Maximum door threshold height is $\frac{1}{2}$ -inch. Currently, this facility's main entrance original threshold is less than $\frac{1}{2}$ -inch.

Photo ADA15 Main Entry Threshold Height, ≤1/2 inches

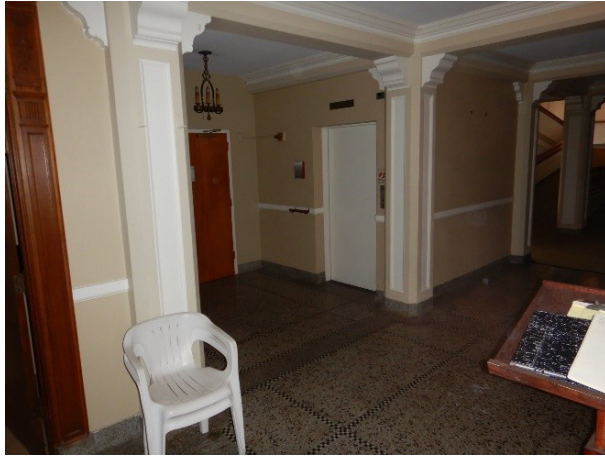
Photo ADA22 Elevator

- Clear width for existing elevator doors is 32 inches. Currently, the clear width of the existing door is greater than 32 inches.
- Minimum clearance from interior face of door to back wall is 54 inches, access to elevator car was not available.
- Minimum clearance from front to back wall is 51 inches, access to elevator car was not available.
- Minimum clearance side to side is 80 inches, access to elevator car was not available.

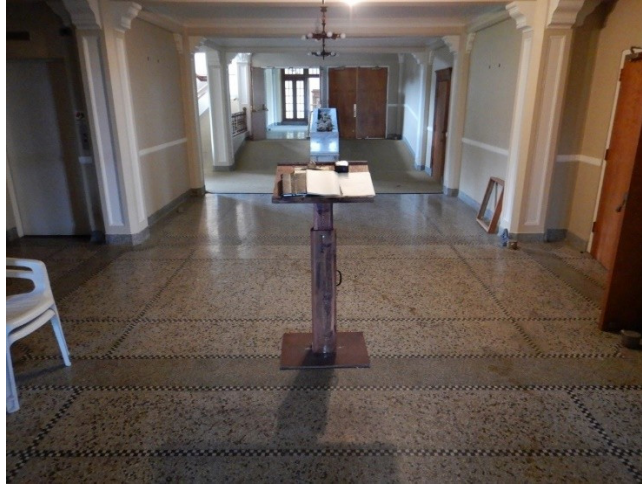
Photo ADA24 Ramp to Back of House

- Minimum clear width of ramp shall be 36 inches. Currently, the width of the back of house north/south wing ramp is greater than 36 inches.
- Maximum rise for any single run/ramp is 30 inches. Currently, the rise of this single run/ramp is greater than 30 inches.
- Ramps with a rise of more than 6 inches shall have a handrail. Currently, this ramp does not have a handrail.
- Ramp slope shall be no steeper than 1:12 with a cross slope no steeper than 1:48. Currently, the slope of this ramp is greater than 1:12 with a cross slope less than 1:48.
- Level landings are required at the top and bottom of all run/ramps. Currently, the landing at the top of this run/ramp is less than 60 inches x 60 inches and the door swings into the landing area.
