**CITY OF DES MOINES**  
**ZENITH PROPERTIES BUILDING DEMOLITION**  
**PERMIT APPLICATION**

**DRAFT ENVIRONMENTAL IMPACT STATEMENT**  
**APPENDICES (PART 1: APPENDICES A-D)**

**JANUARY 2024**

**APPENDIX B**    **DEMOLITION PLAN**

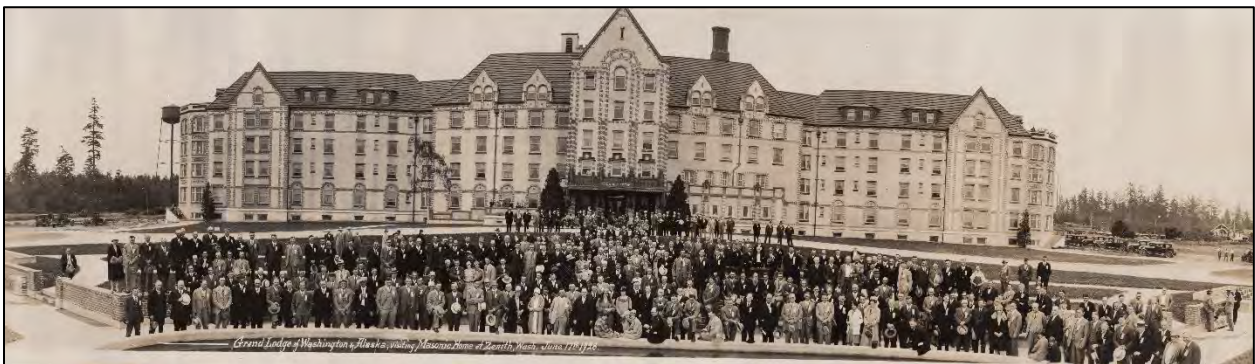
Panoramic photo of the building in June 1928, one year after construction was completed. (Washington Masonic Archives)

According to a 1927 newspaper article covering the opening ceremonies, the concrete and steel building featured a stucco exterior finish, trimmed with brick, terra cotta, and Wilkeson sandstone, and featured a red clay tile roof. The interior featured a main floor reception hall, sitting rooms, library, social hall, an auditorium with stage (also called the chapel), and several living rooms. On the second floor were dining rooms, the women's infirmary, and suites of residential rooms. The men's hospital and residential rooms were on the third floor. The fourth and fifth floors were residential rooms. In the basement were billiard and recreation rooms for men and women. The building was reportedly designed to accommodate 254 residents, although other sources cite a maximum of 192 residents.<sup>34</sup>

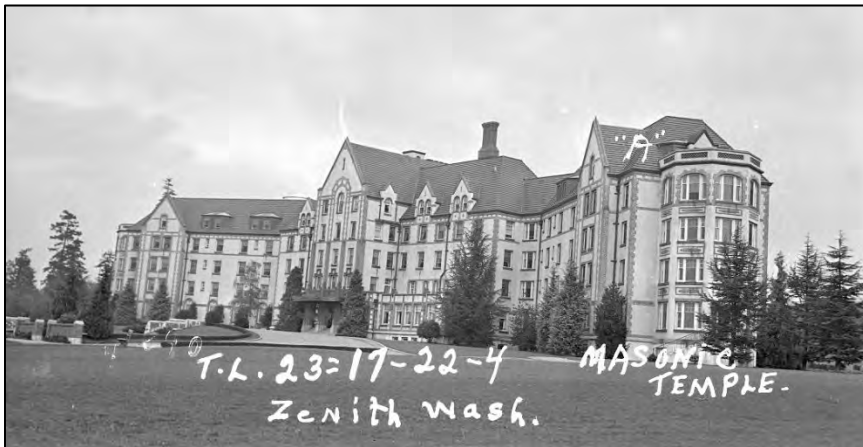
*The building in 1937 (King County Tax Assessor); and in 2019.*

The Main Building derives considerable character from its siting, a highly visible location at the brow of a hill with a sloping, formal front lawn that offers spectacular views of Puget Sound to the west. In addition, the building's massing, which consists of a high central block with lower flanking wings, surmounted by high hipped roofs, contrasts sharply with the surrounding context of mostly single family houses.

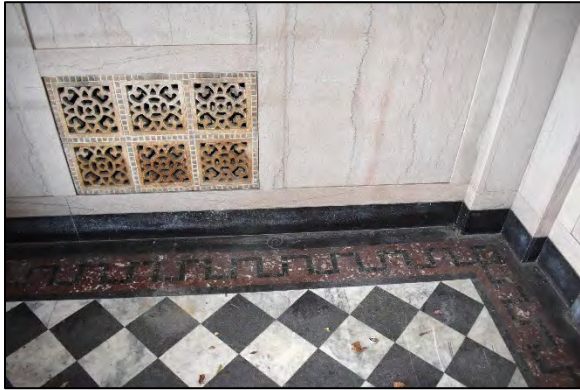
*The Entry Vestibule in 2022 (both photos)*

The small, ornate Entry Vestibule is located on the First Floor and lies between the Main Entry Porch and the Main Foyer, serving as transition from outdoor to indoor.

Two sets of double doors are centered on the east and west interior facades. The Main Entry Porch doors are oak (described previously, at discussion of exterior). The doors leading to the Main Foyer appear to be original oak double doors with large central glazed panels and contemporary hardware, surmounted by a stained glass transom. The stained glass is divided into three panels apparently showing progressing modes of transportation (horse and wagon, steam locomotive, and jet airplane). In style, materials, and content, the stained glass appears to date to the late 20<sup>th</sup> century.

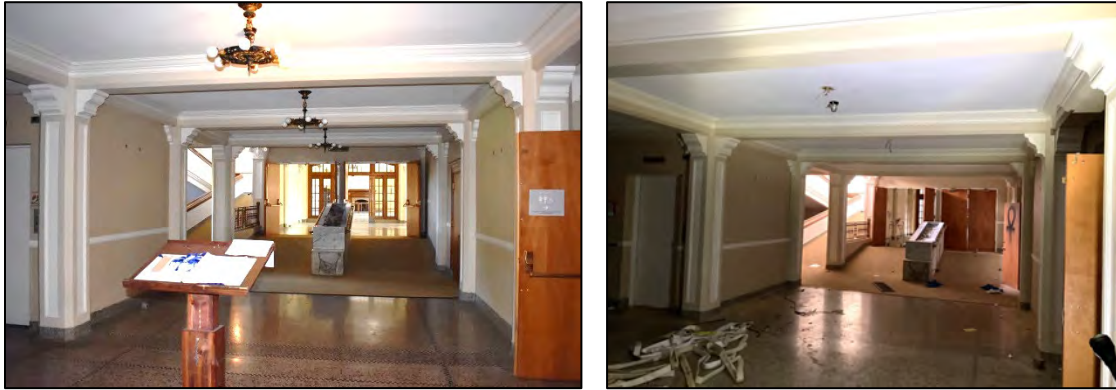
*The Main Foyer in 2019 (left) and May 2023 (right)*

The wide Main Foyer is located on the First Floor and connects the main building entry with most of the building's public spaces, administrative offices, the elevator, and the transverse north-south central corridor. It serves as the initial welcoming lobby for the building and orientation space. Although the Foyer bleeds into adjacent spaces, the area corresponds to the approximately 15' x 48' rectangular floor space, or five structural bays defined by false drop beams supported by pilasters or piers, between the main entry and the Waiting Room. Walls and ceilings are painted plaster, including ceiling molding at beams, recessed panels at piers and pilasters, and simple pilaster brackets resembling oversized slices of crown molding. Walls include a painted dado rail, which is also found in the north-south central corridor.

**Condition** – Fair. Loss of all light fixtures to vandalism since 2022. Minor graffiti on walls.

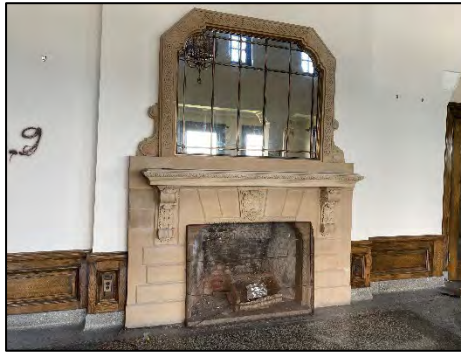
*The Sitting Room in 2022*

The Sitting Room, identified on the original drawings as the Social Hall, is located on the First Floor and is accessed directly from the Main Foyer, south of the building's main entry, as well as from the Central Corridor. This elegant room functioned as a reception hall, lounge, and entertaining space.

The room is dominated by a double-height central volume measuring approximately 19' x 35' in plan, from which extend one-story alcoves on the north, west, and south. The north and south alcoves measure approximately 19' x 12', and 19' x 10' respectively, and each has a similarly-sized musician's alcove with balcony opening onto the volume on the second floor. The north and south musician's alcoves feature oak balustrades with turned wood pickets, and the balconies are reached from the second floor Central Corridor. The west alcove measures approximately 35' x 11' in plan, and is separated from the main volume by two square plan piers with chamfered corners and decorative brackets. The west alcove is the interior of a one-story flat-roofed projection on the front facade of the building, and features five windows opening to the west, one to the south, and one to the north facing the Entry Porch. Above the west alcove, the upper part of the Sitting Room's double-height volume is lit by five fixed wood-sash leaded clear glass windows (with a small amount of colored glass highlights), set in openings that have chamfered jambs and headers.

Interior finishes are painted plaster walls and ceiling, with crown moldings at the alcoves, and decorative brackets at door openings and alcoves. The main floor and base is terrazzo, but uniquely among the public rooms of the Home, the floor features an aggregate mix of green, black, white, gray, and buff, resulting in an overall effect of a dark green color. At the First Floor level, a stained, carved oak paneled wainscot measuring approximately 2' in height wraps the room and alcoves, engaging the bottom of the windows where they occur. Windows and doors feature stained oak casing and stools; there are no window aprons due to the oak wainscot.

**Condition** – At present, the primary condition issue is a severely water-damaged ceiling at the west alcove, over which is an apparently damaged flat roof. Additional condition issues include damaged original light fixtures due to vandalism, and minor graffiti. However, the room is otherwise in fair condition.

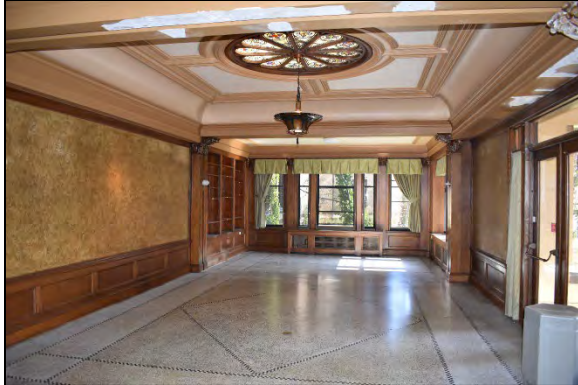
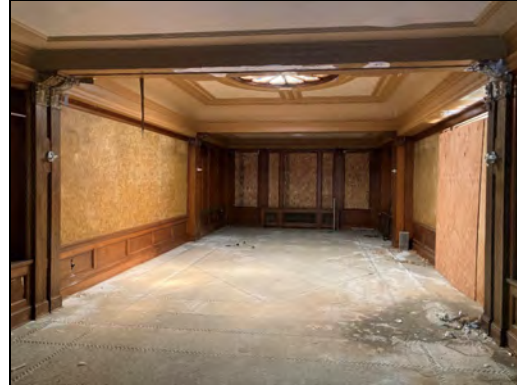
The Library in 2022 (left) and May 2023 (right)

The Library is located on the First Floor, south of the Main Foyer, and across the Central Corridor from the Sitting Room. The room, used for reading and study, originally featured freestanding bookcases and a large central table which are no longer intact.

Like the other primary public rooms, floors and base are terrazzo (with patterns and colors similar to those found in the Main Foyer), and walls and ceilings are painted plaster with crown molding. The room is rectangular in plan, measuring approximately 19' x 44', and divided into three bays by plaster pilasters and drop beams which divide the ornate ceiling. Pilasters feature small but ornate composite capitals and brackets. The center bay of the ceiling is larger than the other two, and features a deep cove molding around the perimeter, with an original circular stained glass skylight at the center, outlined by frame molding. The skylight, constructed of oak, resembles a rose window with twelve petals, each having a colorful circular shield pattern at the wide end. A pendant light fixture is suspended from the center.

**Condition** – Fair; walls and windows are boarded up. Some vandalism. Water damage to plaster work along south wall.

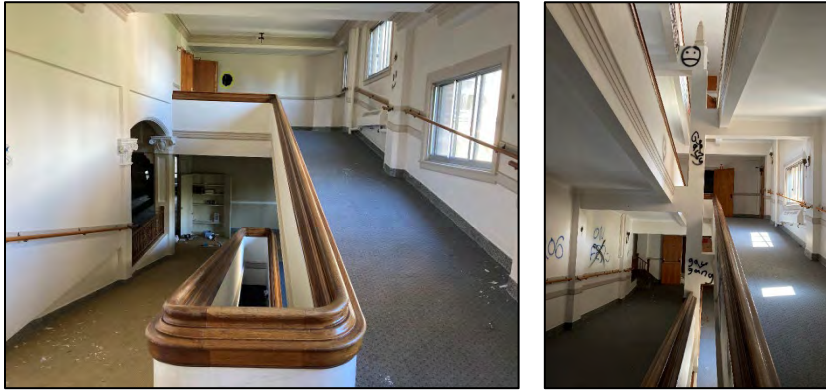
*The Ramp in 2022*

The Ramp serves as the primary formal vertical circulation connecting all floors, rather than a central staircase, intended to accommodate wheelchairs and to serve as a gentler means of ascent for the elderly residents of the Home. On the First Floor, it is reached from the Main Foyer, north of and visible from the Waiting Room. Between the Ramp and the Waiting Room is a segmental arched opening with a low, decorative bronze-colored wrought iron railing on a low stem wall.

**Condition** – Fair. However, there is a considerable amount of graffiti and damage to light fixtures due to vandalism.

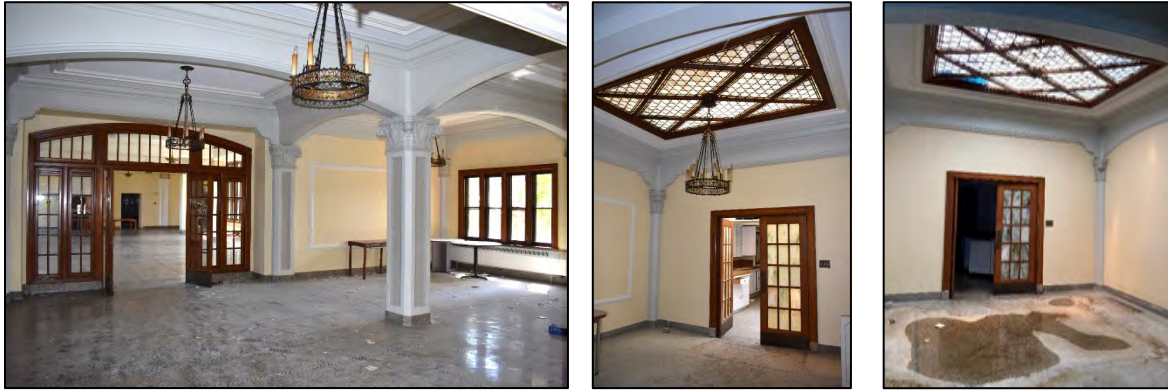
*The Waiting Room in 2022 (left and center), and in May 2023 (right)*

The Waiting Room served as a gathering area and prefunction space for the Home's residents while waiting for the adjacent Dining Room's doors to be opened for meal service. It is located on the First Floor, directly in line with the Main Foyer, from which it is separated by two sets of non-original solid double doors. Large glazed doors which separate the Waiting Room from the Dining Room will be described under the latter.

Floors and bases are terrazzo that match the pattern found in the Main Foyer. Walls and ceilings are painted plaster and both feature frame molding, in addition to deep crown molding. There is an apparently original skylight in the southwest part of the Waiting Room, which features heavy wood muntins in a diamond pattern supporting a central pendant light fixture, and amber-colored translucent leaded glass in a grid-like repeating Star of David pattern. Oak double swing doors in the west wall adjacent to the skylight, leading to a small altered kitchenette, feature similar amber-colored, milky, marbled glazing, consisting of a grid of three by five lites per door, each with brass push and kick plates. Stained oak trim is used at the single window lighting the Waiting Room.

**Condition** – Skylight near kitchenette leaks, water pools on floor below. Loss of all light fixtures to vandalism since 2022.

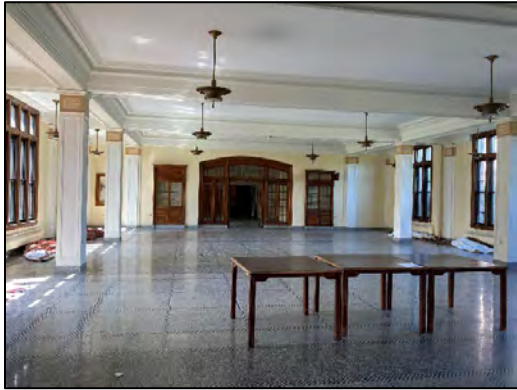
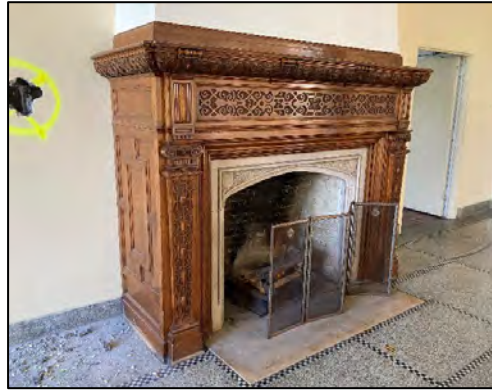
*The Dining Room in 2022*

The Dining Room served as the Home's community dining hall. It is accessed from the Waiting Room to the west and the Kitchen from the east.

The Dining Room is a large, high-ceilinged rectangular space, approximately 78' x 46' wide, occupying four structural bays at the center part of the First Floor rear wing of the building. The room is lit on the north and south walls by tall rectangular windows that measure approximately 8' wide x 10' high, with heavy oak muntins and oak trim, stools, and aprons. Two rows of square-plan structural piers located close to the south and north walls create a wide clearspan central dining space. Piers support drop beams which are supported at exterior walls by pilasters.

Stained oak trim and cabinetry is used throughout the room. The west interior wall features a wide glazed oak doorway connecting it to the Waiting Room. Measuring approximately 15' wide and 10' tall, the doorway assembly features double doors flanked by wide fixed double multi-lite sidelights, topped by a segmentally arched tripartite multi-lite fixed transom. The Dining Room side of the doorway features turned engaged posts as decorative elements at mullions, and a carved mull cover. The doorway is flanked by two built-in glazed oak cabinets, approximately 4' wide and 9' in height, which feature leaded clear glass double doors over paired drawers and solid panel cabinets below, and topped by solid panel cabinets above. Oak trim resembles that of the adjacent doorway, with engaged turned oak posts and carved horizontal and vertical trim elements above.

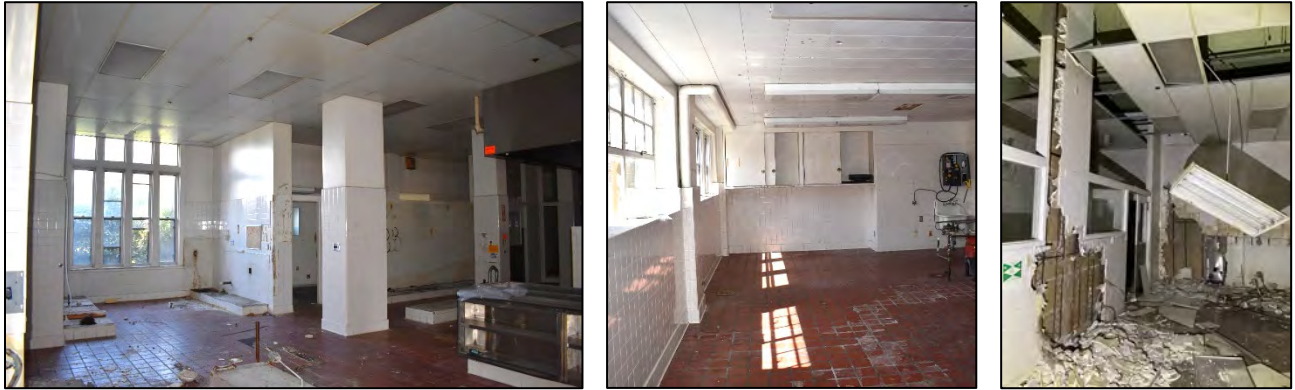
*The Kitchen area in 2022 (left and center), and in May 2023 (right)*

The Kitchen is a service space, and consists of a suite of rooms occupying the whole of the First Floor at the far eastern end of the Masonic Home's rear wing. It is connected to the Dining Room (and an adjacent smaller dining room) on the west, and to the 1966 Infirmary Wing on the south. The large, commercial-scale facility was the center for the preparation of all of the meals for the Home's residents. At the rear of the Kitchen is a loading dock original to the building.

The Kitchen consists of a large, high-ceilinged central space which served as the main cooking area, surrounded by smaller rooms that served as the scullery, kitchen office, walk-in refrigerator, storage, and related service spaces. All of the large equipment was removed around 2020, leaving the walls partly damaged.

**Condition** – Poor. The Kitchen spaces included much equipment which have been removed, leaving walls and floor finishes somewhat damaged. Numerous locations of wall damage due to pipes/wiring being removed by vandals. However, no serious water damage or exposure to elements was observed.

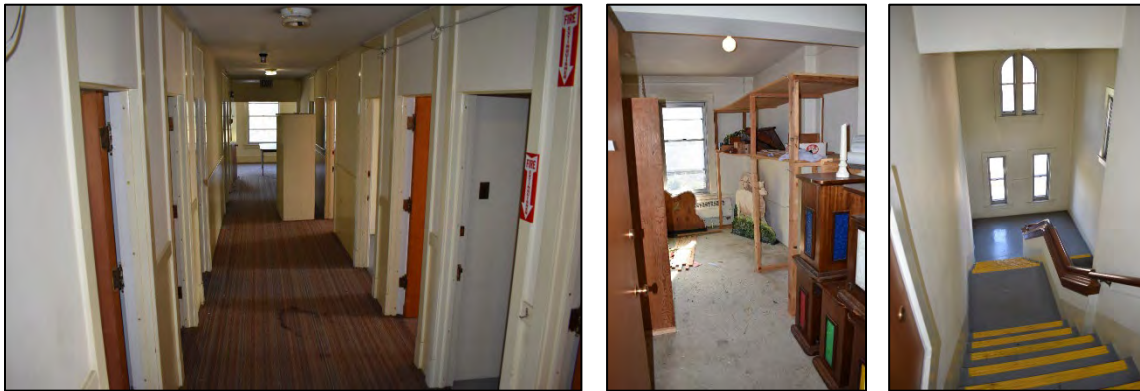
*The Dormitory area in 2022 (three photos)*

The Dormitory is on the Second Floor consisting of a suite of approximately ten residential rooms located behind or east of the Auditorium/Chapel, and is directly connected to it by a door at the rear of the stage. In spite of this connection, the Dormitory was apparently used for Kitchen help who accessed the Kitchen area, directly below the Dormitory, by way of a stair at the northeast building corner. The Dormitory may also have been used over the years for other visitors, or used for storage or office space. It appears to have never been intended as anything more than a modest support space.

**Changes over time** – Alterations to the Dormitory include apparent updates at an unknown time, likely in the mid-to-late 20<sup>th</sup> century, when unit doors were replaced with contemporary doors, and lighting fixtures updated.

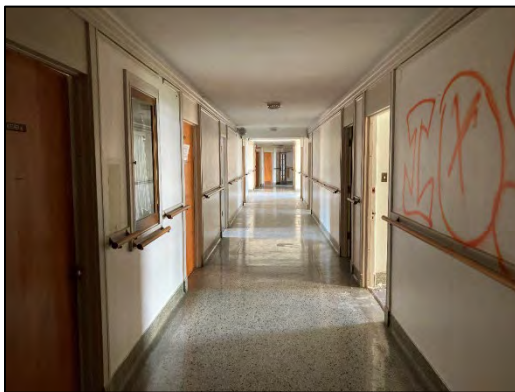
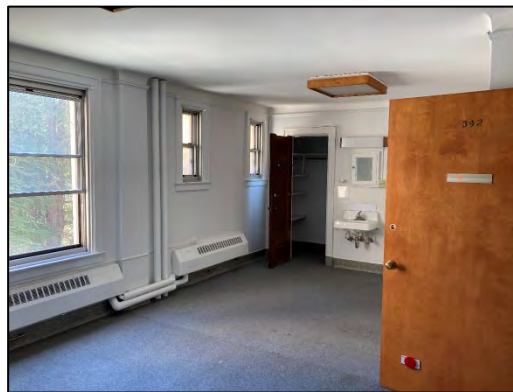
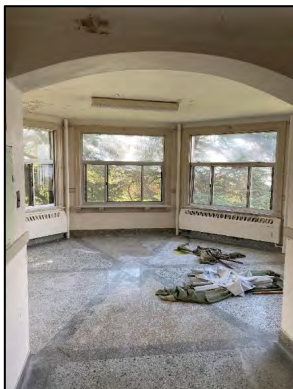
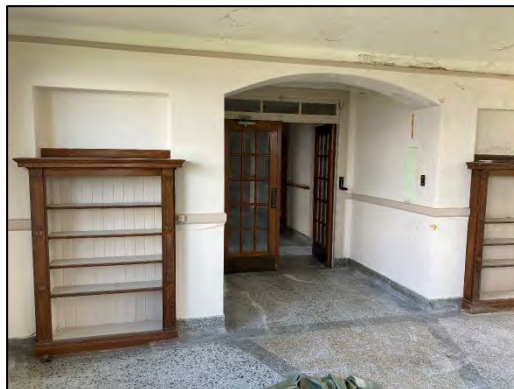
*Typical corridor and residential unit in 2022 (top); two views of a solarium, and a bathroom in 2022 (below)*

The Residential Areas of the Masonic Home occupy the majority of the building. They occur on the Second through Fifth Floors, at the north, south, and central wings of the Main Building; and on the First Floor at the north and south wings. For simplicity, the Residential Areas category includes the Main Building's main offices, which consist of a suite of three rooms at the center wing on the First Floor, between the Main Foyer and the north wing residential units, and feature the same finishes. All of the Residential Areas are organized along the long, double-loaded north-south central corridor extending the length of the building, and include private residential sleeping rooms interspersed with common bathrooms, common sitting alcoves located where the wings meet the central mass of the building, and Solariums at the end of each wing for use by the residents. There are also secondary stairwells along the corridor at each wing, and elevators next to the Ramp at the central wing. Male and female residents apparently lived in separate wings of the

The Solariums at the north and south ends of the central corridor are half-octagonal in plan, and feature wide windows overlooking the grounds. Multi-lite glazed oak double doors with transom open into the room under an arch from the central corridor. The terrazzo floor here features multicolored triangular sections meeting at a diamond form in the center of the room. Flanking the double doors on the interior side are stained oak bookshelves, approximately 6' in height, built into taller wall niches. The bookshelves are modestly ornamented with side pilasters and simple rosettes.

**Condition** – On the whole, the Residential Areas are in fair condition. However, there are numerous instances of water damaged ceilings or walls throughout the Fifth, Fourth, and Third Floors in particular. Damage includes peeling paint, evidence of earlier mold and mildew, and failing plaster or drywall. Water damage appears to be linked to both roof issues and plumbing, although less the latter since utilities have been turned off. See structural report for additional information.

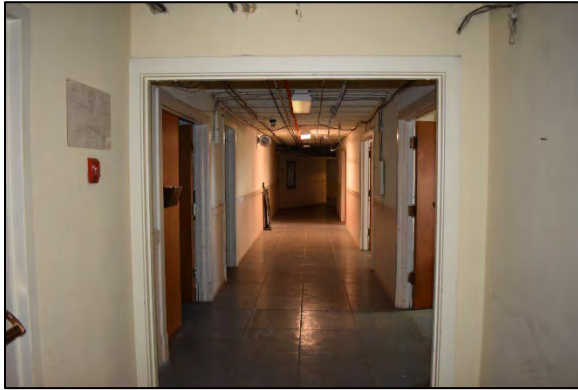
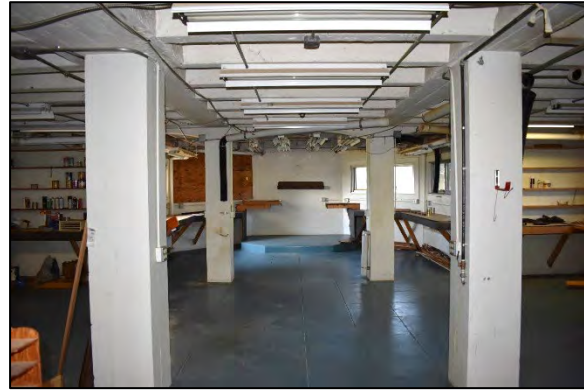
*The Basement in 2022*

The entire basement level of the Masonic Home was devoted to service and support spaces, and received the most utilitarian finishes. Large and small rooms depending on use are organized along a double loaded corridor that runs east-west through the east wing, and north-south through the western part of the building. The basement is reached by the Ramp, or by secondary stairs located in the wings. The floor is only partly below grade, and windows light many rooms.

At the east wing of the basement were and are the location of the primary mechanical, electrical, and boiler rooms for the building, as well as the location of food storage and pantries for the Kitchen above, and large laundry rooms. Small ramps and double doors at three locations along the northeast exterior of the building provide some loading access to these spaces. In the western part of the building were storage rooms, work rooms, building maintenance offices, and a bank-type walk-in vault with vault door. This part of the building also held some workshop rooms for the Home's residents' use, including a woodshop. An assembly room is located under the First Floor Sitting Room features a large, simple concrete fireplace, and a curving, wrought iron handrail at the short flight of brick entry steps from the corridor.

**Condition** – Fair. The Basement level spaces are utilitarian, and the spaces reflect heavy use. Some rooms, such as workshops or offices that were occupied by staff or residents, are in better condition than mechanical rooms.

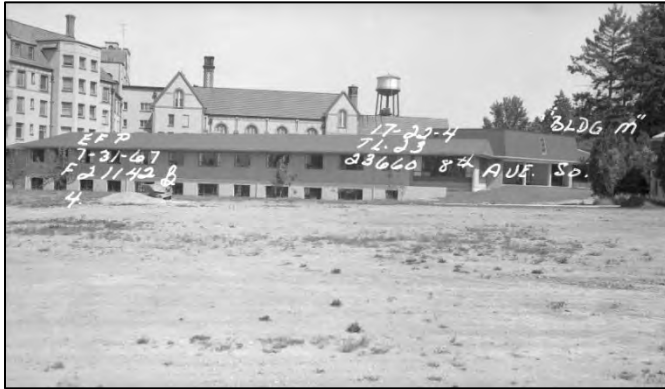
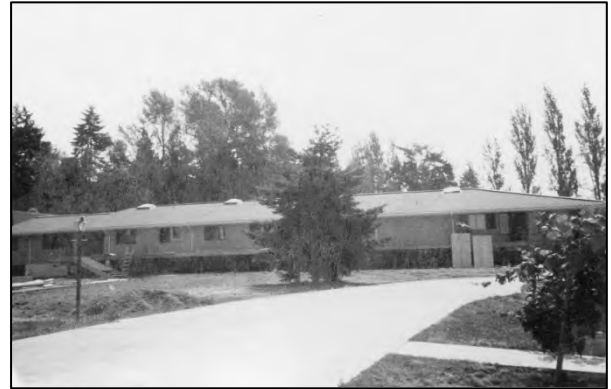
*The Infirmary Wing in 1967 (left) and the Infirmary Wing Addition in ca. 1988 (right). (King County Tax Assessor)*

The Infirmary Wing and Infirmary Wing Addition are part of the Main Building but are described here separately for clarity. The Infirmary Wing is a low, pitched-roof building constructed in 1966 as an addition to the southeast side of the Masonic Home Main Building to house the Infirmary, which from 1927 to 1965 had been located on the second floor of the Main Building's south wing. In 1987, two additional arms were added to the Infirmary Wing, adding patient rooms, a solarium, a multi-purpose room, a physical therapy room, a spa pool room, and a walled outdoor exercise area extending to the southeast towards the existing Octagonal Pumphouse. The 1966 addition was designed by Naramore, Bain, Brady & Johanson, and the 1987 addition designed by Harold Dalke & Associates.

The southwest and east arms, constructed in 1987, are one-story wood frame construction clad with marblecrete, over a concrete foundation. The hipped roofs have boxed eaves and is clad in asphalt composite shingles. Windows are the original bronzed aluminum sash, and are typically horizontally oriented sliders. On the west and south side of the southwest arm, because the grade slopes down slightly, a concrete ramp and walkway on piers, with steel railing, provides an accessible path to the First Floor, and an enlarged deck on the west side of the wing.

**Condition** – Fair to Poor. The exterior marblecrete cladding has been badly stained from downspout-related water damage at the north facade of the east arm. Roof surfacing is in poor condition. Foundation plantings are overgrown at some facades, and at the outdoor exercise area. On the interior, the floors of the 1966 portions are frequently spongy and bouncy, with deteriorating vinyl flooring.

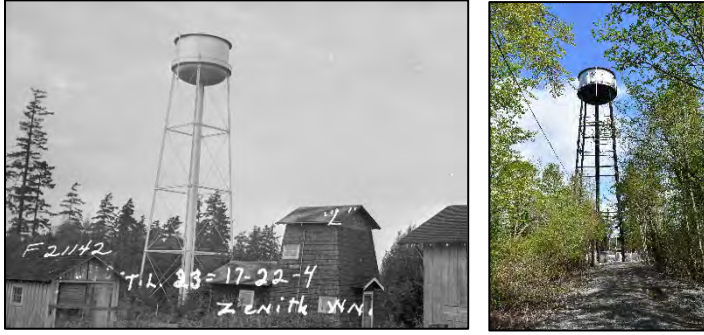
The water tower in 1937 (left) and in 2022 (right)

The Water Tower, three drilled wells, and the three pumphouses over the wells were constructed in 1926 as one of the first steps in preparing the site for the construction of the Main Building, since there was no public water supply available to the site at the time. The tower is located northeast of the Masonic Home Main Building, in the parcel's north panhandle. The three pumphouses were located as follows: the Water Tower Pumphouse was at the base of the water tower; the Gabled Pumphouse (no longer extant) was located approximately 150' east and 100' north of the southwest property corner; and the Octagonal Pumphouse was located approximately 275' south of the rear wing of the Masonic Home Main Building. Together, they supplied water for the residents, for the ornamental oval pool in front of the main building, and for landscaping. The water tower is no longer used for its original purpose.

The Water Tower is a "traditional style" elevated water tower manufactured by the Chicago Bridge & Iron Works Company, the leading manufacturer of elevated water storage tanks in the country at the time. The company was founded in 1889 with the merger of two bridge engineering firms and was located in Washington Heights, Illinois. With the growth of the oil drilling industry and westward expansion of the railroads at the turn of the century, the company diversified from bridge design to the design and manufacture of elevated water tanks and above ground petroleum tanks. The firm had an office in Seattle, and the structure was likely erected by one of their company crews.<sup>61</sup>

**Condition:** Appears to be good, but overdue for repainting, with minor signs of rust.

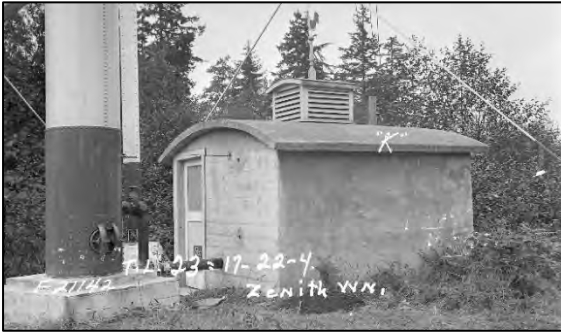
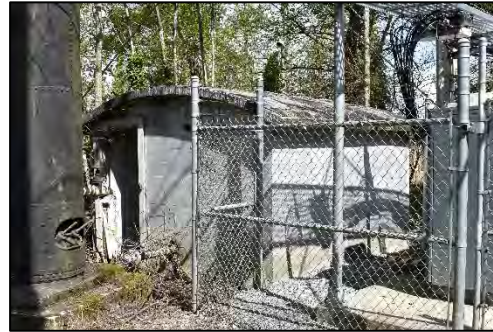
*The structure in 1937 and 2022*

The Water Tower Pumphouse is associated with the Water Tower (see entry), located adjacent to it. It is part of the water system constructed in 1926 as one of the first steps in preparing the site for the construction of the Main Building, since there was no public water supply available to the site at the time. The building was likely designed by architects Heath, Gove & Bell.

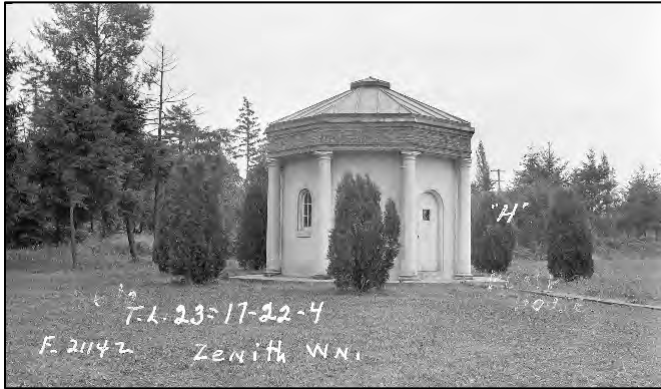
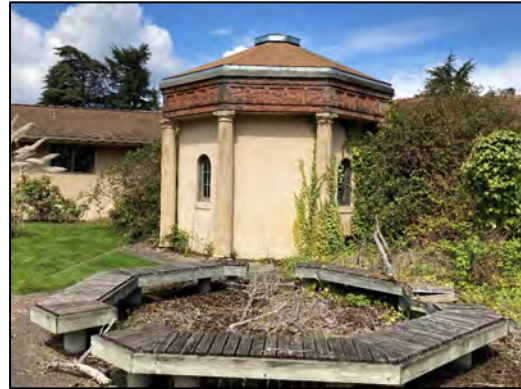
*The building in 1937 and in 2022.*

The Octagonal Pumphouse was completed in 1926 as part of the water well system for the Masonic Home, and was integral to the Home's establishment. The building was likely designed by architects Heath, Gove & Bell. When originally constructed, building was located in an open field approximately 275' south of the rear wing of the Masonic Home Main Building. Besides serving as a pumphouse, the building was intended to also grace the landscape as a freestanding decorative element.

New roofing has moderately diminished the Octagonal Pumphouse's integrity of materials, and construction of the Infirmary Wing Addition in 1987 diminished the pumphouse's integrity of setting. Nevertheless, the Octagonal Pumphouse remains sufficiently intact with integrity of location, design, workmanship, feeling, and association. While the structure lacks distinction to be recommended individually eligible, it contributes to the recommended Masonic Home of Washington Historic District as a component of the early physical development of the Masonic Home of Washington. The period of significance begins and ends in 1926, the year of construction.

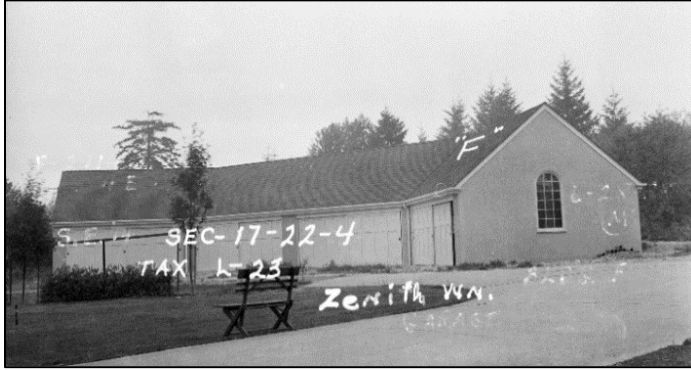
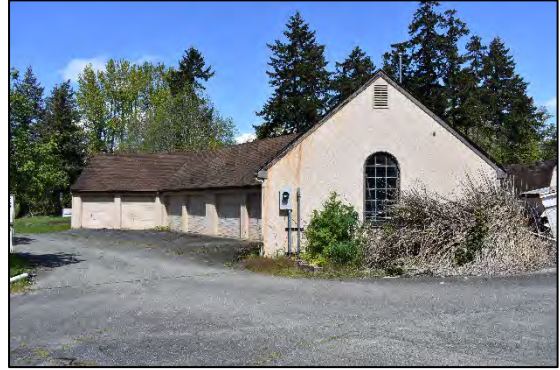
The building in 1938 and in 2022.

The Garage is located northeast of the Masonic Home Main Building's rear wing, on the rear service drive which leads to the Main Building's loading dock. The Garage was constructed in 1937 and was designed to accommodate eight vehicles for the Home's staff. The designers of the Garage were Mock & Morrison, a prominent Tacoma architecture firm which occasionally collaborated with Heath, Gove & Bell on projects in the 1930s. At the time, the two firms were designing several buildings together at the Western Washington Hospital in Steilacoom. Behind the Garage, to the east, is a V-shaped Storage Building constructed in 1997.

The Garage is a 21' wide, C-shaped building with angled, gable-front wings, with a 118' long rear facade and a 83' long front facade. The structure is wood frame on a concrete foundation, clad with painted, textured stucco. The gable roof, with ridge line running longitudinally, has no overhang and is clad with asphalt composite shingles. Each gable end features a centered, vertically oriented, arched, painted wood sash fixed window with three-by-six lites, and a painted wood sill. There are non-original roof vents at the top of the gables. The front facade has eight paired garage openings, each with non-original roll-up wood garage doors; two pairs in the center portion, and one pair at each angled wing. Garage door pairs are separated by non-original vertical wall segments. The area between the road and the Garage doors is paved with concrete. There are two person doors and four fixed multi-lite wood-sash windows, with wood sills, on the rear facade. The gutters and leaders are contemporary aluminum. The Garage interior is unfinished, exposed studs and joists. There is a non-original chain link and metal pipe enclosure at south part of east facade, apparently used for storage.

The loss of the original garage doors and door openings in particular has somewhat diminished the integrity of design, materials, workmanship, and feeling, but the building retains its unusual plan and massing, which recalls that of the front of the Masonic Home. Additionally, the Garage retains integrity of location, setting, and association. While the building lacks distinction to be recommended individually eligible, it contributes to the recommended Masonic Home of Washington Historic District as a component of the early physical development of the Masonic Home of Washington. The period of significance begins and ends in 1937, the year of construction.

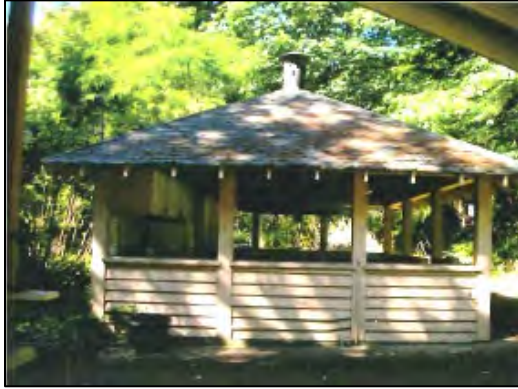
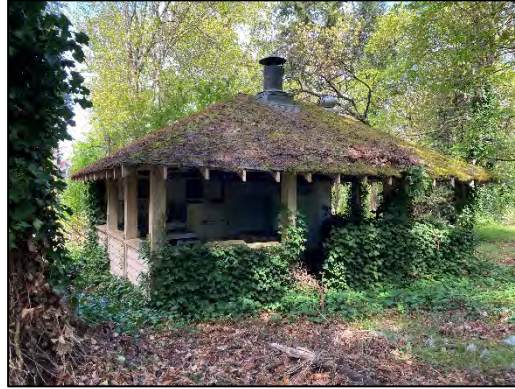
*The Outdoor Kitchen in 2002 (left), and in 2022 (right).*

The Outdoor Kitchen is situated in the part of the Eastern Woods referred to as the “Picnic Area,” which had been used as such by the Home and visitors to the Home since the early 1930s. In 1937, the Outdoor Kitchen and Outdoor Restroom were built to facilitate gatherings. In 1950, a Masonic Home brochure of that year described the site: “An outdoor kitchen and tables are provided in the park at the rear of the Home where Lodges, Chapters, or family groups may gather for picnicking in season. These are greatly enjoyed by our members in the Home. It is not unusual to discover five or six of the Brethren enjoying the cozy warmth of one of the stoves and the companionship it affords.”<sup>62</sup> An east-west asphalt path leading from the Main Building to the Picnic Area connects the Outdoor Kitchen, Covered Patio, and Outdoor Restroom buildings.

Although in poor condition, the Outdoor Kitchen retains sufficient integrity of location, design, setting, feeling, materials, workmanship, and association. While the building lacks distinction to be recommended individually eligible, it contributes to the recommended Masonic Home of Washington Historic District as a component of the early physical development of the Masonic Home of Washington. The period of significance begins and ends in 1937, the year of construction.

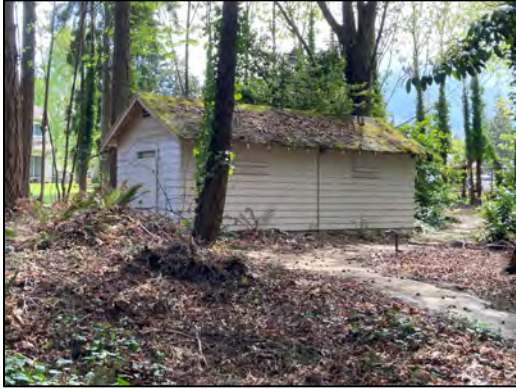
*The Outdoor Restroom in 2022.*

The Outdoor Restroom is situated in the part of the Eastern Woods referred to as the “Picnic Area,” which had been the site of picnics by residents and visitors of the Home since the early 1930s. In 1937, the Outdoor Restroom and the nearby Outdoor Kitchen were built to facilitate these gatherings. The nearby Covered Patio was added several decades later.

The Outdoor Restroom retains integrity of location, setting, design, materials, workmanship, feeling, and association. While the building lacks distinction to be recommended individually eligible, it contributes to the recommended Masonic Home of Washington Historic District as a component of the early physical development of the Masonic Home of Washington. The period of significance begins and ends in 1937, the year of construction.

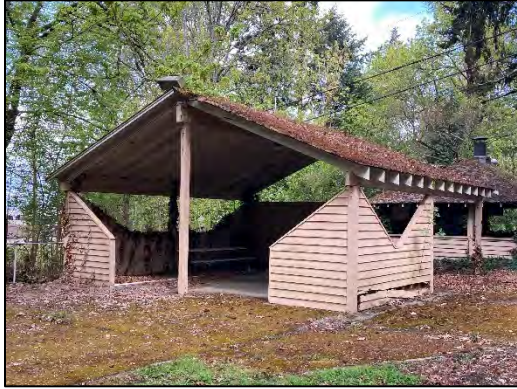
*The Covered Patio in 2022*

The Covered Patio is situated in the part of the Eastern Woods referred to as the “Picnic Area,” which had been the site of picnics by residents and visitors of the Home since the early 1930s. In 1937, the nearby Outdoor Kitchen and Outdoor Restroom were built to facilitate these gatherings. The Covered Patio appears to date to ca. 1965-80, providing simple weather protection for outdoor dining.<sup>63</sup>

Loss of some siding and the somewhat deteriorated condition of the surrounding concrete pavement has slightly diminished the building's integrity of materials, design, and setting, but the distinctive building form and relationship to the picnic area's Outdoor Kitchen and Outdoor Restroom remains. The building remains relatively intact, and retains integrity of location, workmanship, feeling, and association. However, the building is not recommended eligible for the NRHP at this time, because it lacks individual distinction, and because the date of the construction of the building, ca. 1965-1980, has not been definitively determined, and falls partly within and without the fifty-year-limit historic period. For the same reasons, the building is recommended as a non-contributing resource to the recommended Masonic Home of Washington Historic District.

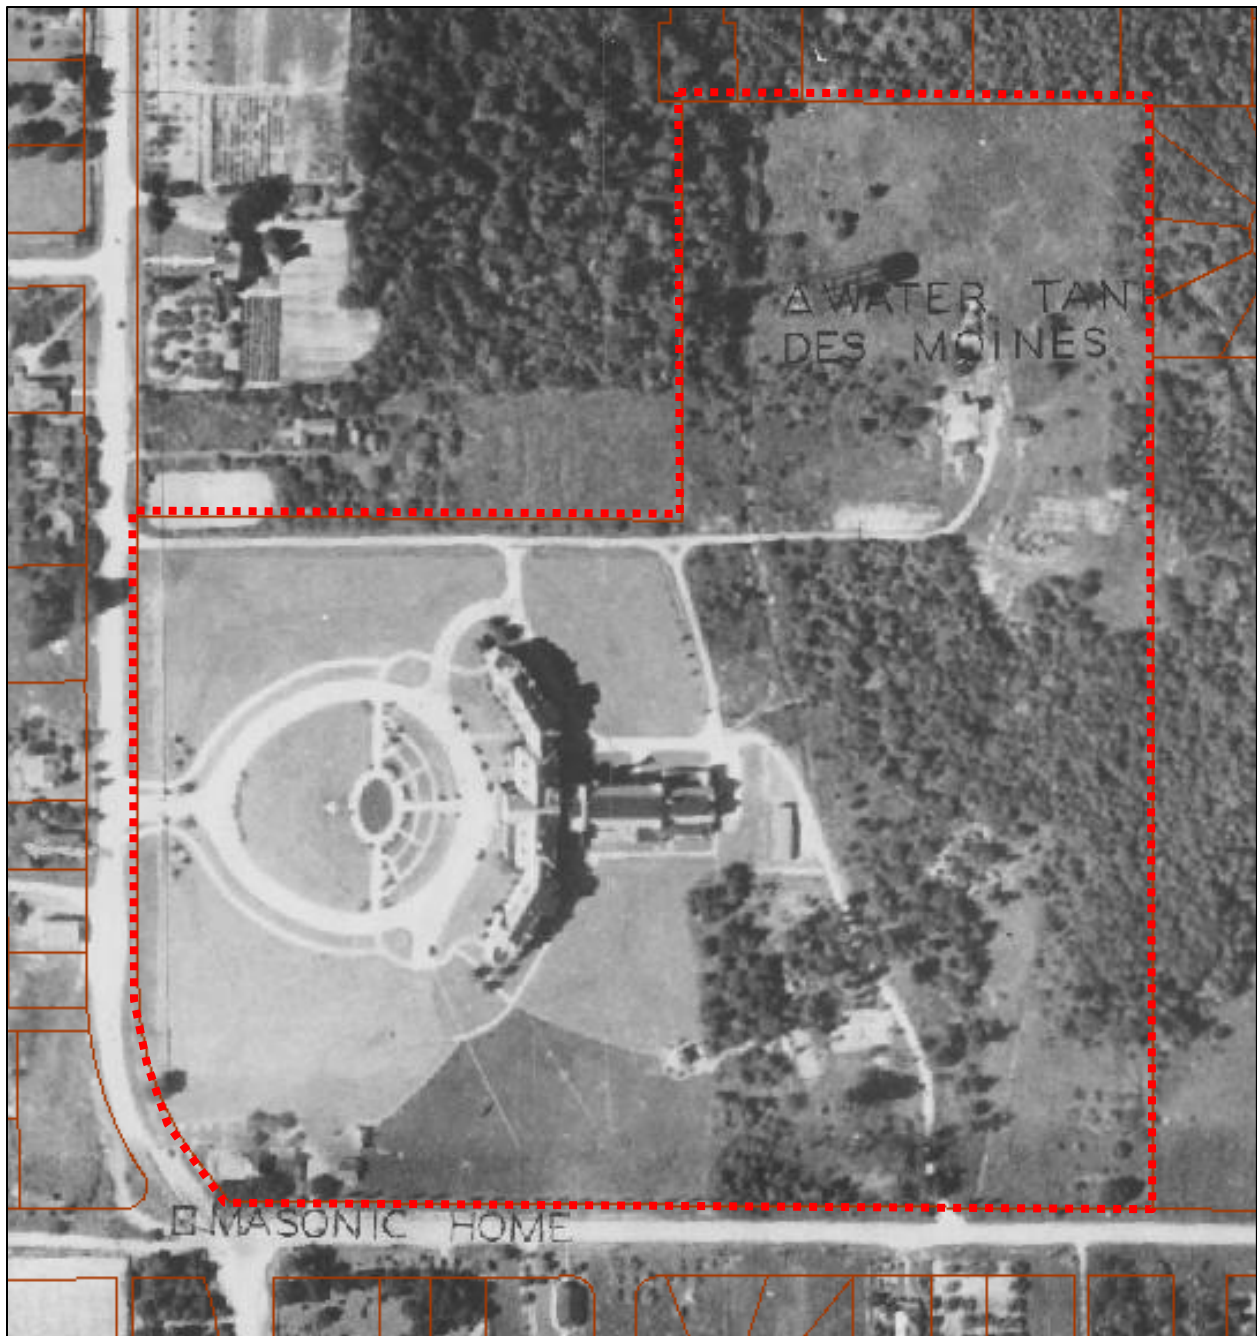
Fig. 6 – An aerial photo of the site in 1936, overlaid with current parcel. (King County Tax Assessor)

The 1936 image above is the earliest aerial photo found for this report. The red dotted line indicates the current 30-acre parcel boundaries; however, the original site extended eastward and encompassed 85 acres in total, although the exact dimensions of the original property have not been discovered. (Note that the historic photo and actual parcel boundaries do not align exactly). By 1936, the date of this photo, the Garage and Greenhouse had not yet been built. The purpose of the narrow rectangular building oriented north-south behind the Main Building is unknown, but it appears to be a shed or covered parking area.

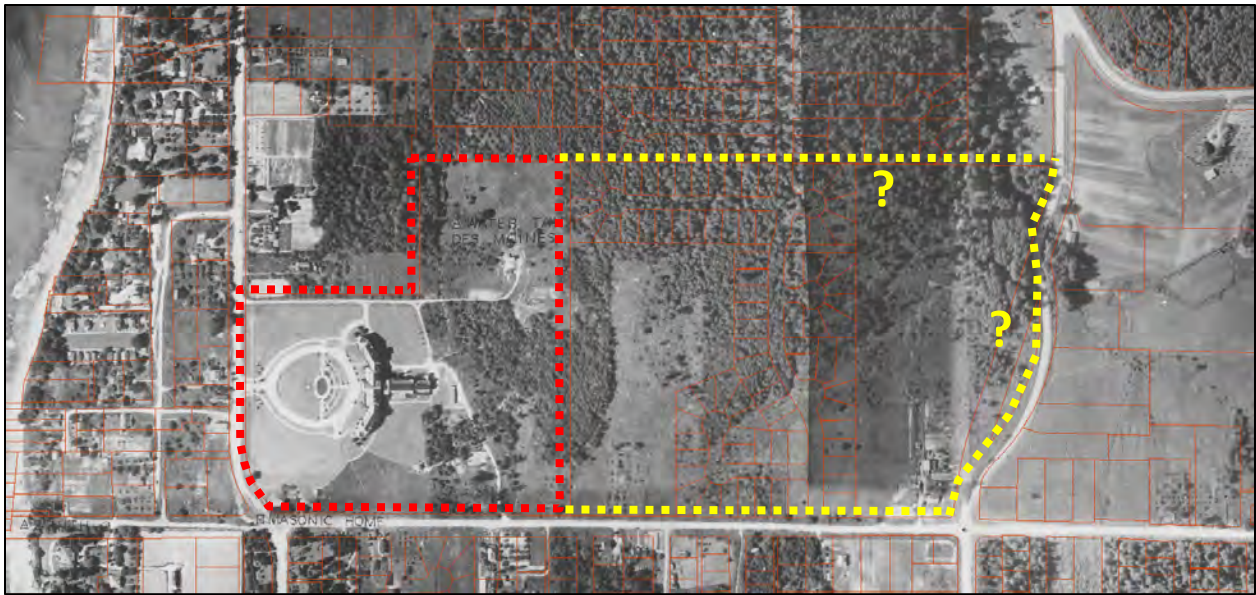
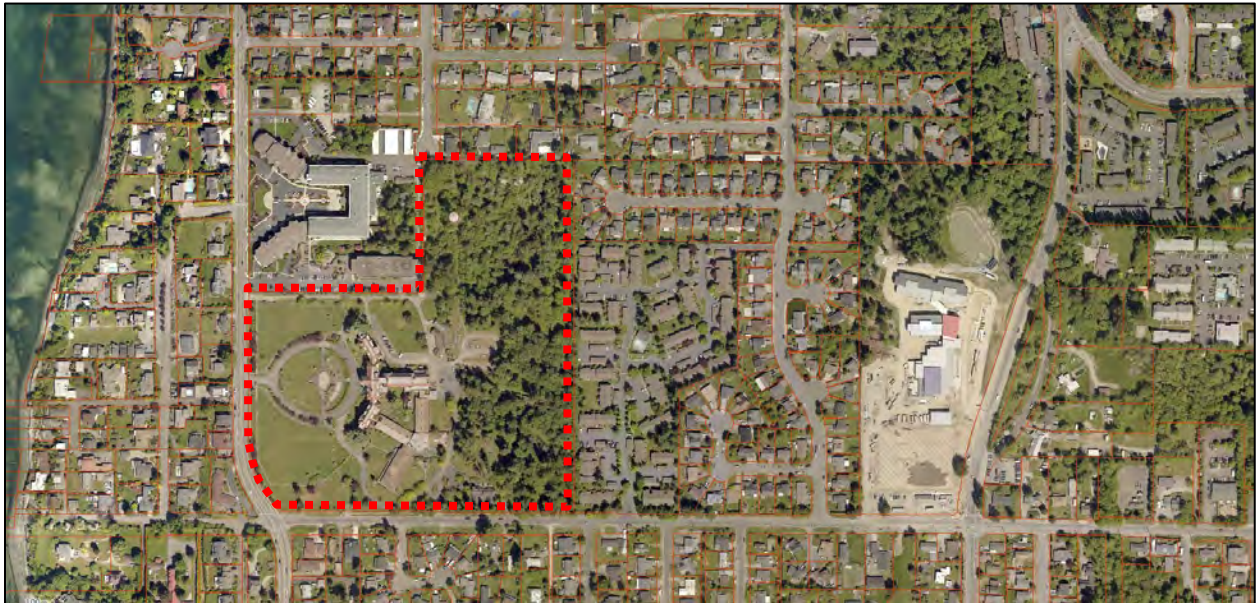
Fig. 7 – Aerial photos of the neighborhood in 1936 and present day.

Current parcel of 30.3 acres indicated by the red dotted line. The original parcel extended eastward from the rear of the present parcel, and encompassed 85 acres in total. The exact dimensions of the original property have not been discovered. Plausible alternatives have not been found; for example, if the north and south property lines of the existing parcel were extended eastward to 16<sup>th</sup> Avenue S (identifiable as the curving north-south roadway at right in both photos), as indicated by the yellow lines, the additional area would equal approximately 43 acres, therefore making the total 73.3 acres. Since the original parcel was 85 acres, the original site may have included land east of 16<sup>th</sup> Avenue S, or possibly some portion of the woods north of the parcel. The missing approximate 12 acres must have been sold at another, unknown time. (King County Tax Assessor)

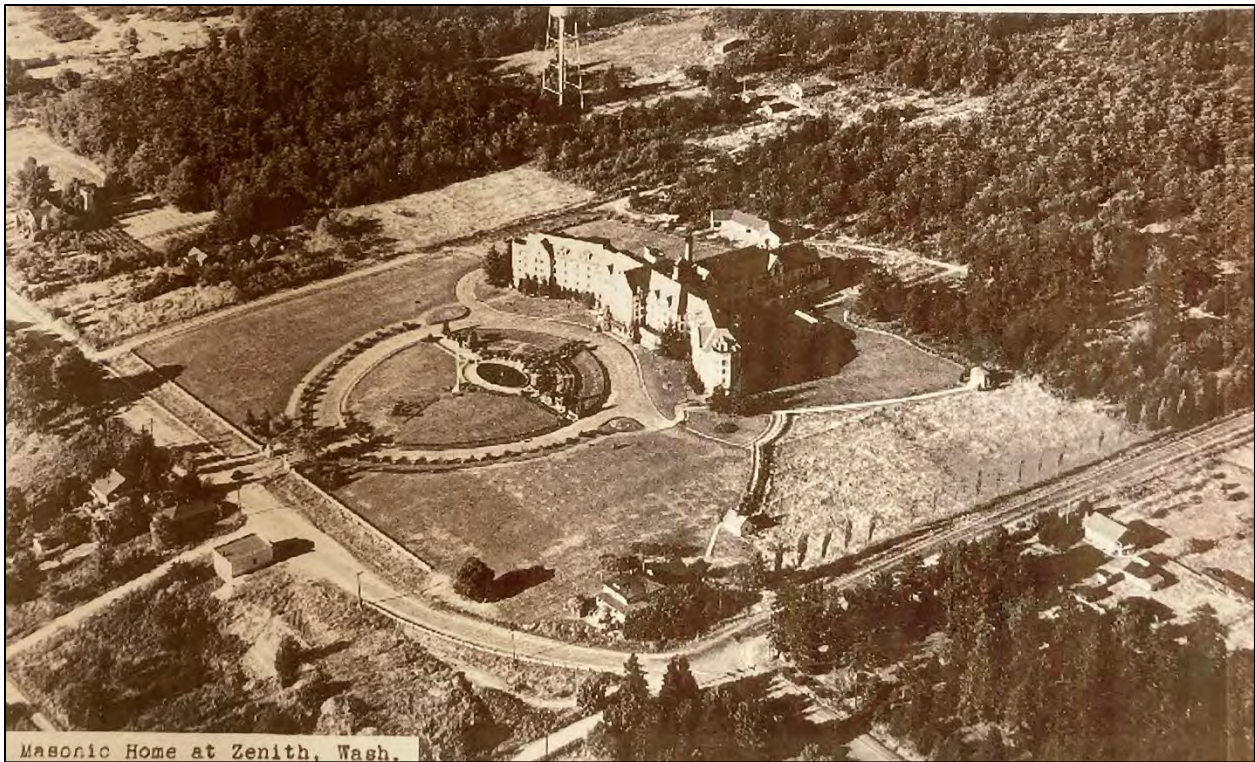
Fig. 8 – Masonic Home, c. 1940. North is oriented to the upper left of the photo. (Washington Masonic Archives)

The image above from 1940 shows almost all of the essential features of the Masonic Home, which were intact by 1937. The large T-shaped main building, constructed in 1927, dominates the site, and its formal front is set back from Marine View Drive S by a wall and gates, large lawn, and landscaped oval drive. Behind the main building, the property is largely wooded. The water tower constructed in 1926 is visible at the center top of the photo; it is fed by a well and pumphouse, not visible, at its base. Two other small pumphouses are visible to the southeast and southwest of the main building, and are linked by an irregular paved walk across the lawn. Residential structures for Home staff are visible at the southwest property corner, which were removed by the 1980s. Another staff home is discernable east of the water tower. The Garage, built in 1937, is visible just above the rear wing of the Main Building. The access road to it is visible along the north property line.

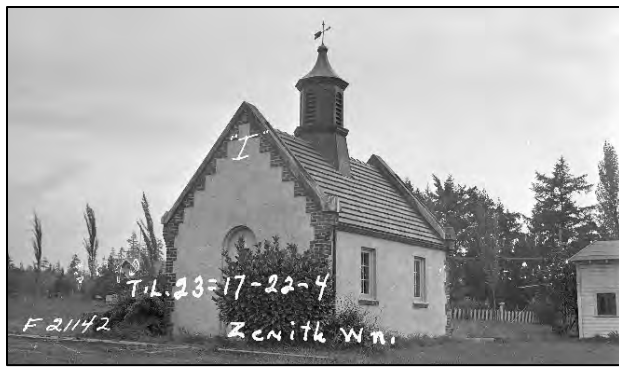
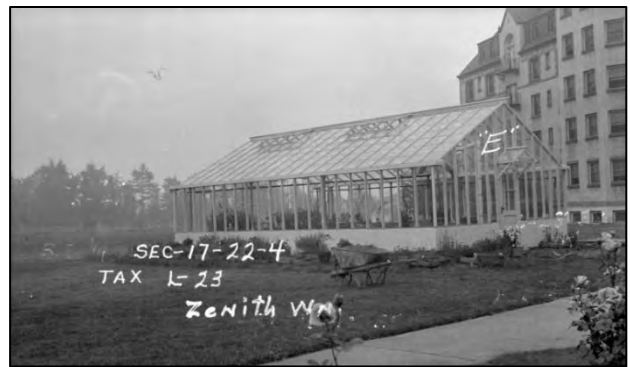
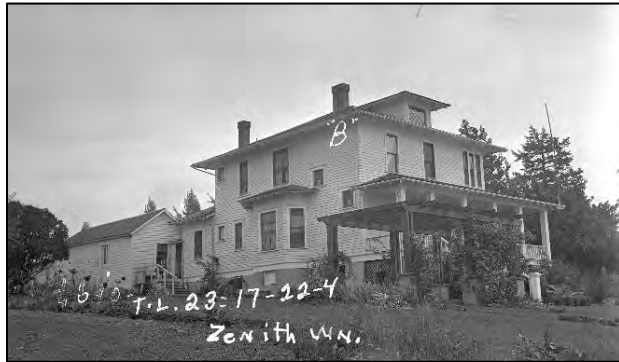
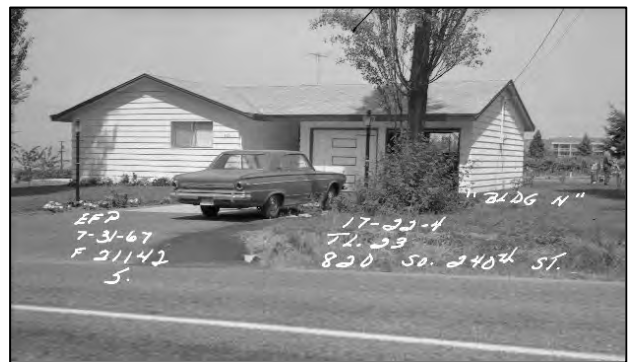
Fig. 16 – These King County tax assessor photos record buildings no longer on the Masonic Home property.

(Top Row) The Gabled Pumphouse (left) and Greenhouse (right). The Pumphouse was built in 1926 as part of the original water system, and once covered the well at the southwest part of the site. It was demolished by the 1970s and the well is currently covered with a concrete slab. The Greenhouse was constructed in 1937, as indicated by tax records, and was located behind the Main Building, south of the rear wing. Later, it was enclosed in the courtyard when the Infirmary Annex was constructed in 1966. It deteriorated and was demolished at an unknown time, and a ca. 1990 wood-frame and corrugated metal Garden Shed was built on the foundation.
