**CITY OF DES MOINES**  
**ZENITH PROPERTIES BUILDING DEMOLITION**  
**PERMIT APPLICATION**

**DRAFT ENVIRONMENTAL IMPACT STATEMENT**  
**APPENDICES (PART 1: APPENDICES A-D)**

**JANUARY 2024**

**APPENDIX B**    **DEMOLITION PLAN**

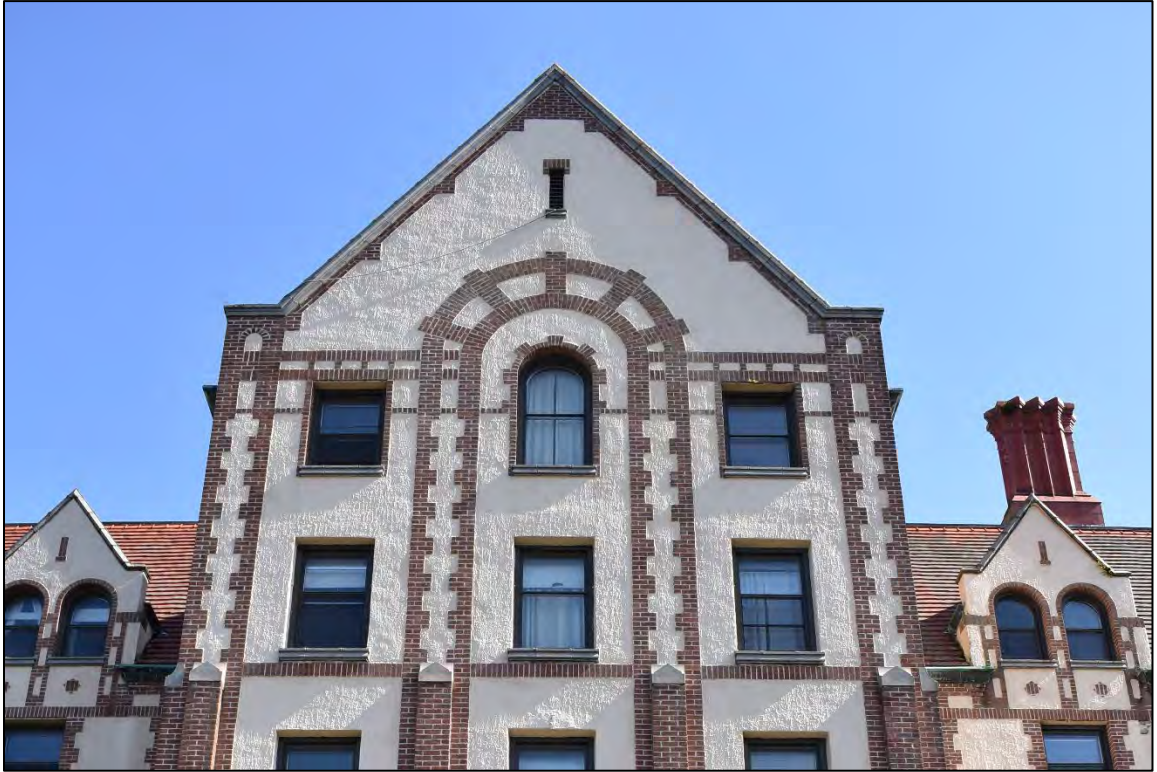
Fig. 5 – Main Building, west facade, detail of central upper gable. (2019)

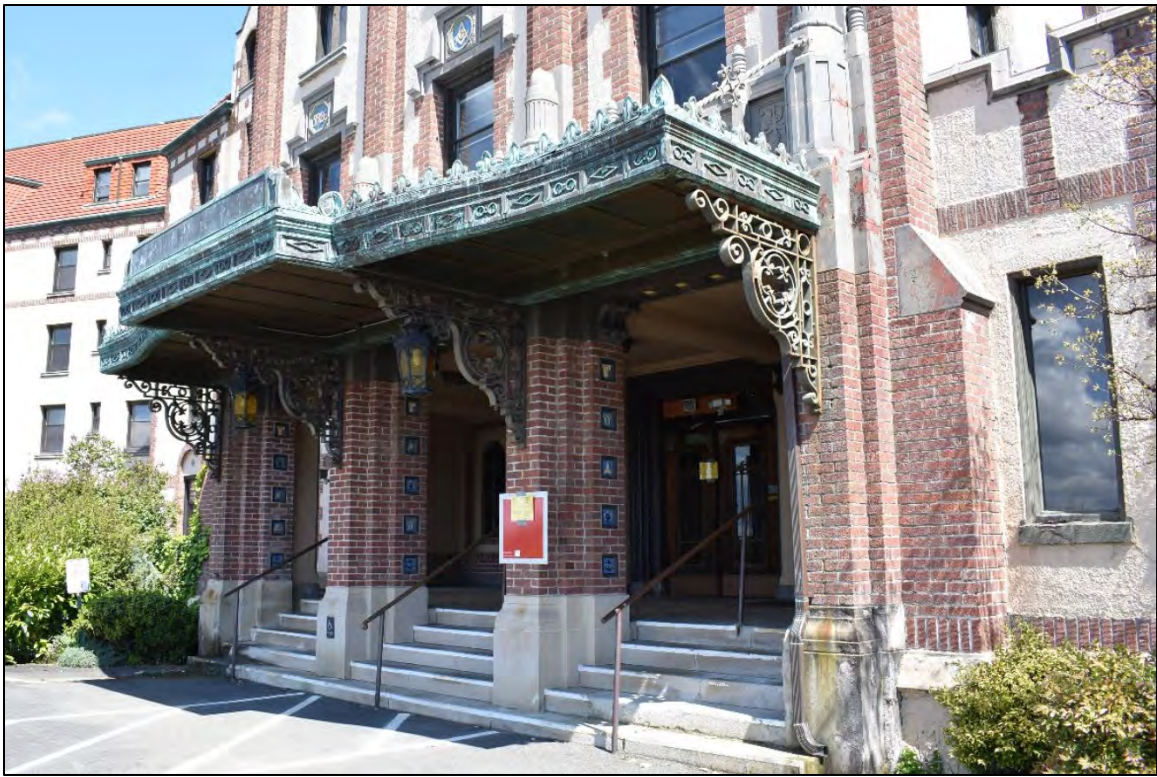
Fig. 6 – Main Building, west facade, main entrance marquee.

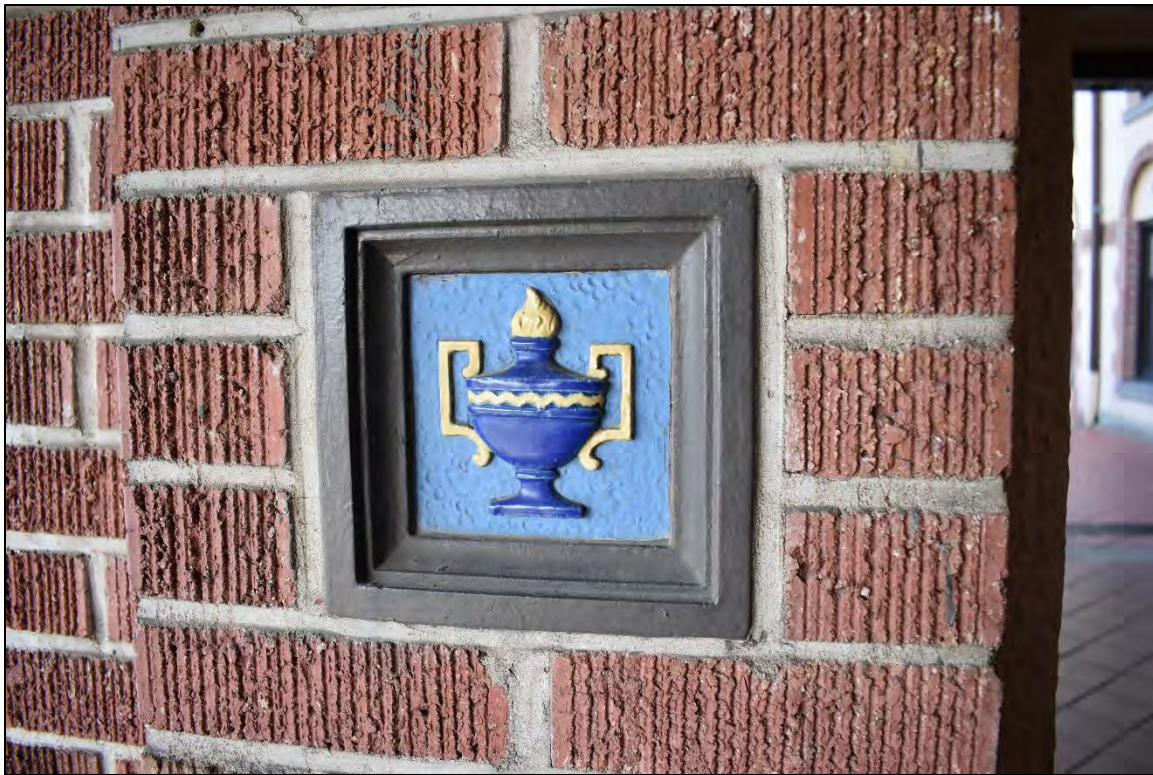
Fig. 8 – Main Building, west facade, main entrance porch, detail of Masonic ornamental tile.

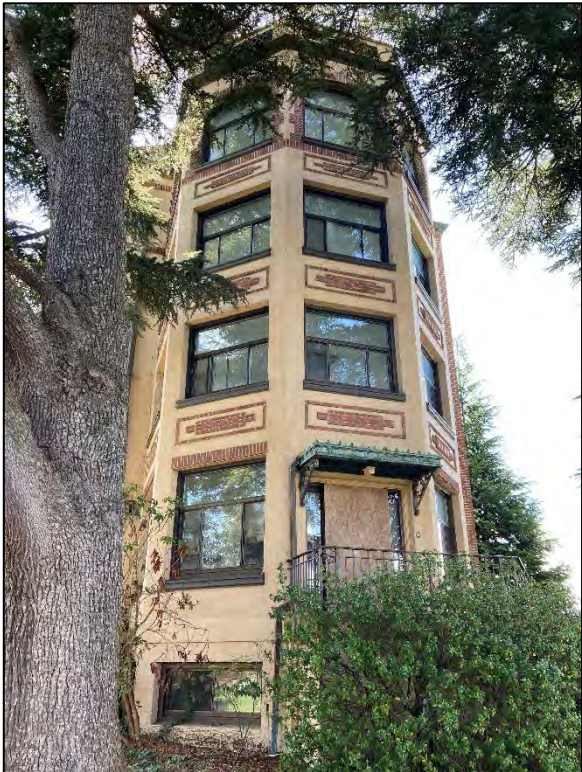
Fig. 11 – Main Building, north wing, north facade (north solarium bay).

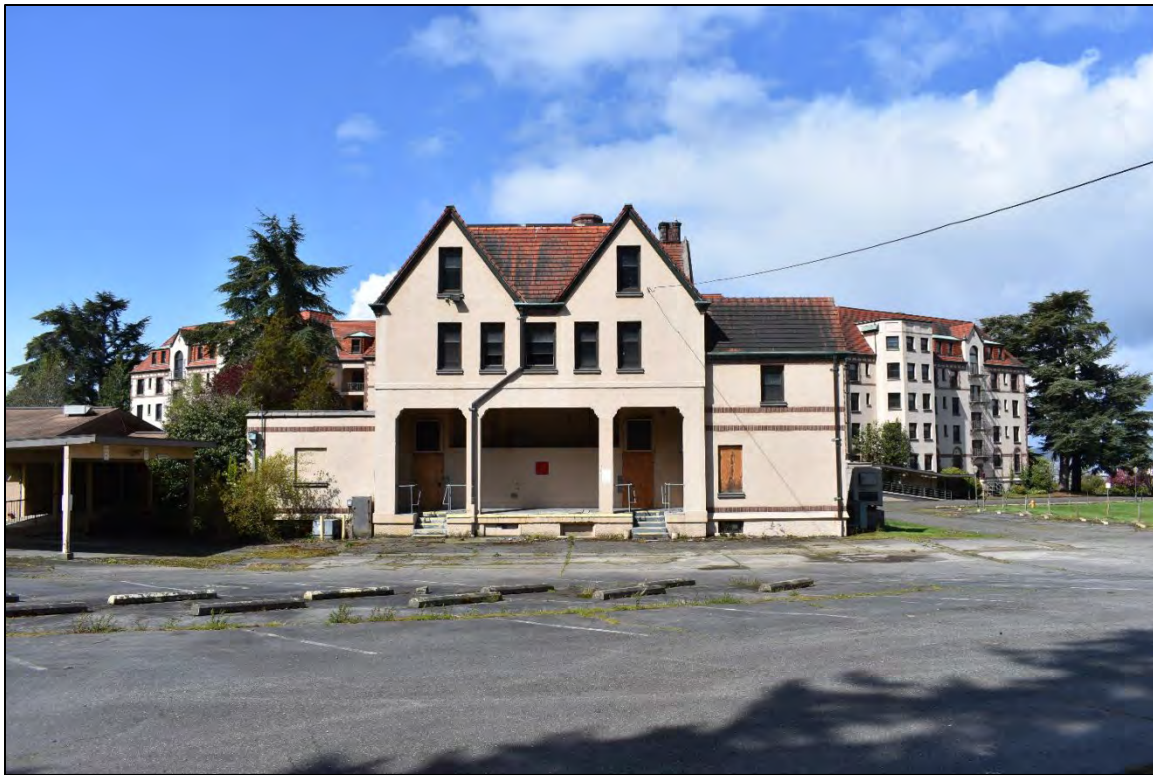
Fig. 16 – Main Building, rear wing, east facade, showing loading dock.

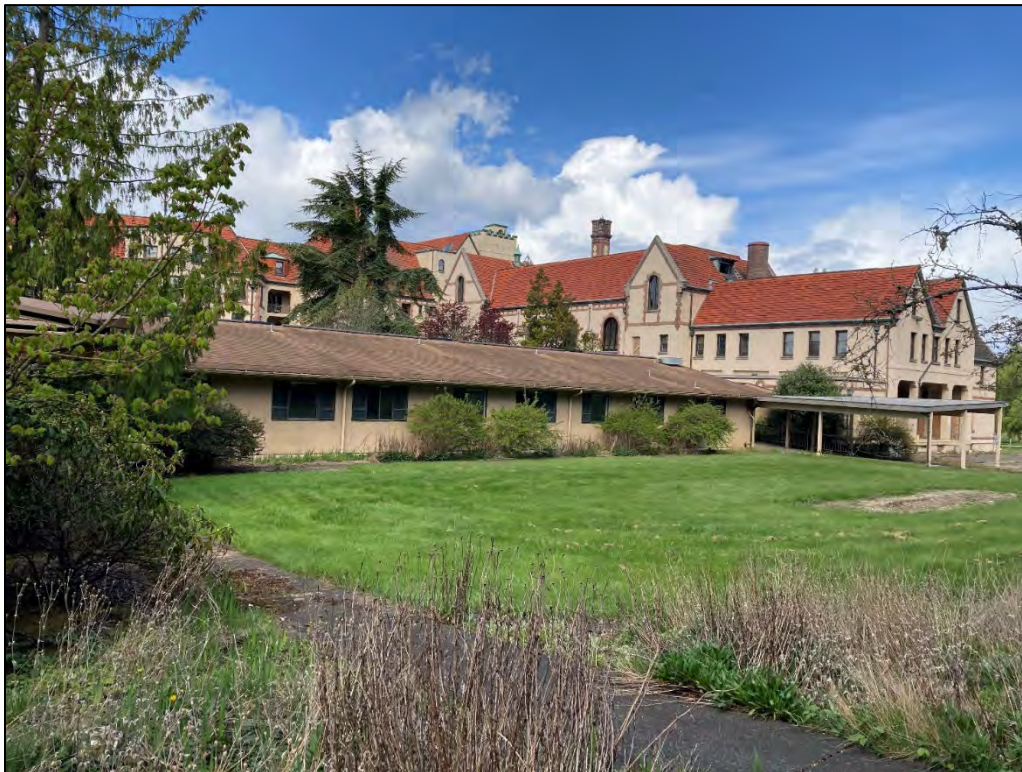
Fig. 17 – Main Building, rear wing (in distance) showing loading dock at right. Infirmary Wing (built 1966) north arm in foreground at left.

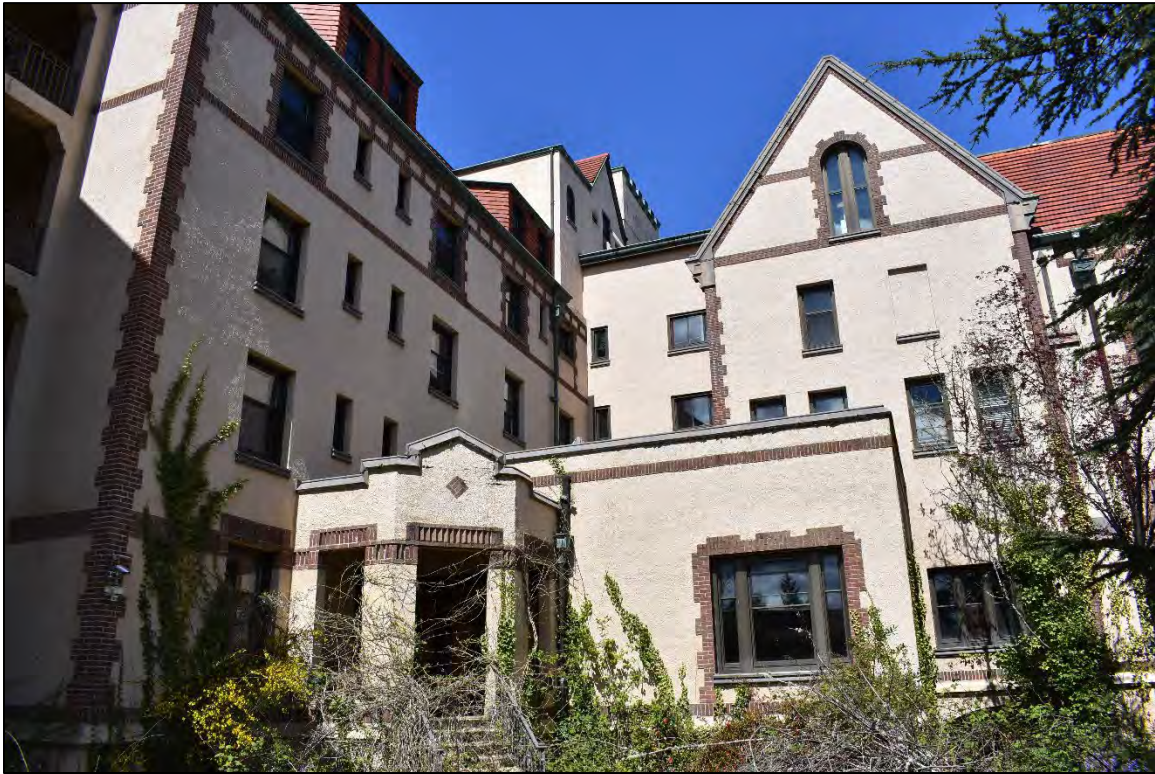
Fig. 20 – Main Building, rear wing, south facade from interior courtyard.

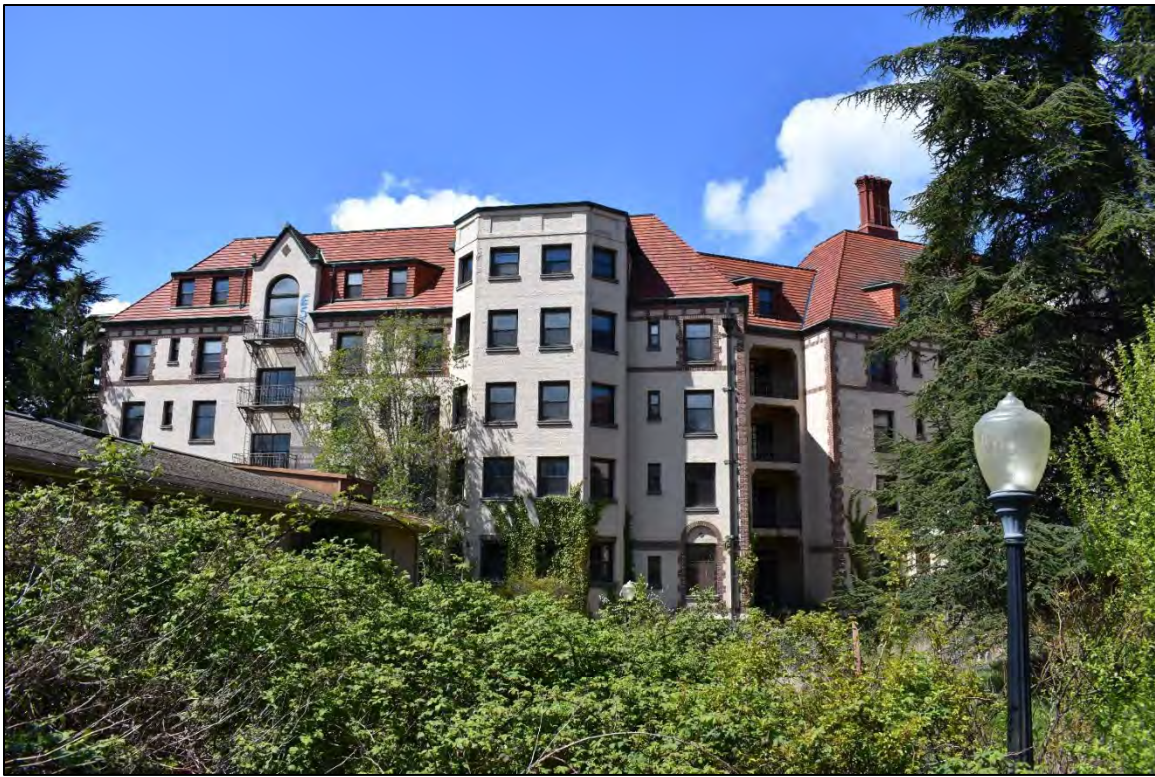
Fig. 21 – Main Building, south facade of rear wing (right) and east facade of south wing (left), from interior courtyard.

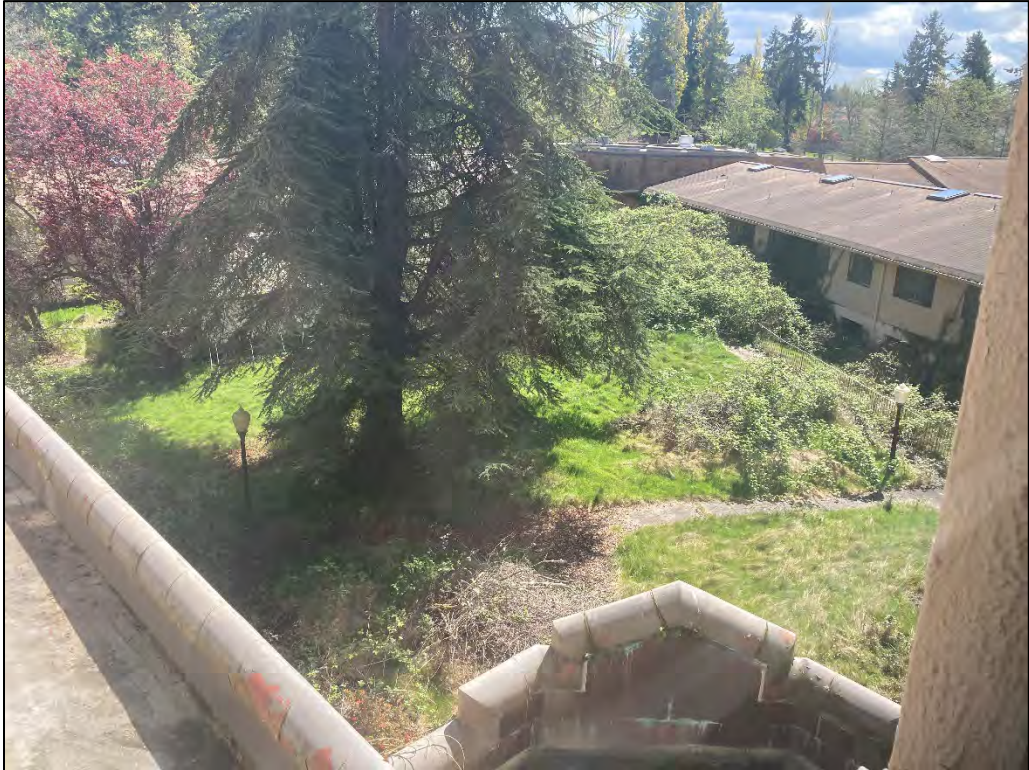
Fig. 22 – Main Building, south wing, east facade, from interior courtyard.

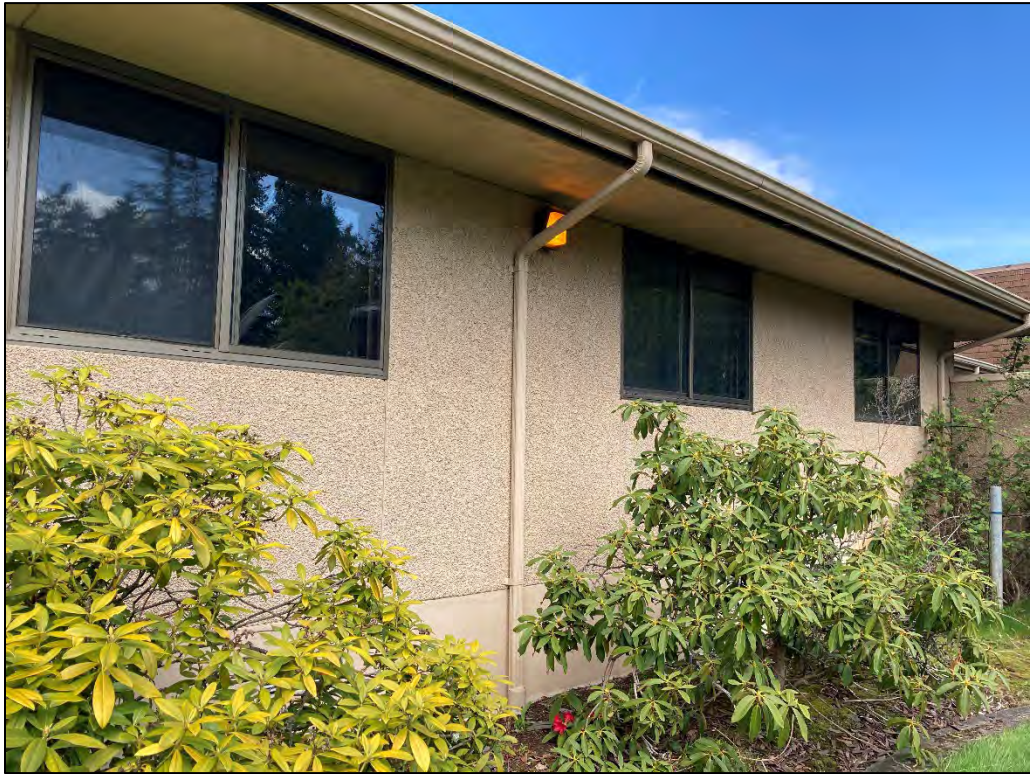
Fig. 26 – Infirmary Wing north arm, east facade, covered entrance. (2019)

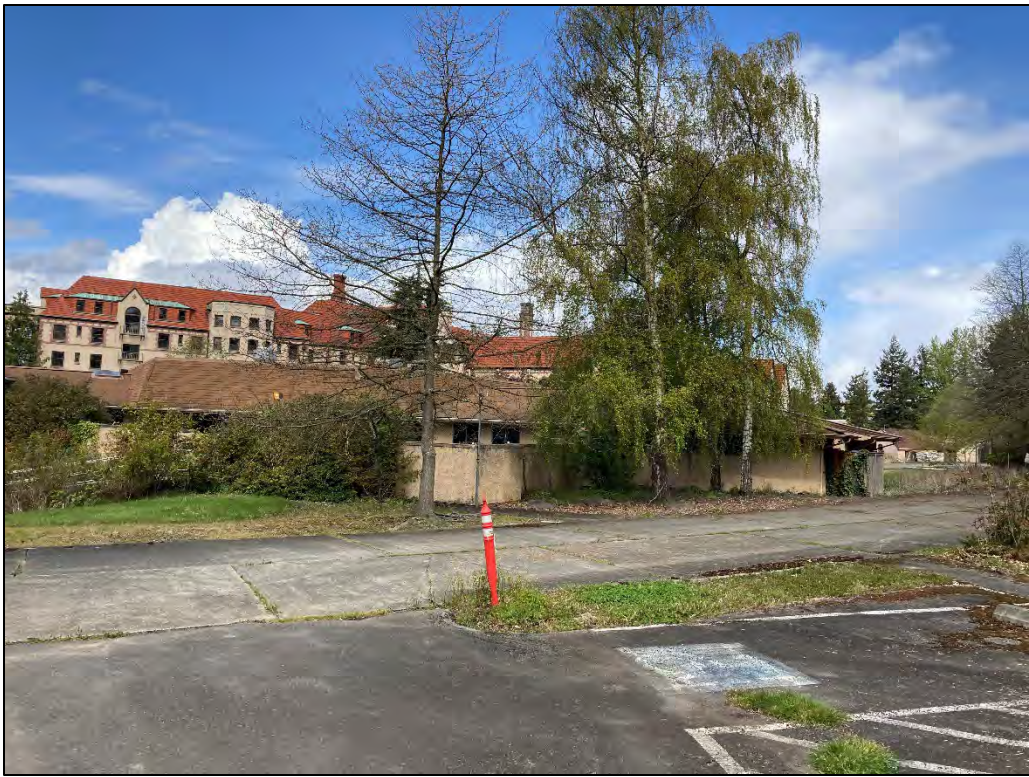
Fig. 27 – Infirmary Wing north arm, east facade, covered entrance.

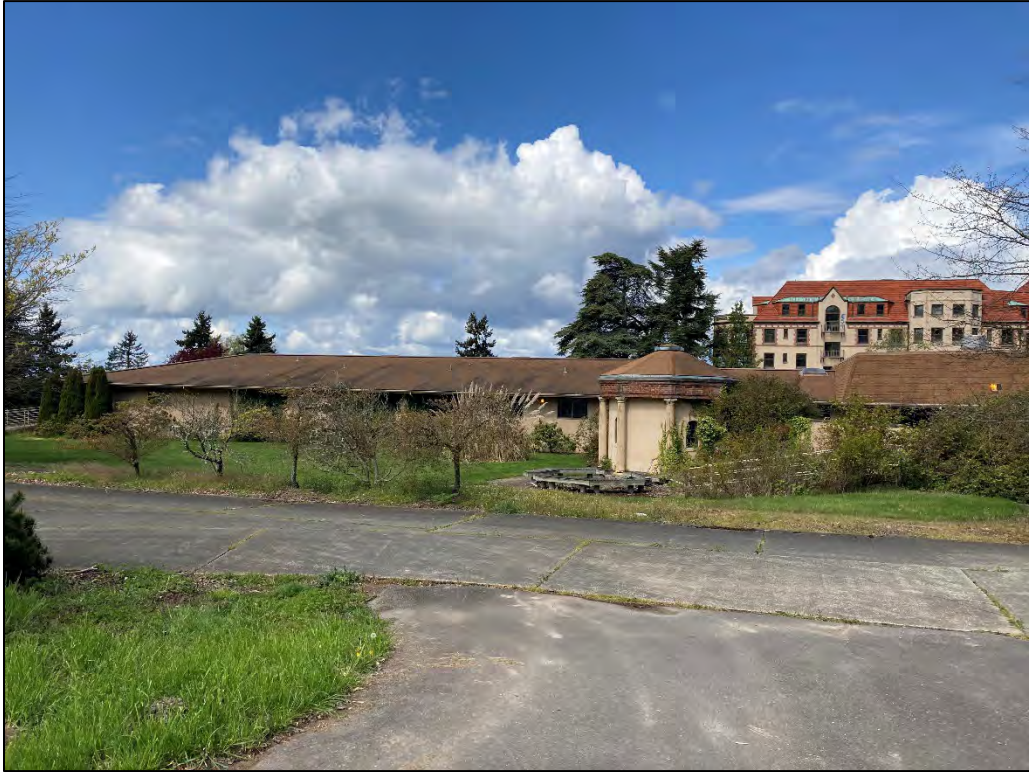
Fig. 28 – Infirmary Wing Addition, east facade.

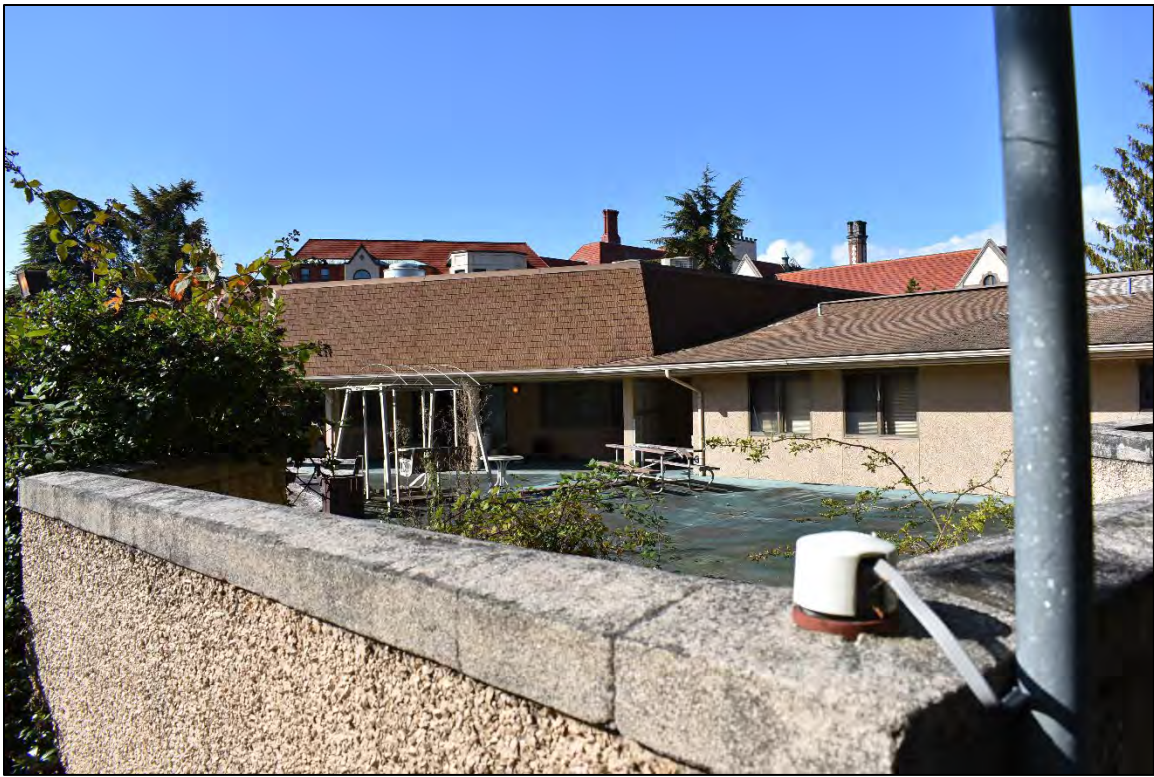
Fig. 29 – Infirmary Wing Addition, east facade. Octagonal Pumphouse visible in foreground.

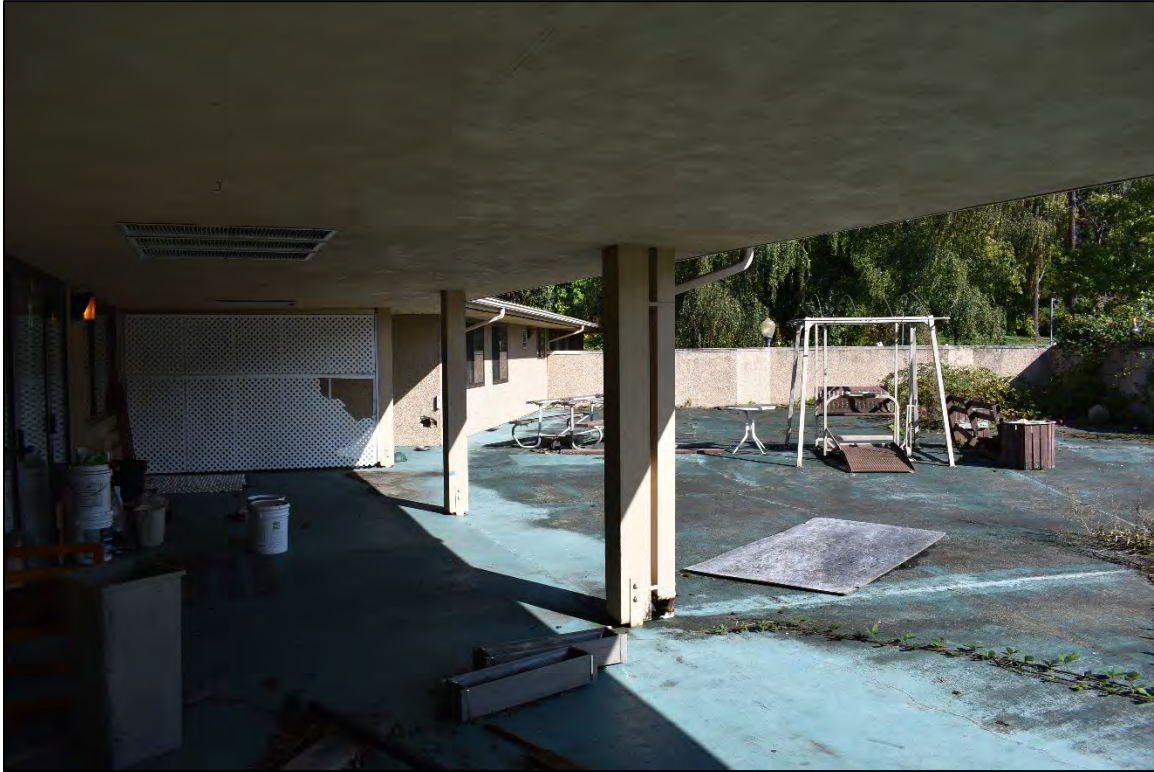
Fig. 30 – Infirmary Wing Addition, east facade, showing outdoor walled exercise area. (2019)

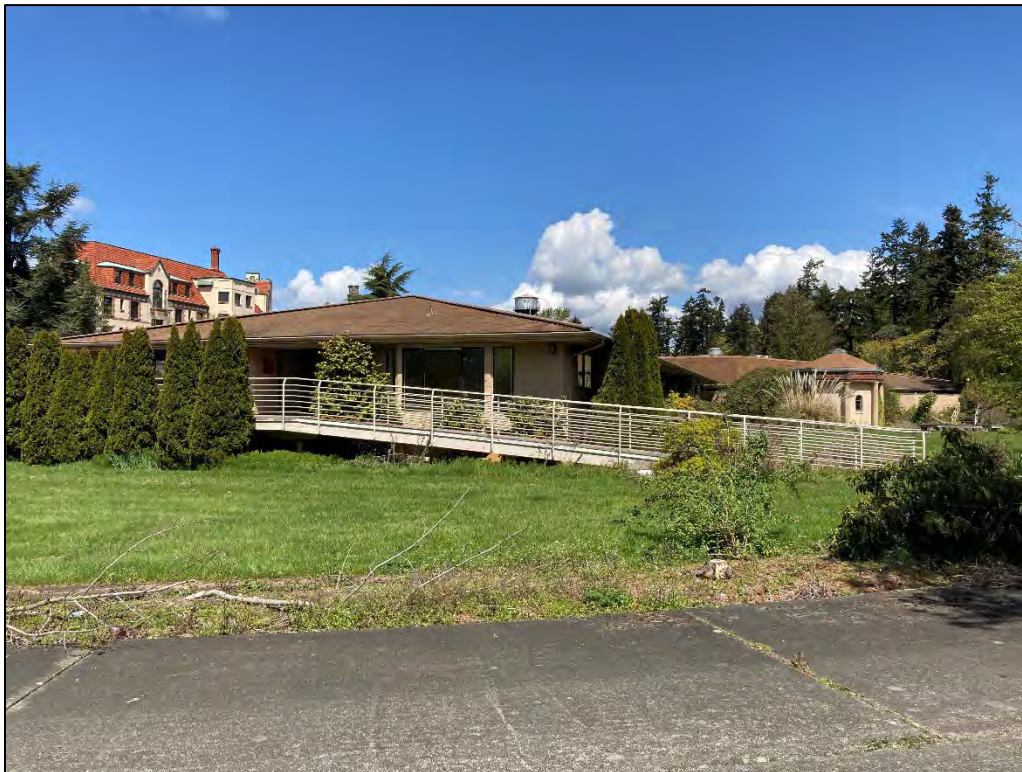
Fig. 32 – Octagonal Pumphouse, east facade.

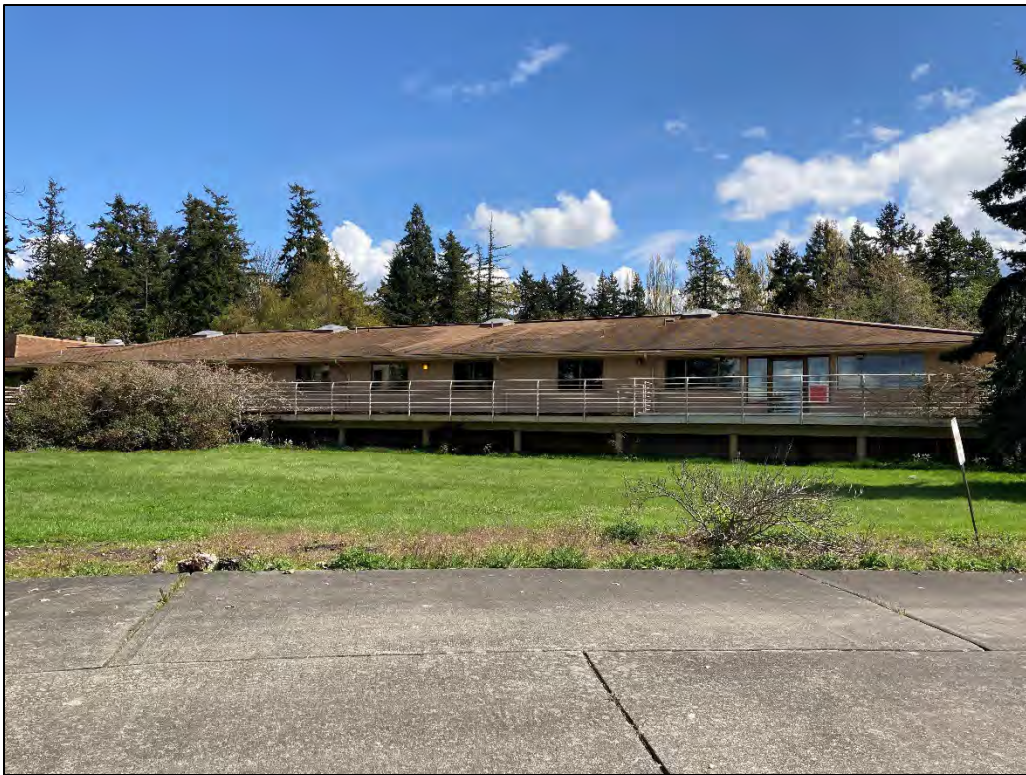
Fig. 33 – Infirmary Wing Addition, southwest facade. Octagonal Pumphouse visible in distance at right.

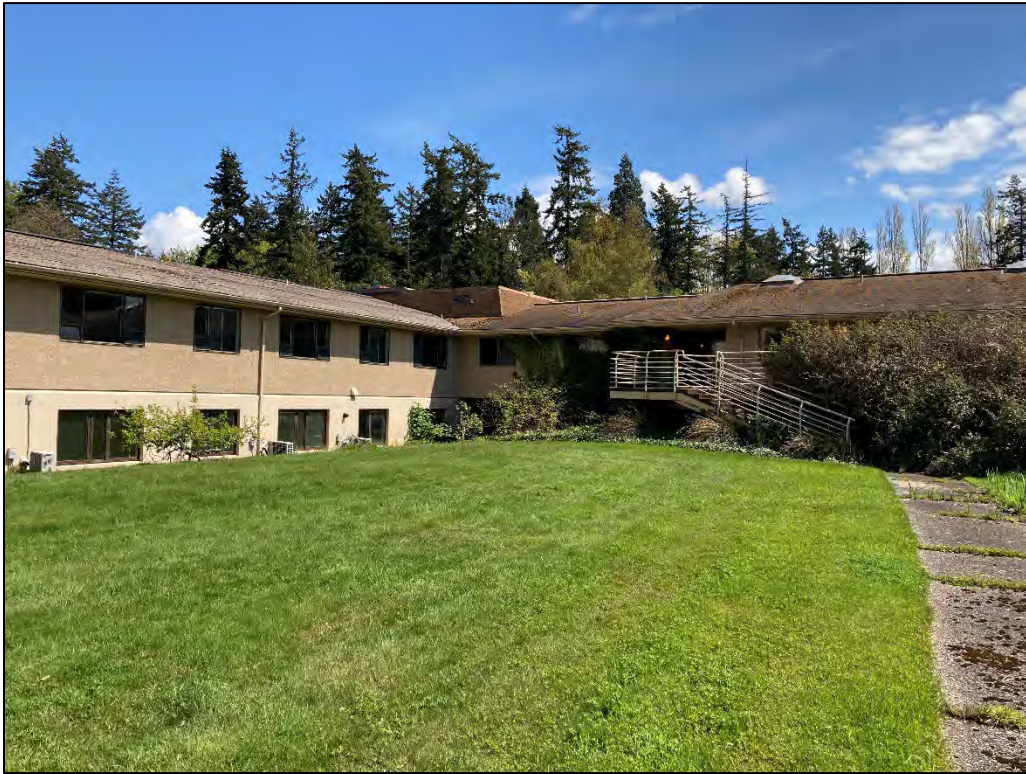
Fig. 34 – Infirmary Wing Addition, northwest facade.

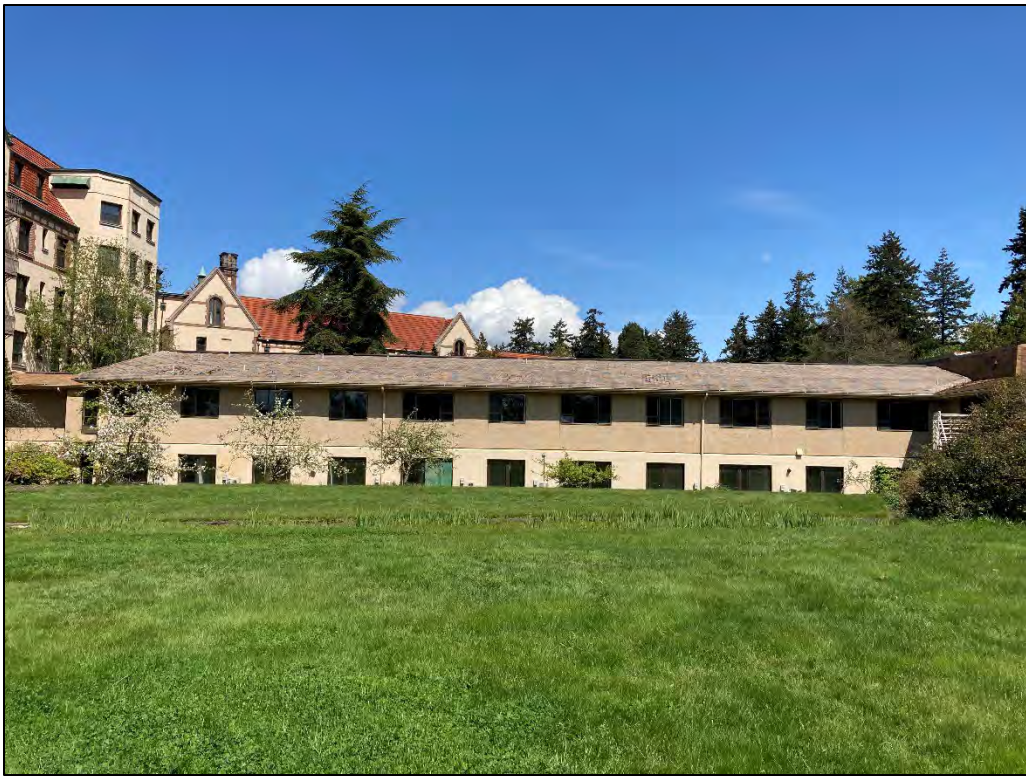
Fig. 35 – Infirmary Wing west arm, southwest facade (left), and Infirmary Wing Addition, northwest facade (right).

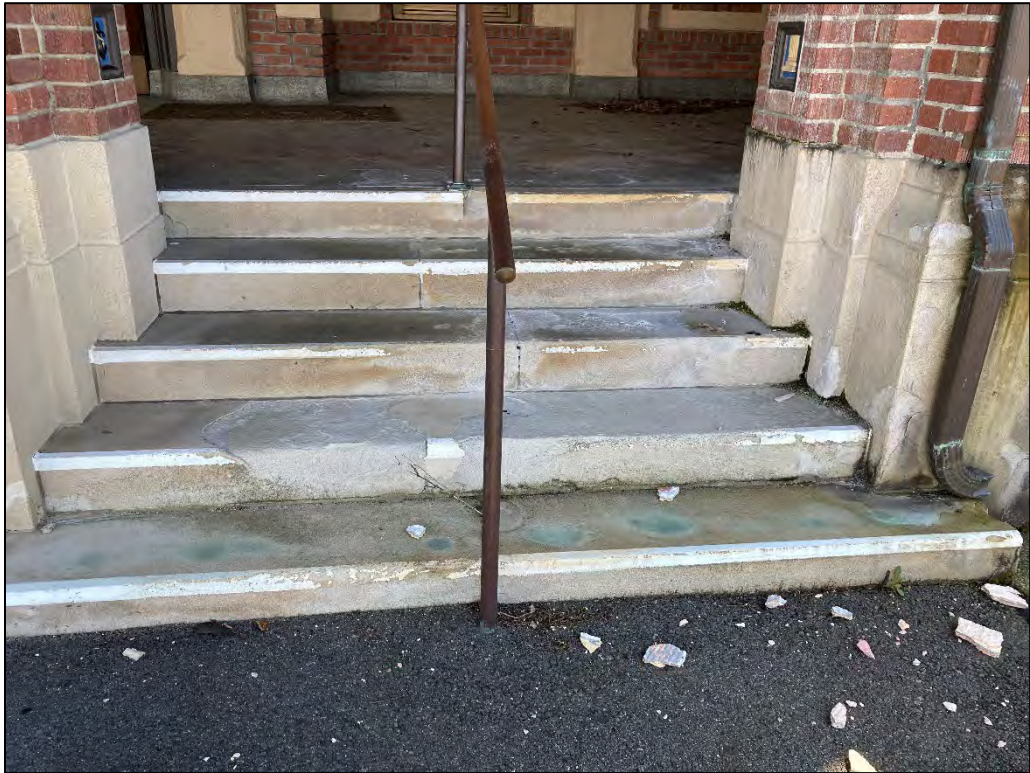
Fig. 37 – Main Building, front entrance. (2019)

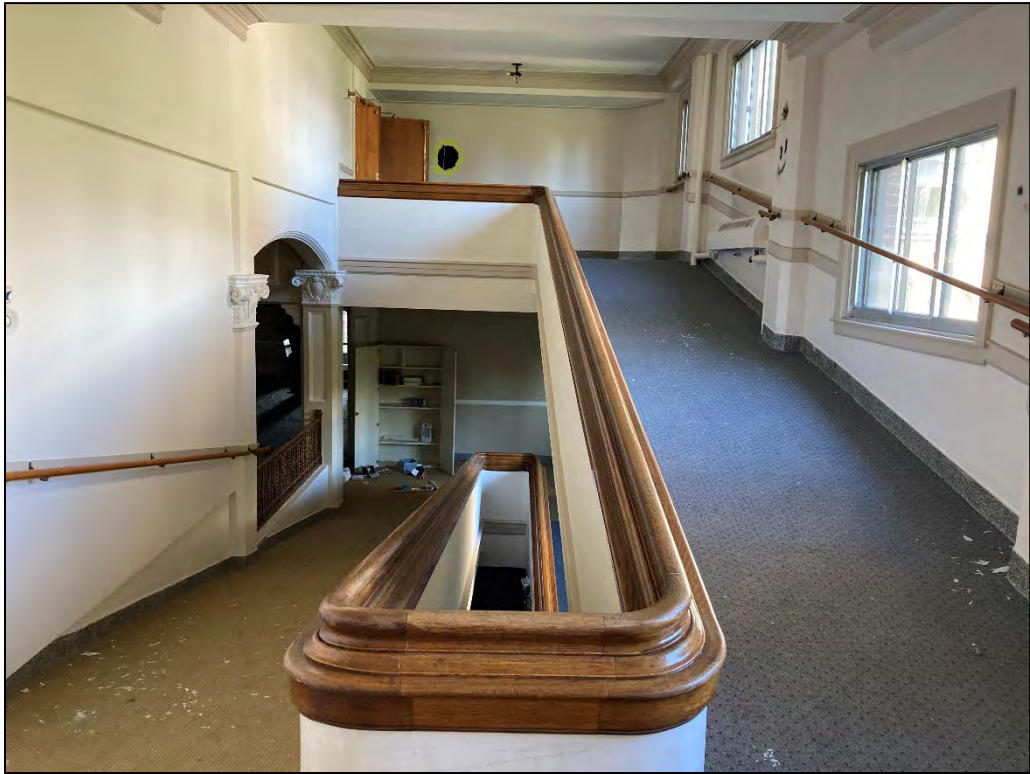
Fig. 53 – Main Building, interior, first floor, main circulation ramps off main hall. (2019)

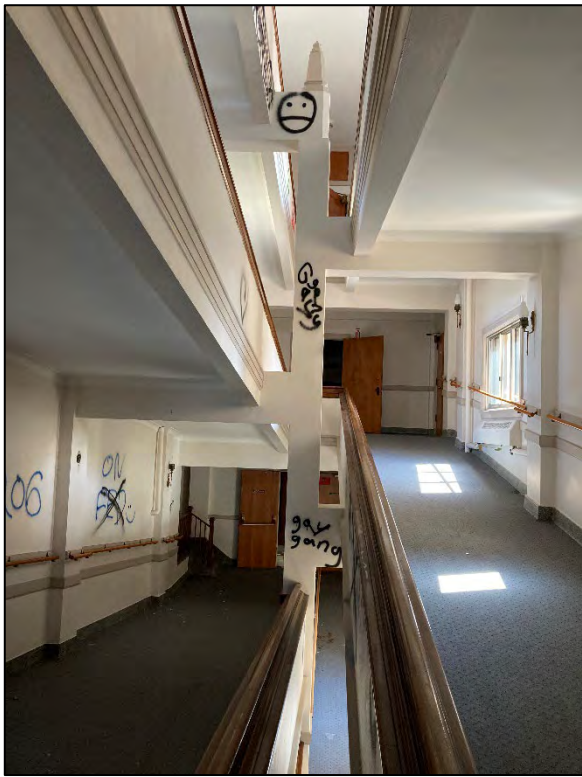
Fig. 54 – Main Building, interior, second floor, main circulation ramps.

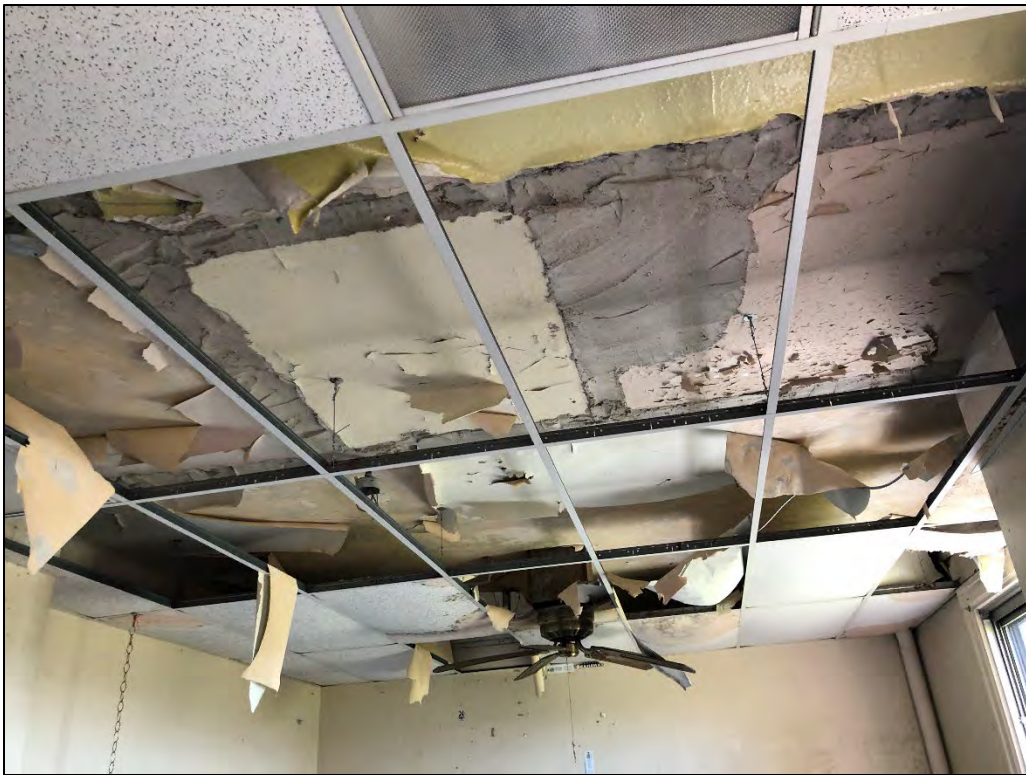
Fig. 80 – Condition: Main Building, interior, first floor, water damage at sitting room.

**FIRST FLOOR – WATER DAMAGE**

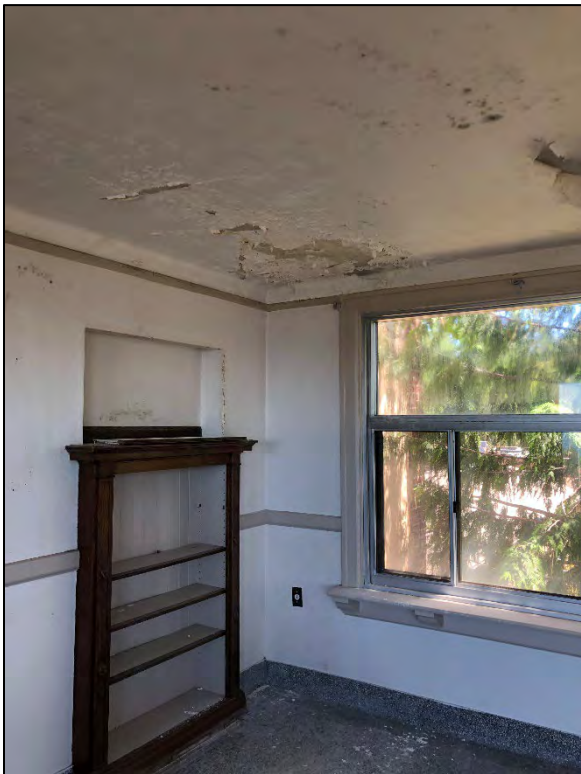
Fig. 81 – Condition: Main Building, interior, first floor, water damage at residence quarters.

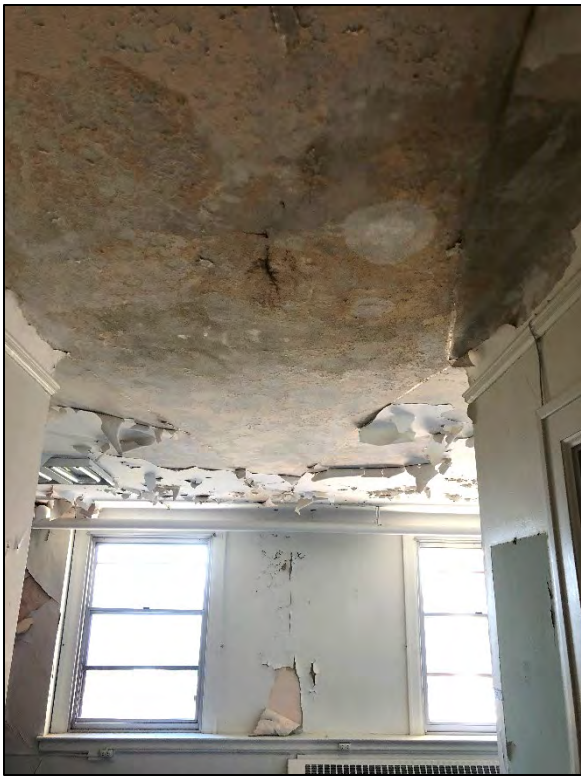
Fig. 82 – Condition: Main Building, interior, second floor, water damage at south Solarium.

SECOND FLOOR – WATER DAMAGE

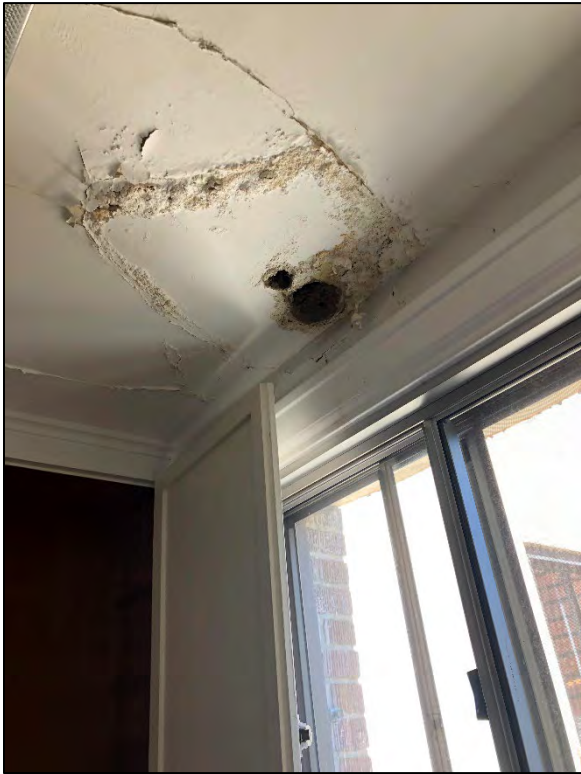
Fig. 83 – Condition: Main Building, interior, third floor, water damage.

THIRD FLOOR – WATER DAMAGE

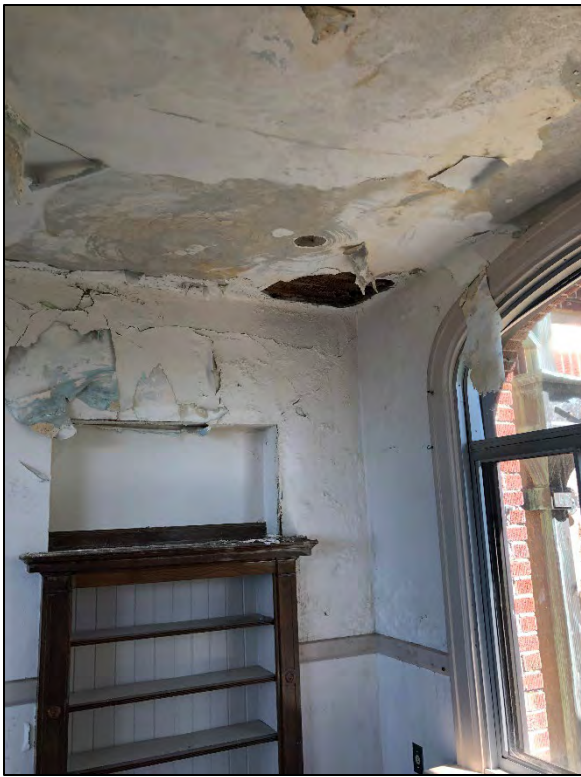
Fig. 84 – Condition: Main Building, interior, fourth floor, water damage at residential kitchen.

FOURTH FLOOR – WATER DAMAGE

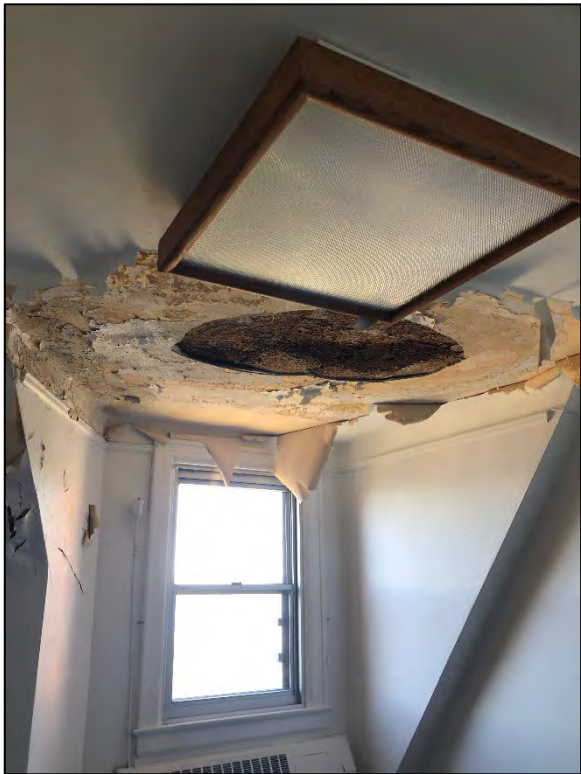
Fig. 85 – Condition: Main Building, interior, fourth floor, water damage at south Solarium.

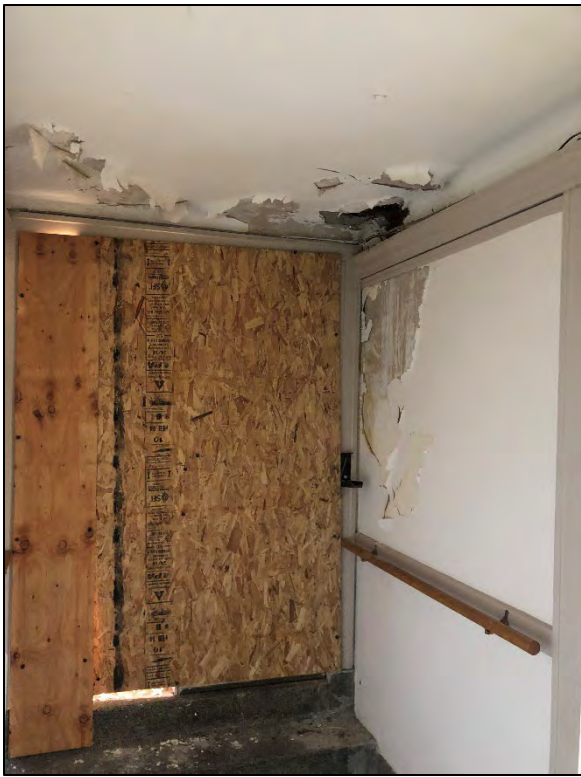
Fig. 86 – Condition: Main Building, interior, fifth floor, water damage at a bedroom.

FIFTH FLOOR – WATER DAMAGE

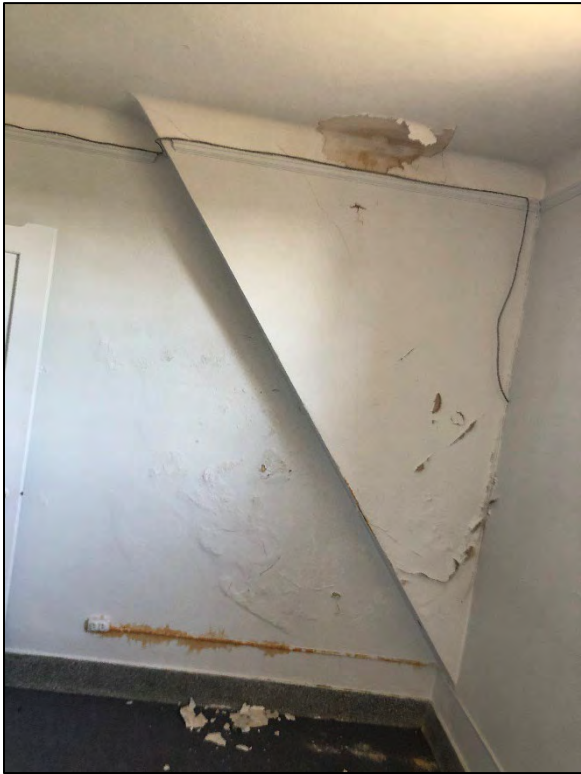
Fig. 87 – Condition: Main Building, interior, fifth floor, water damage at south wing.

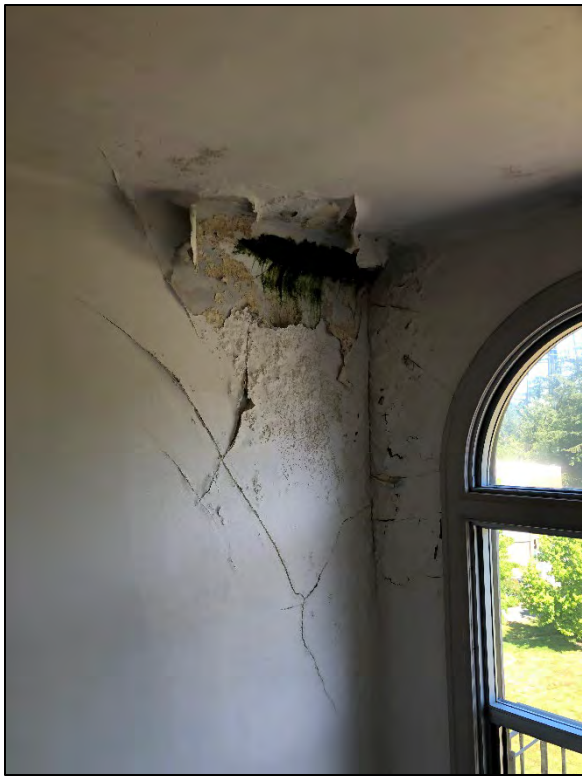
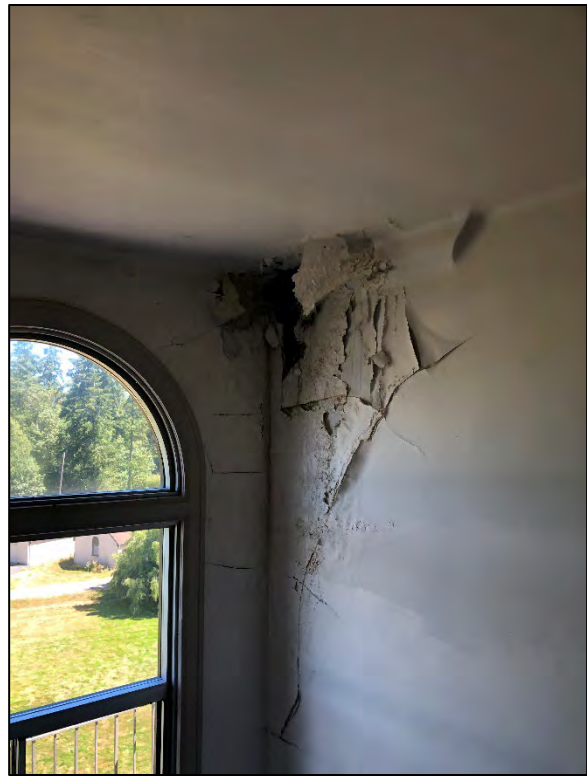
Fig. 88 – Condition: Main Building, interior, fifth floor, water damage.

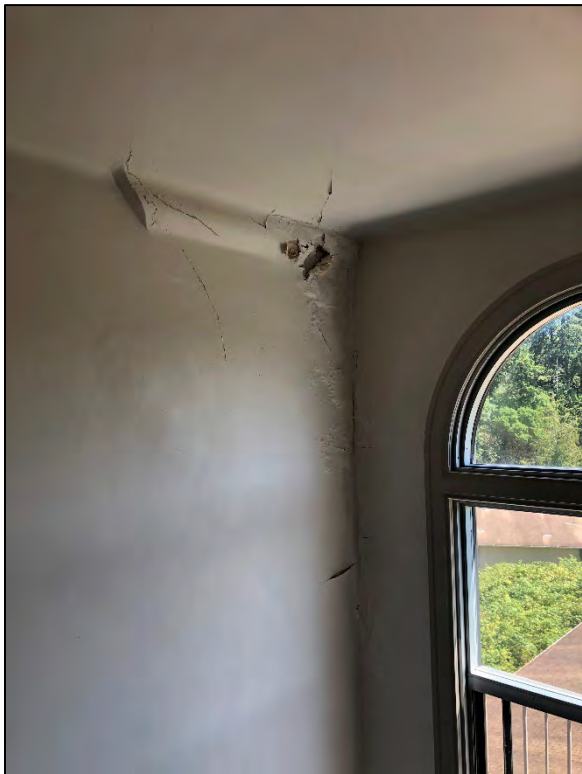
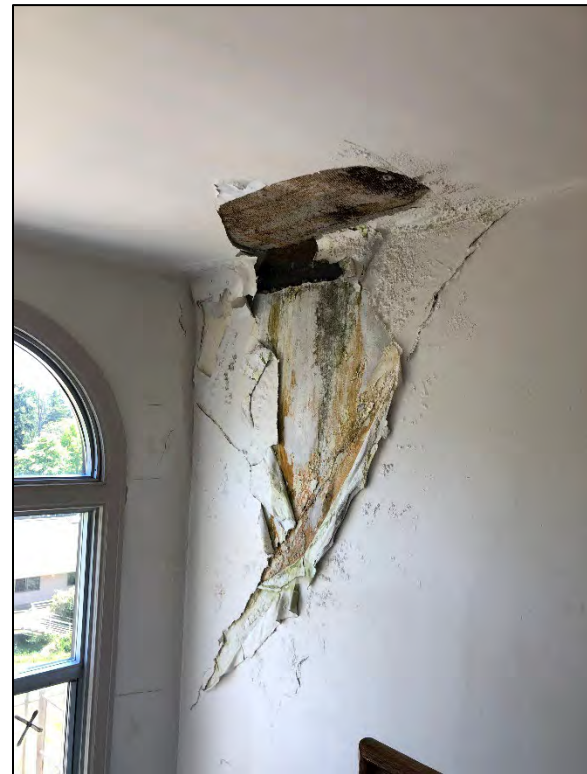
Fig. 89 – Condition: Main Building, interior, fifth floor, water damage at north stair tower
