**CITY OF DES MOINES**  
**ZENITH PROPERTIES BUILDING DEMOLITION**  
**PERMIT APPLICATION**

**DRAFT ENVIRONMENTAL IMPACT STATEMENT**  
**APPENDICES (PART 1: APPENDICES A-D)**

**JANUARY 2024**

**APPENDIX B**    **DEMOLITION PLAN**

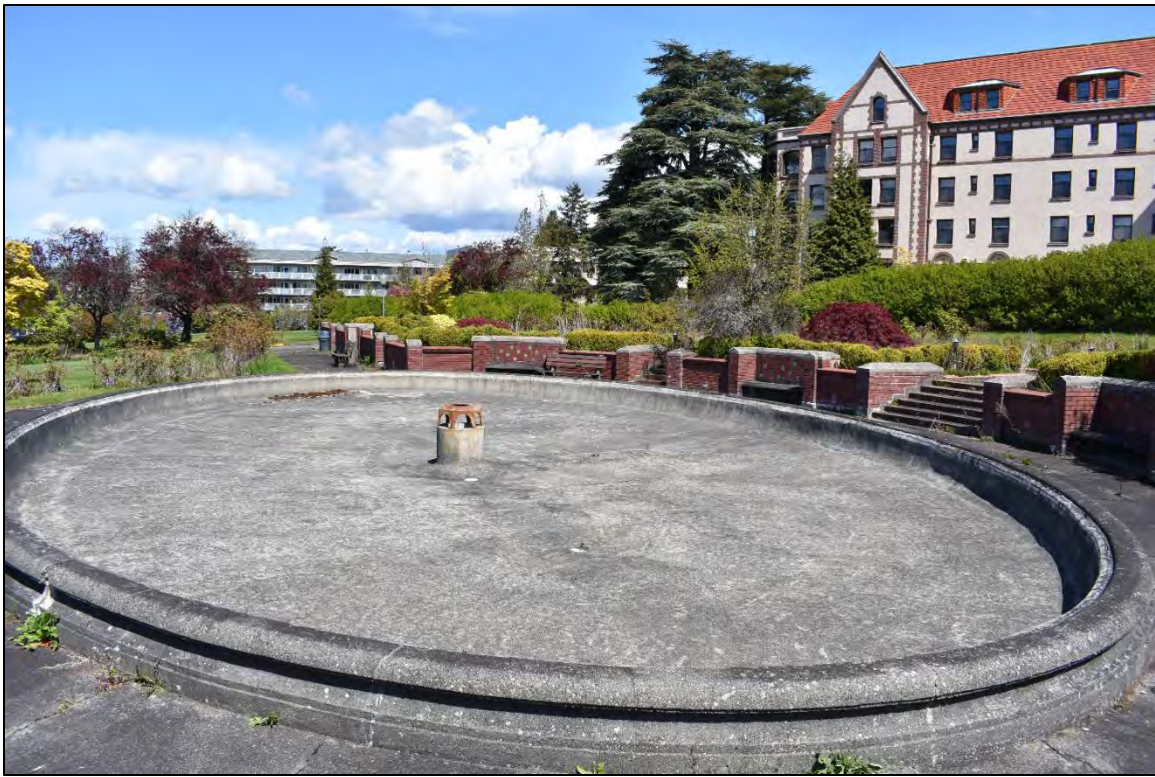
Fig. 99 – Central Oval, pool and curved brick retaining wall with seating.

Fig. 98 – Central Oval, view northwest from Main Building.	53
Fig. 99 – Central Oval, pool and curved brick retaining wall with seating.	54
Fig. 100 – Central Oval, brick retaining wall at walk, view south.	54
Fig. 101 – Central Oval, brick retaining wall, detail of seating.	55
Fig. 102 – Central Oval, detail of paths and garden beds with curbs.	55
Fig. 103 – Central Oval, detail of memorial flagpole base and sundial.	56
Fig. 104 – Central Oval, detail of concrete roadway, walk, and garden beds with curbs.	56
Fig. 105 – Central Oval lawn, view north. Buildings visible are off the subject property.	57
Fig. 106 – Central Oval lawn, view south.	57
Fig. 107 – Central Oval lawn, view west.	58
Fig. 108 – Central Oval lawn, view east.	58
Fig. 109 – View northeast across front lawn from southwest property corner towards Main Building	59
Fig. 110 – Central Oval, Masonic Home sign.	59
Fig. 111 – Front gates.	60

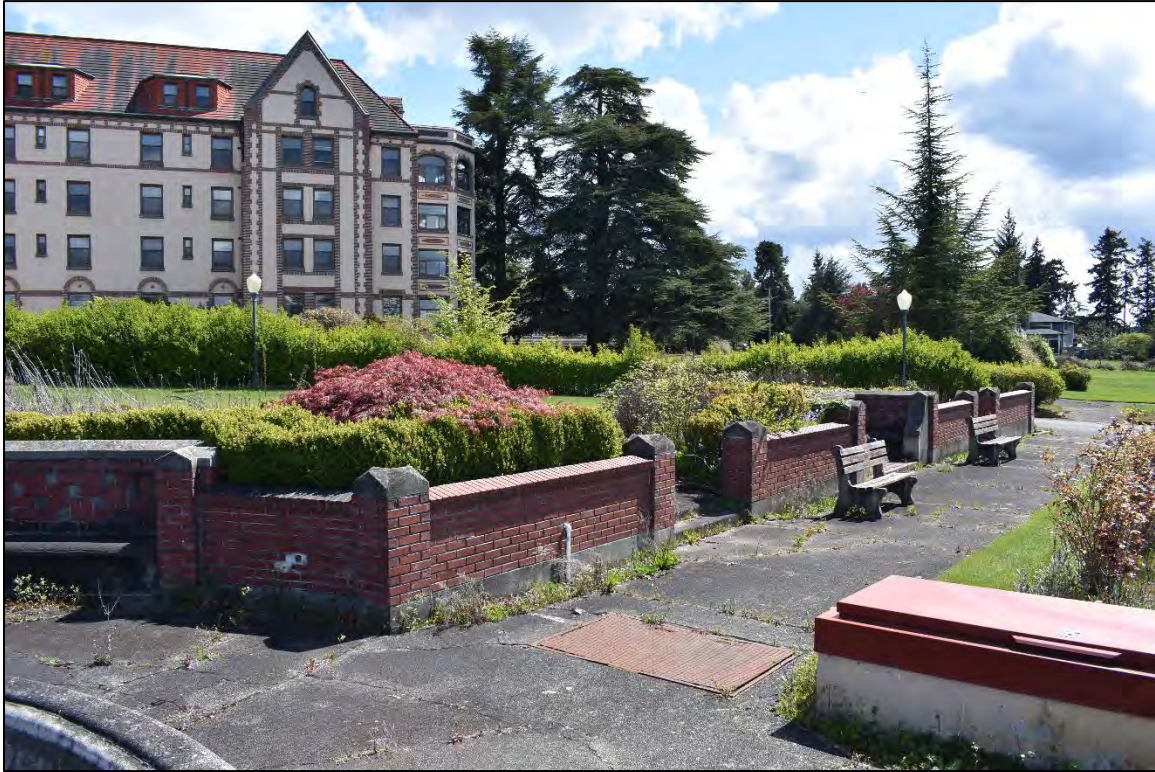
Fig. 100 – Central Oval, brick retaining wall at walk, view south.

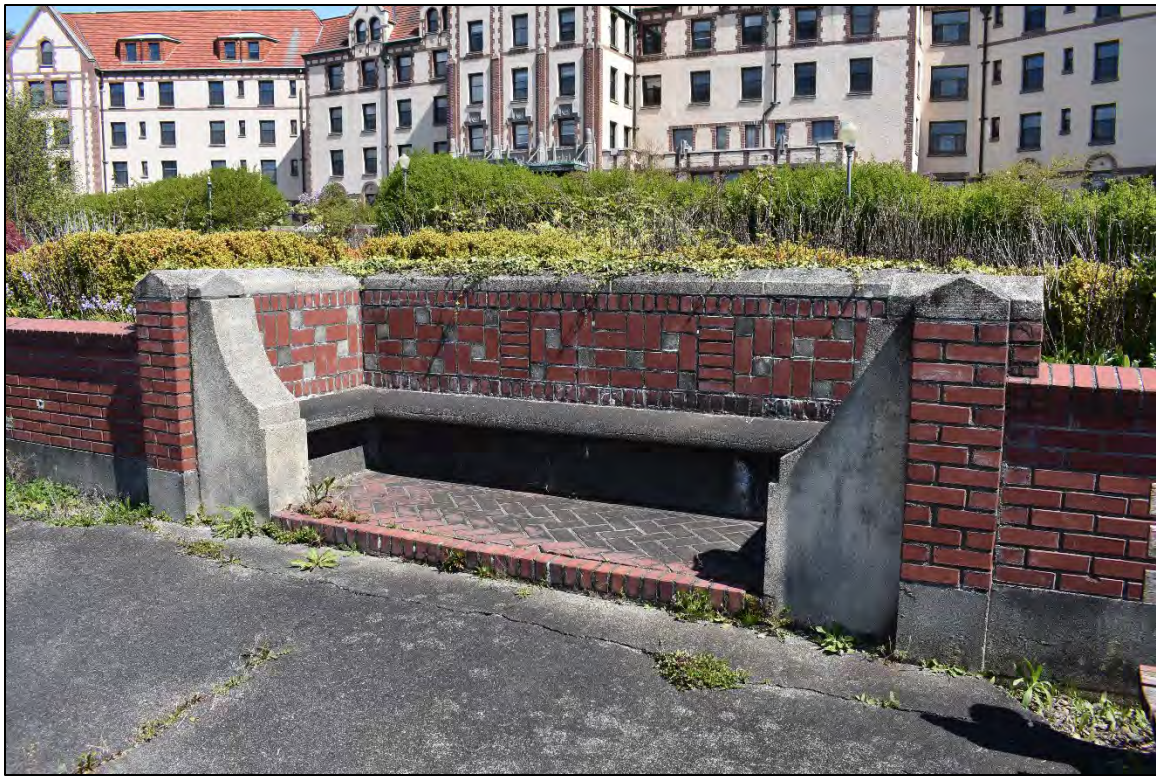
Fig. 101 – Central Oval, brick retaining wall, detail of seating.

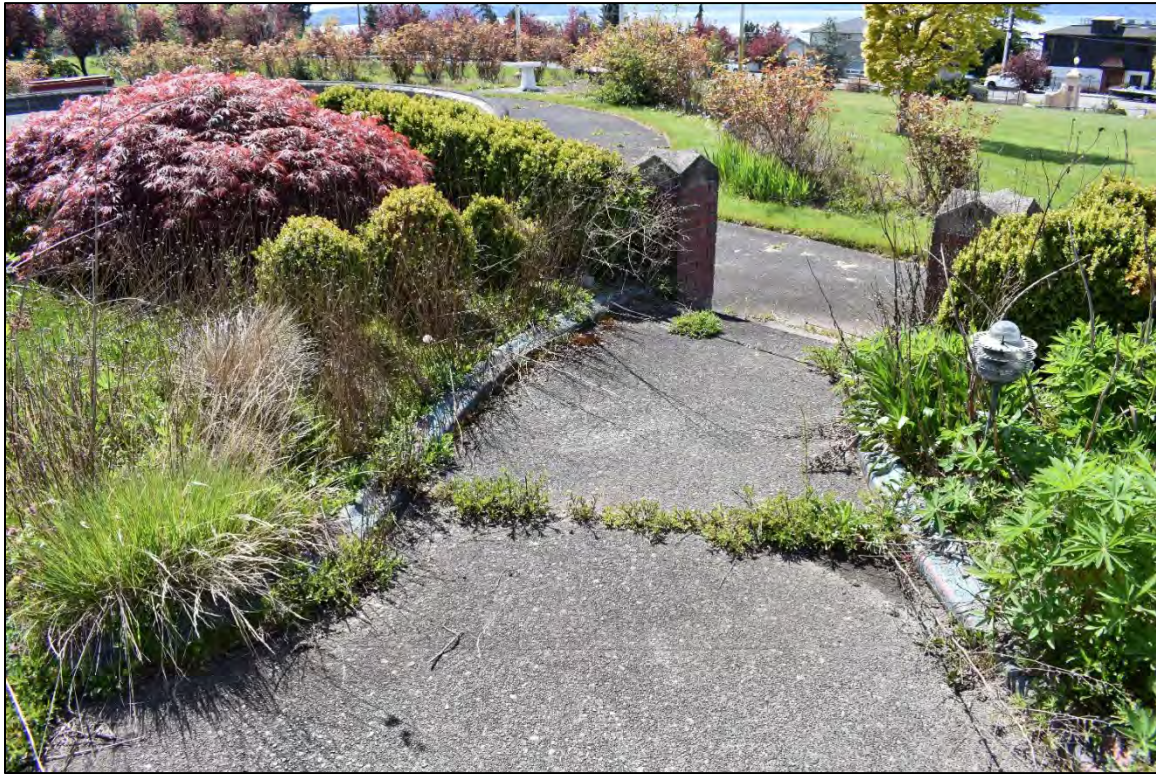
Fig. 102 – Central Oval, detail of paths and garden beds with curbs.

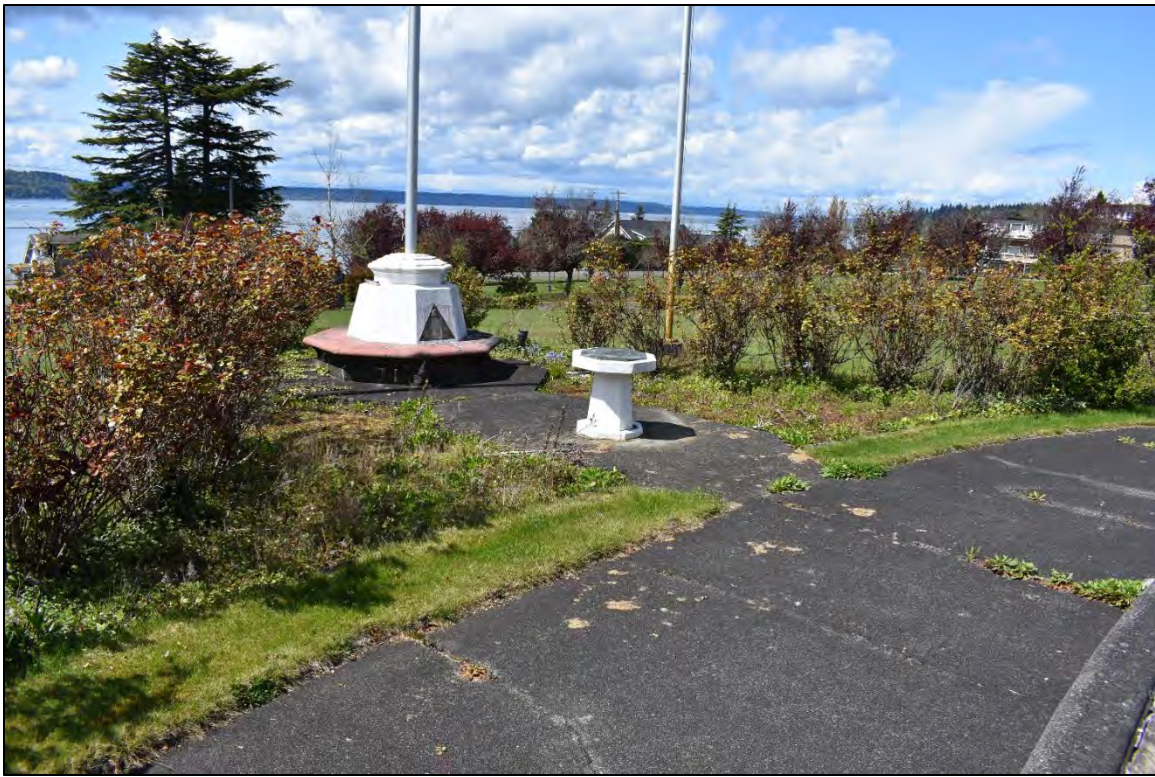
Fig. 103 – Central Oval, detail of memorial flagpole base and sundial.

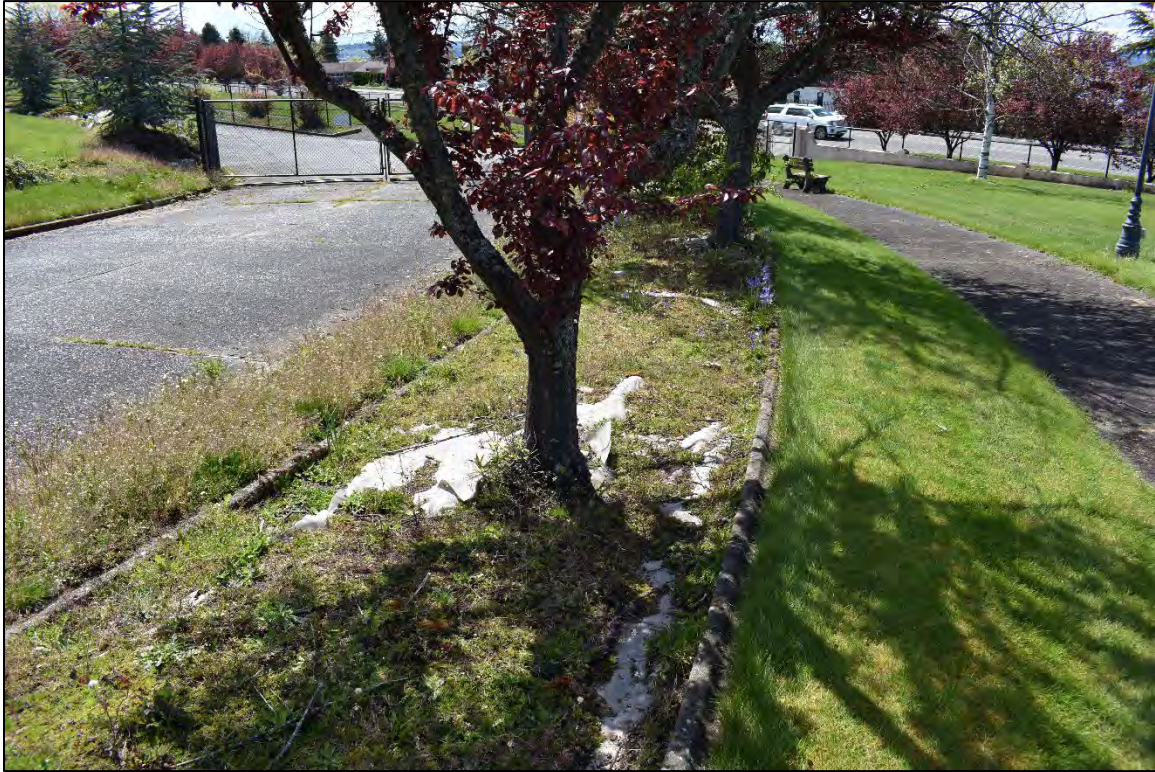
Fig. 104 – Central Oval, detail of concrete roadway, walk, and garden beds with curbs.

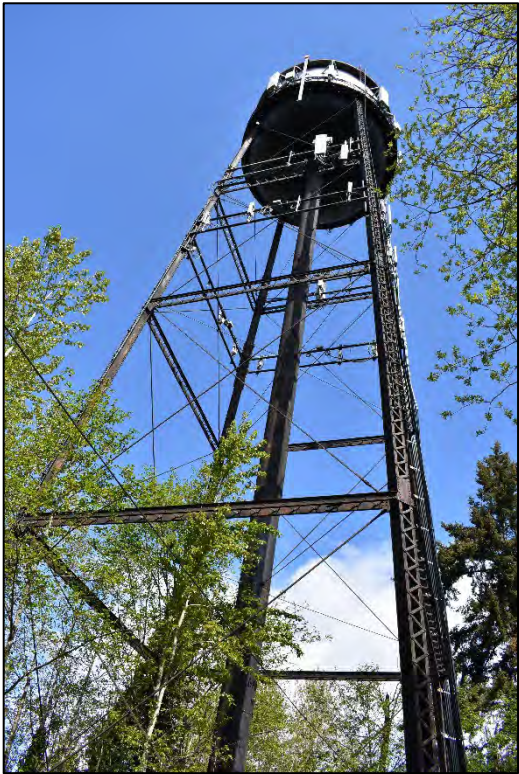
Fig. 112 – Water Tower (built 1926).

Fig. 112 – Water Tower (built 1926).	60
Fig. 113 – Water Tower pump house (built 1926).	61
Fig. 114 – Storage Building at left (built 1997); Garage at right (built 1937).(2019)	61
Fig. 115 – Outdoor Kitchen (unknown construction date, mid-20 <sup>th</sup> century) in woods east of the Main Building.	62
Fig. 116 – Dining Patio (unknown construction date, late 20 <sup>th</sup> century) in woods east of the Main Building. Visible at right is the Outdoor Kitchen.	62
Fig. 117 – Restroom Building (unknown construction date, mid-20 <sup>th</sup> century) in woods east of the Main Building.	63
Fig. 118 – Path to Outdoor Kitchen, Dining Patio, and Restrooms in woods east of the Main Building.	63
Fig. 119 – Path along eastern property line (marked by chain link fence) in woods east of the Main Building. Buildings visible at right are off the subject property.	64
Fig. 120 – Site: View north through glade towards Outdoor Kitchen, in woods east of the Main Building. (2019)	64

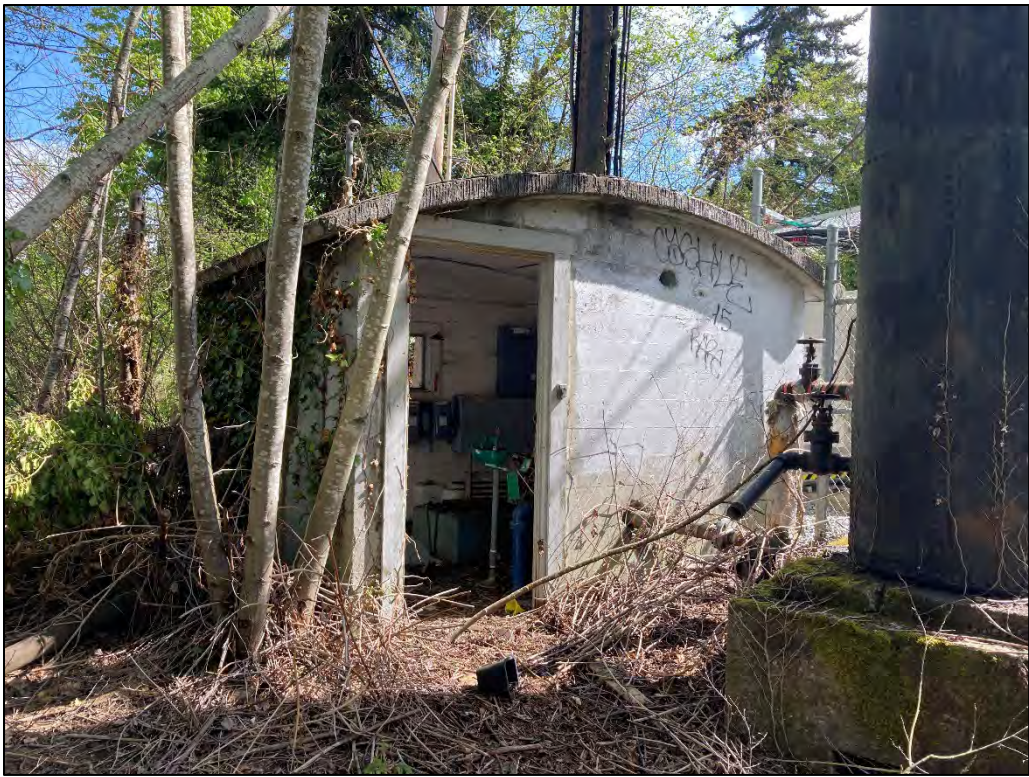
Fig. 113 – Water Tower pump house (built 1926).

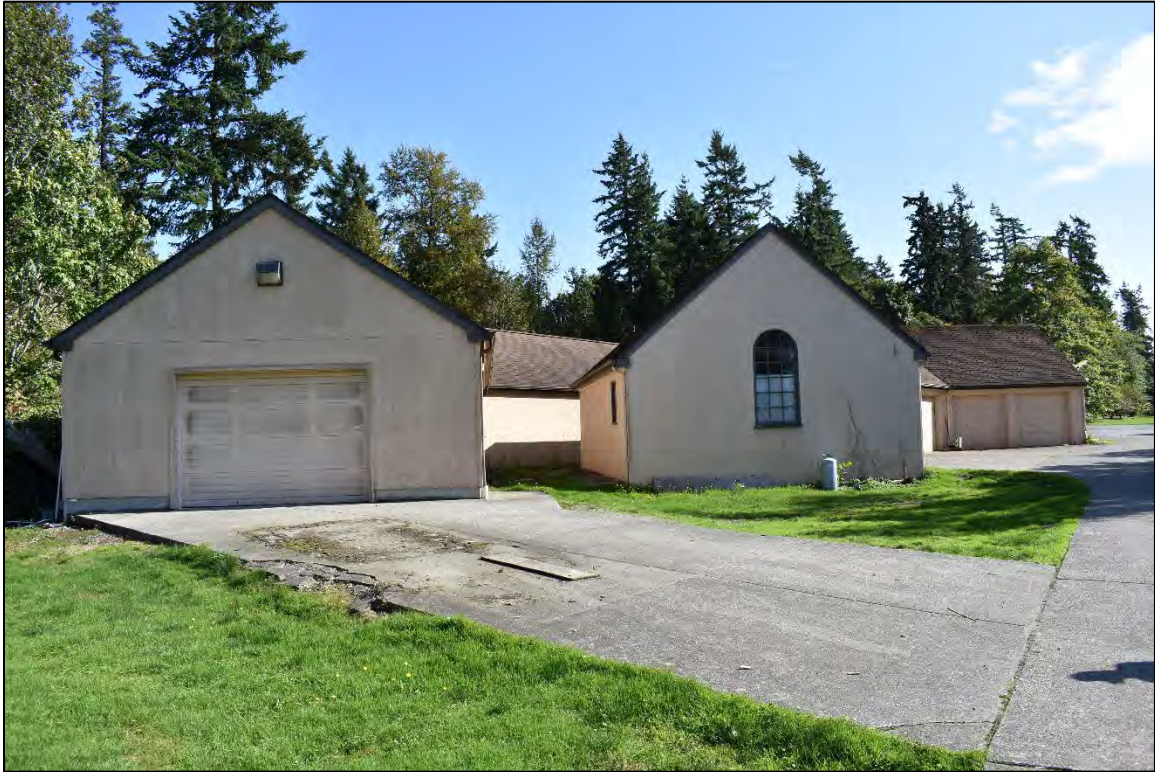
Fig. 114 – Storage Building at left (built 1997); Garage at right (built 1937). (2019)

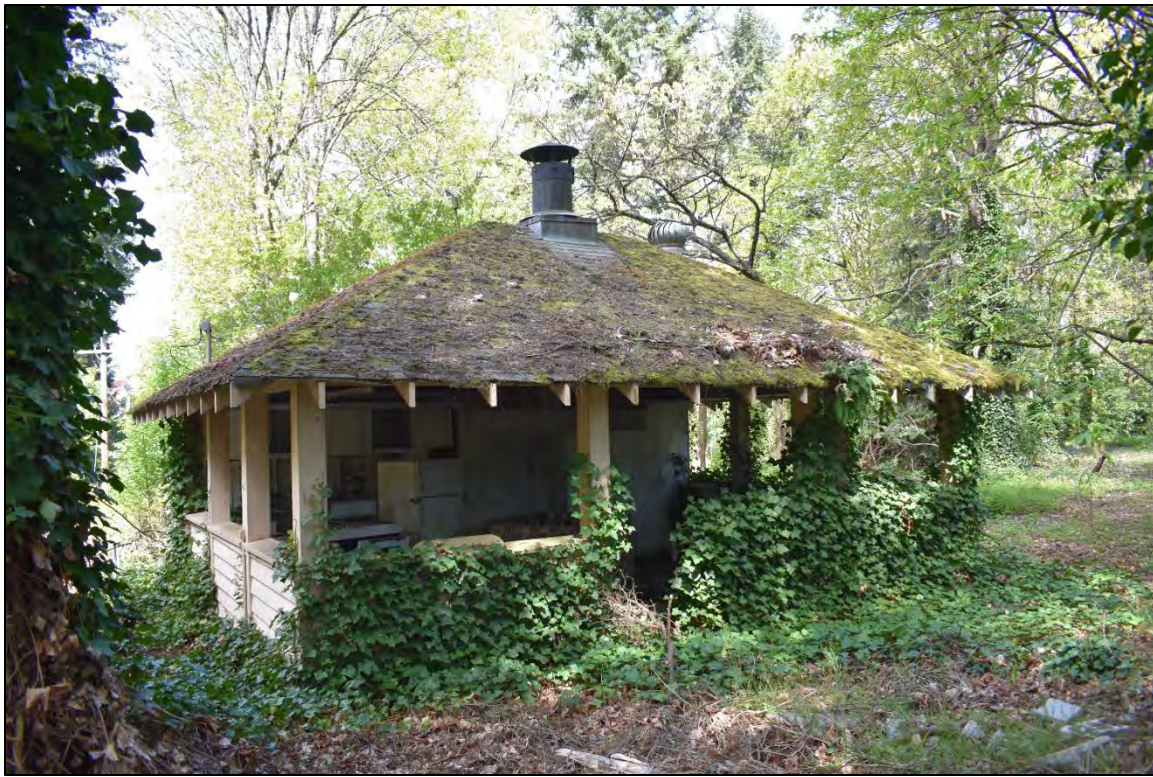
Fig. 115 – Outdoor Kitchen (unknown construction date, mid-20<sup>th</sup> century) in woods east of the Main Building.

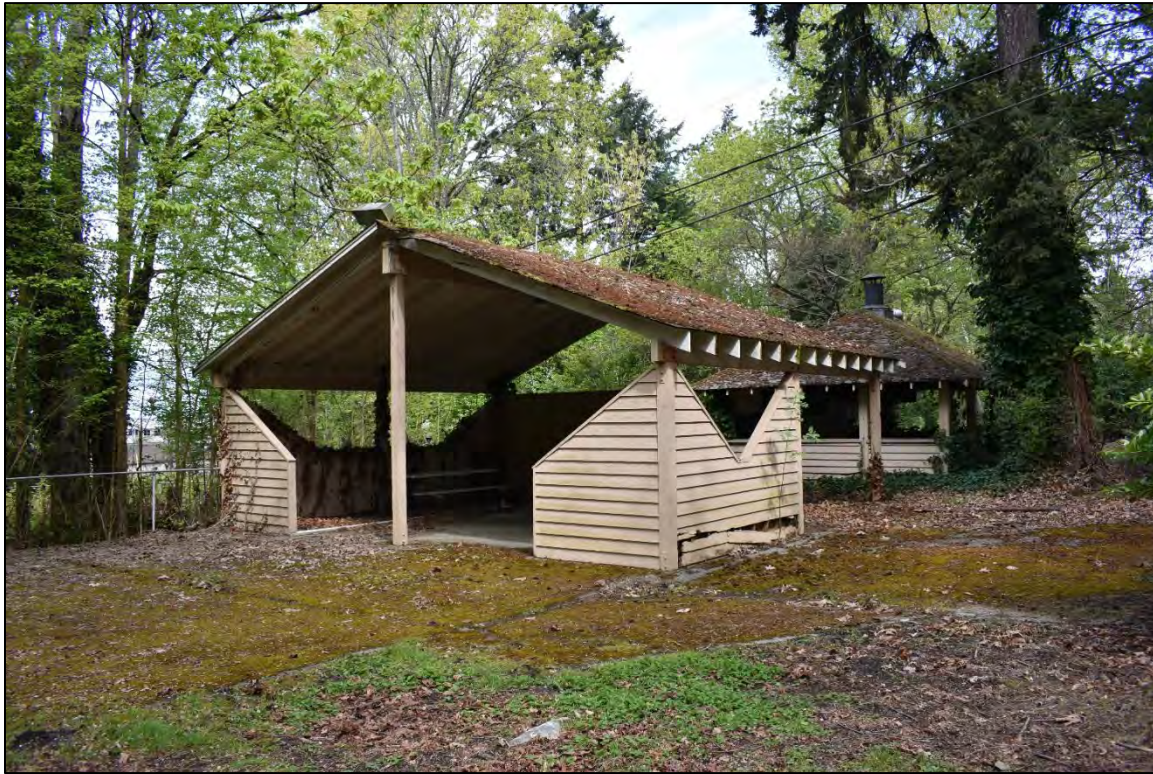
Fig. 116 – Dining Patio (unknown construction date, late 20<sup>th</sup> century) in woods east of the Main Building. Visible at right is the Outdoor Kitchen.

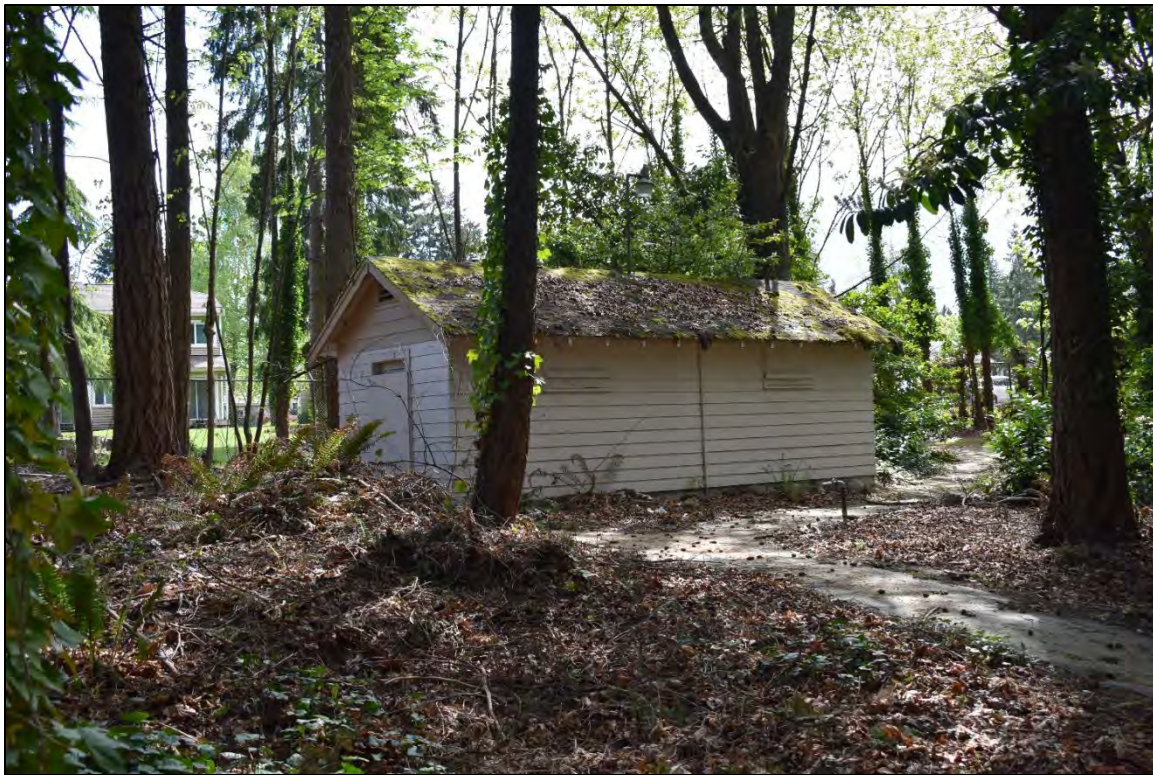
Fig. 117 – Restroom Building (unknown construction date, mid-20<sup>th</sup> century) in woods east of the Main Building.

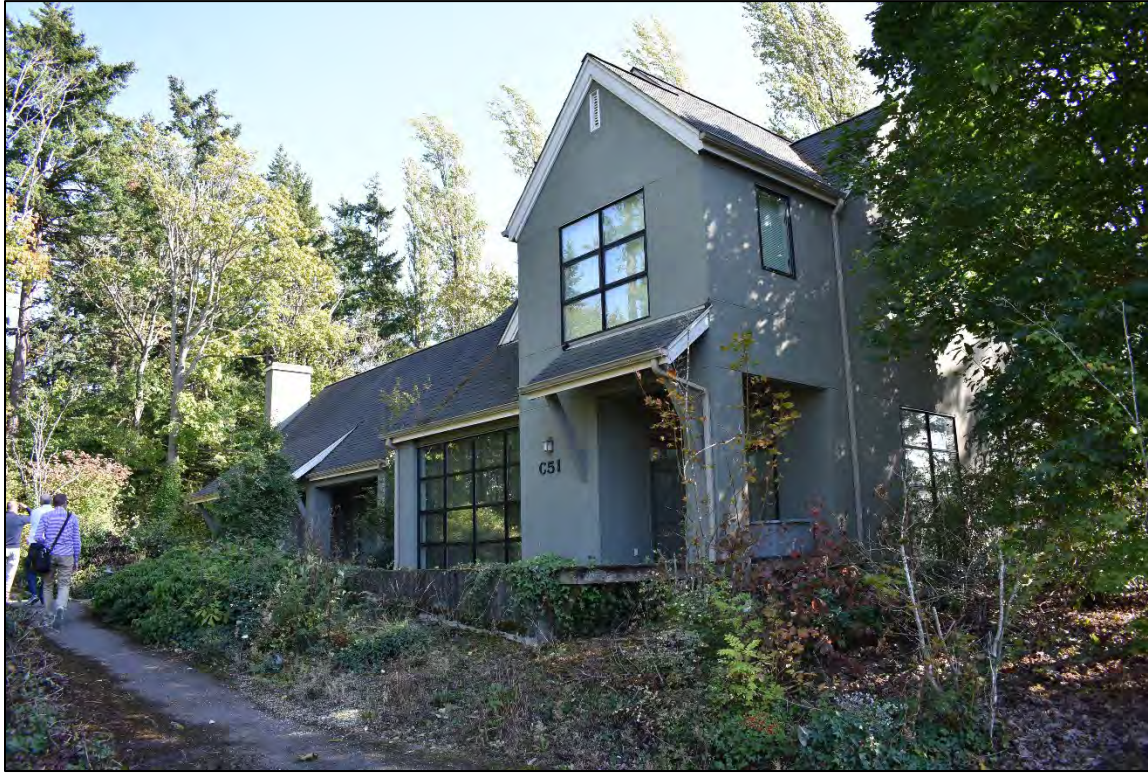
Fig. 122 – House (built 2004 as a model home and sales office) southeast of Infirmary Wing along south property line, view southeast. (2019)

Fig. 121 – Site: Glade in woods east of Main Building and Infirmary Wing, view north. (2019)	65
Fig. 122 – House (built 2004 as a model home and sales office) southeast of Infirmary Wing along south property line, view southeast. (2019)	65
