NOTICE OF UPDATED SEPA RECORD AND EXTENSION OF PUBLIC COMMENT PERIOD FOR THE ZENITH PROPERTIES BUILDING DEMOLITION APPLICATION DRAFT ENVIRONMENTAL IMPACT STATEMENT (DEIS)

CITY OF DES MOINES
ZENITH PROPERTIES BUILDING DEMOLITION
PERMIT APPLICATION

DRAFT ENVIRONMENTAL IMPACT STATEMENT
APPENDICES (PART 2: APPENDICES E-K)

Zenith Properties LLC Des Moines Masonic Lodge Economic Feasibility Analysis

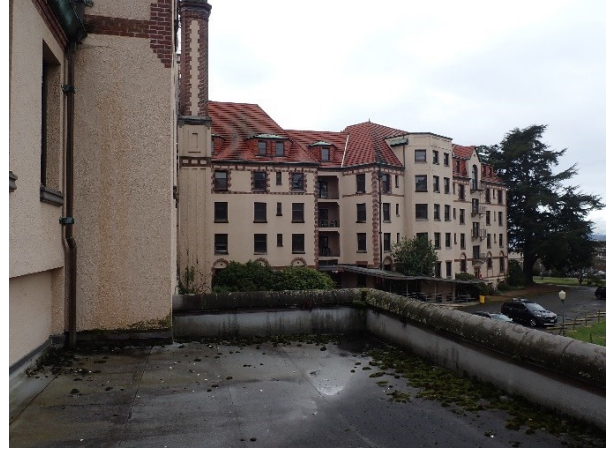
Photo BE8 Typical Low Roof

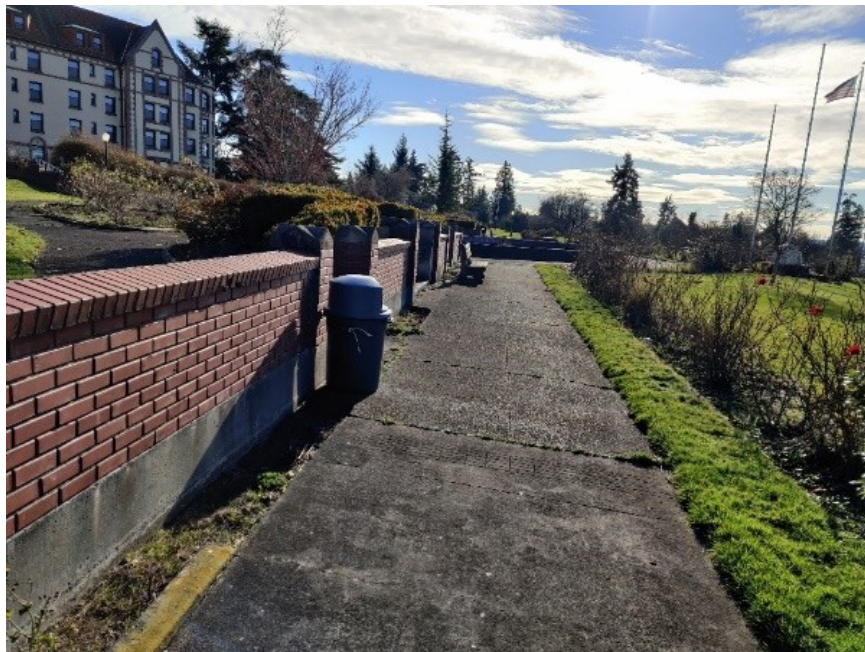
Photo C3 Example pavement

The pavement onsite is nearing the end of its design life but is still usable. It displays differential settlement at the rear of the building but remains adequate. Existing cross slopes on some walkways are not compliant particularly in the entry area. See Photo C3 below.

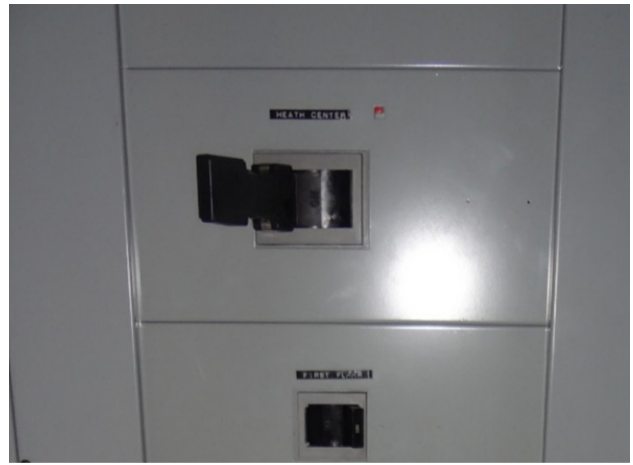
Photo E4 Health center – from main building switchboard

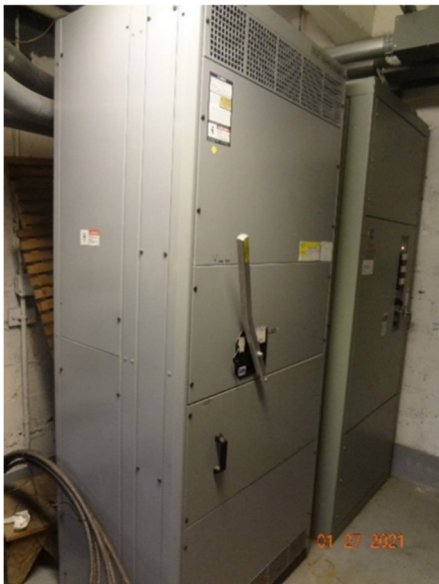
Photo E7 Left-Service Disc. Right – ATS

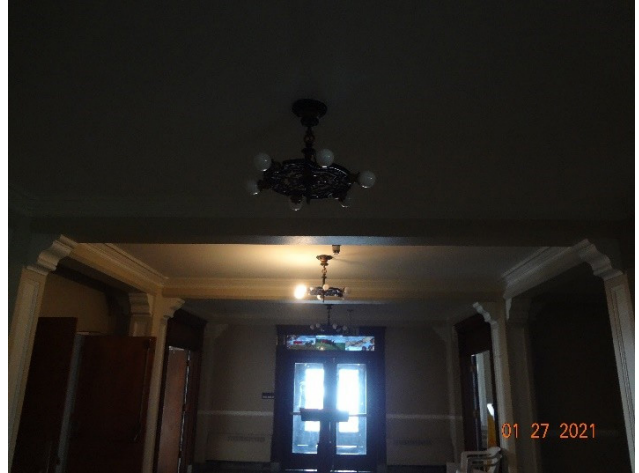
- Lighting fixtures are most compact fluorescent, or incandescent type (Photos E15, E16), will not comply to current energy code.
- Dwelling units and corridor receptacles are in fair or poor condition and mix with surface and recess mounted type (Photo E17)

Photo E16 Incandescent type lights at entrance

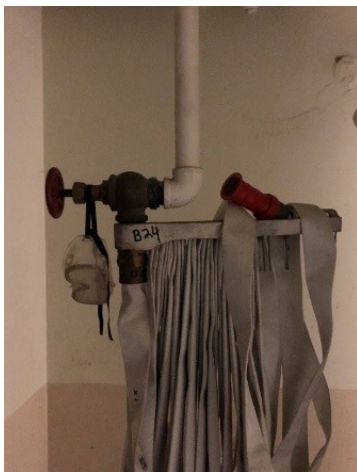
- The main building is served by multiple fire hose connections (Photo FP1) on various floors.
- The existing fire water controls valve are located in the basement (Photo FP2).

Photo FP1 Fire Hose

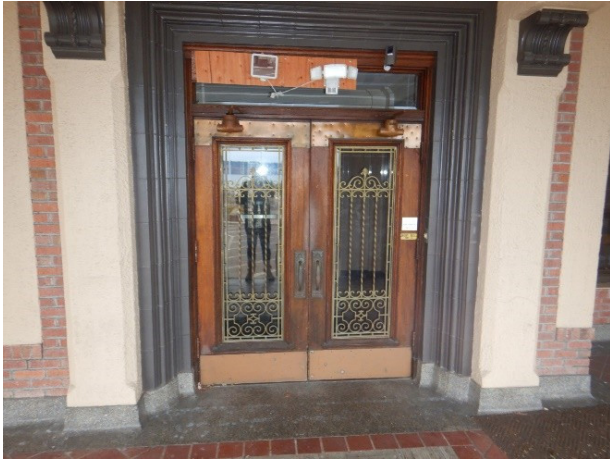
Photo ADA10 Main Entry

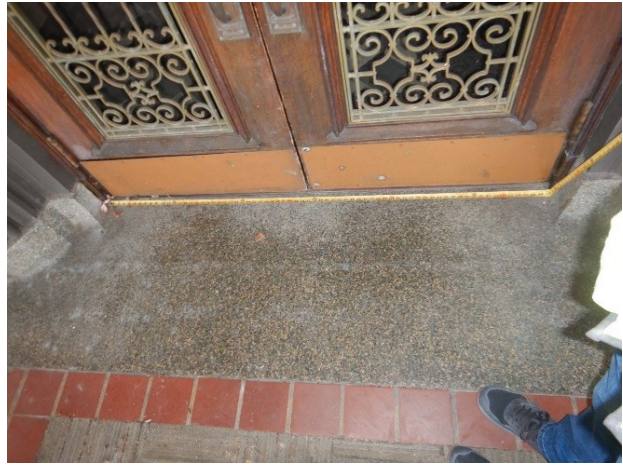
- Minimum clear width through any single door openings is 32 inches with no projections into the opening less than 34 inches above the floor. Currently, this door clear width is greater than 32 inches.
- Door closers should be adjusted so that closing time from 90 degrees to 12 degrees is 12 seconds minimum. Currently, the door closer speed is properly adjusted.
- Minimum maneuvering clearance in vestibule, between two doors is 48 inches plus the width of any door(s) swinging into that space. In addition to the 48 inches clearance there must also be a minimum maneuvering space of 60-inch diameter. Currently, this facility's main entrance vestibule maneuvering clearance meets the ADA requirements.
- Maximum door threshold height is $\frac{1}{2}$ -inch. Currently, this facility's main entrance original threshold is less than $\frac{1}{2}$ -inch.

Photo ADA11 Main Entry Door Widths, >32 inches

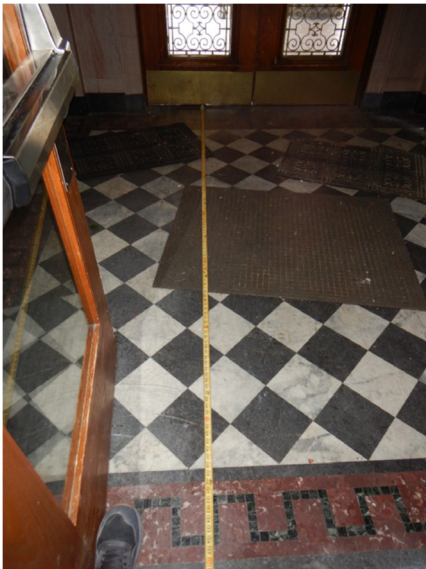
Photo ADA12 Main Entry Vestibule

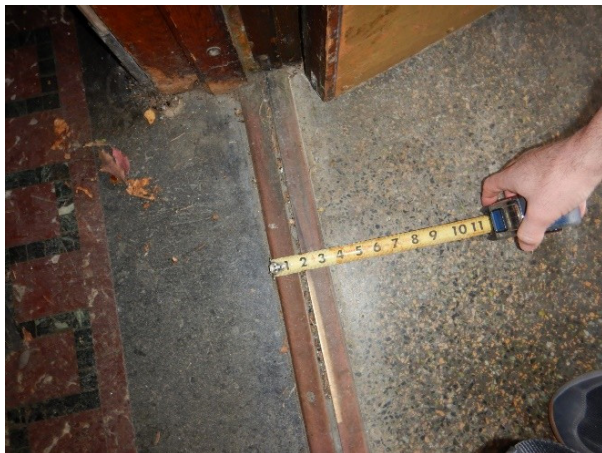
Photo ADA14 Main Entry Threshold Width

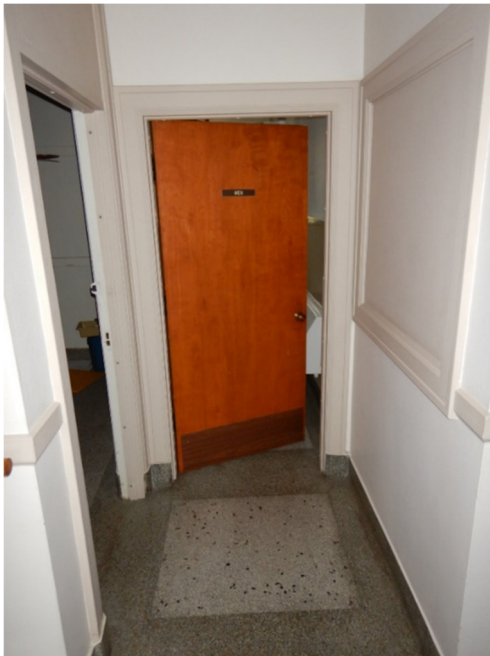
Photo ADA16 Men's Restroom

- Minimum clear width through any single door openings is 32 inches with no projections into the opening less than 34 inches above the floor. Currently, the single door clear width is greater than 32 inches.
- Minimum maneuvering space of 60-inch diameter, no door may swing into the maneuvering space. Currently, the maneuvering space is greater than 60-inch diameter.
- Clear floor space for the forward approach to the sink shall be a minimum of 30 inches. Currently, the clear space is greater than 30 inches.
- Currently, the water closet and toilet do not meet any of the ADA access requirements.

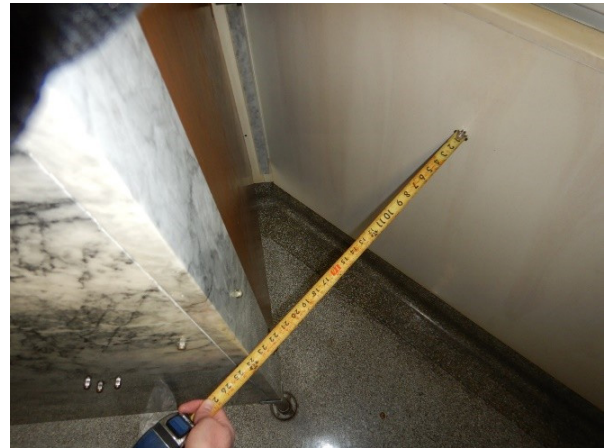
Photo ADA21 Water Closet/Toilet Access
